A Continuation Of The Investigation of the Feasibility of Using Windpower for Space Heating in Colder Climates

"A CONTINUATION OF THE INVESTIGATION OF THE FEASIBILITY
OF USING WINDPOWER FOR SPACE HEATING IN COLDER CLIMATES"

Progress Report for Period Ending
March 31, 1978

Energy Alternatives Program
School of Engineering
University of Massachusetts
Amherst, Massachusetts 01003

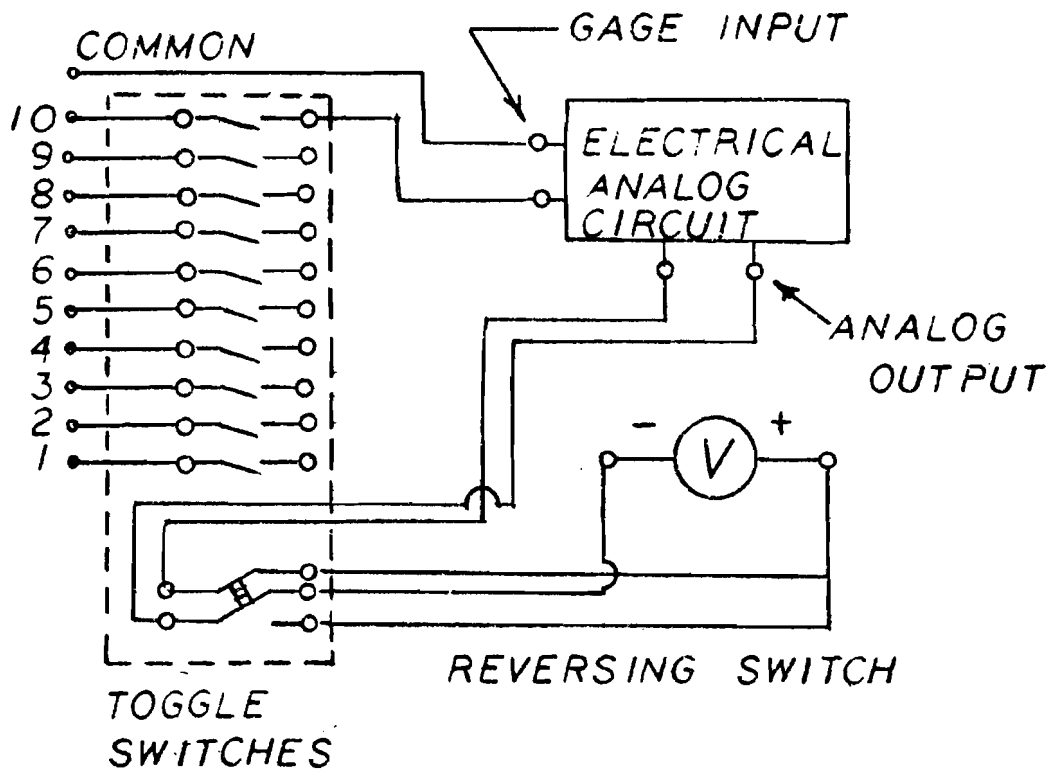
FIGURE 1

STRAIN GAGE ARRANGEMENT

Figure 1 shows the strain gage arrangement around the blade section at the .4875 radius station and a schematic of the circuitry. Tables 1 and 2 show two sets of data taken for a point load of 35 lbs 9.5 oz applied at the .9 radius station. Figure 2 is a plot of strain (micro-inches/inch) as a function of percent of chord. Large error bands are also indicated.

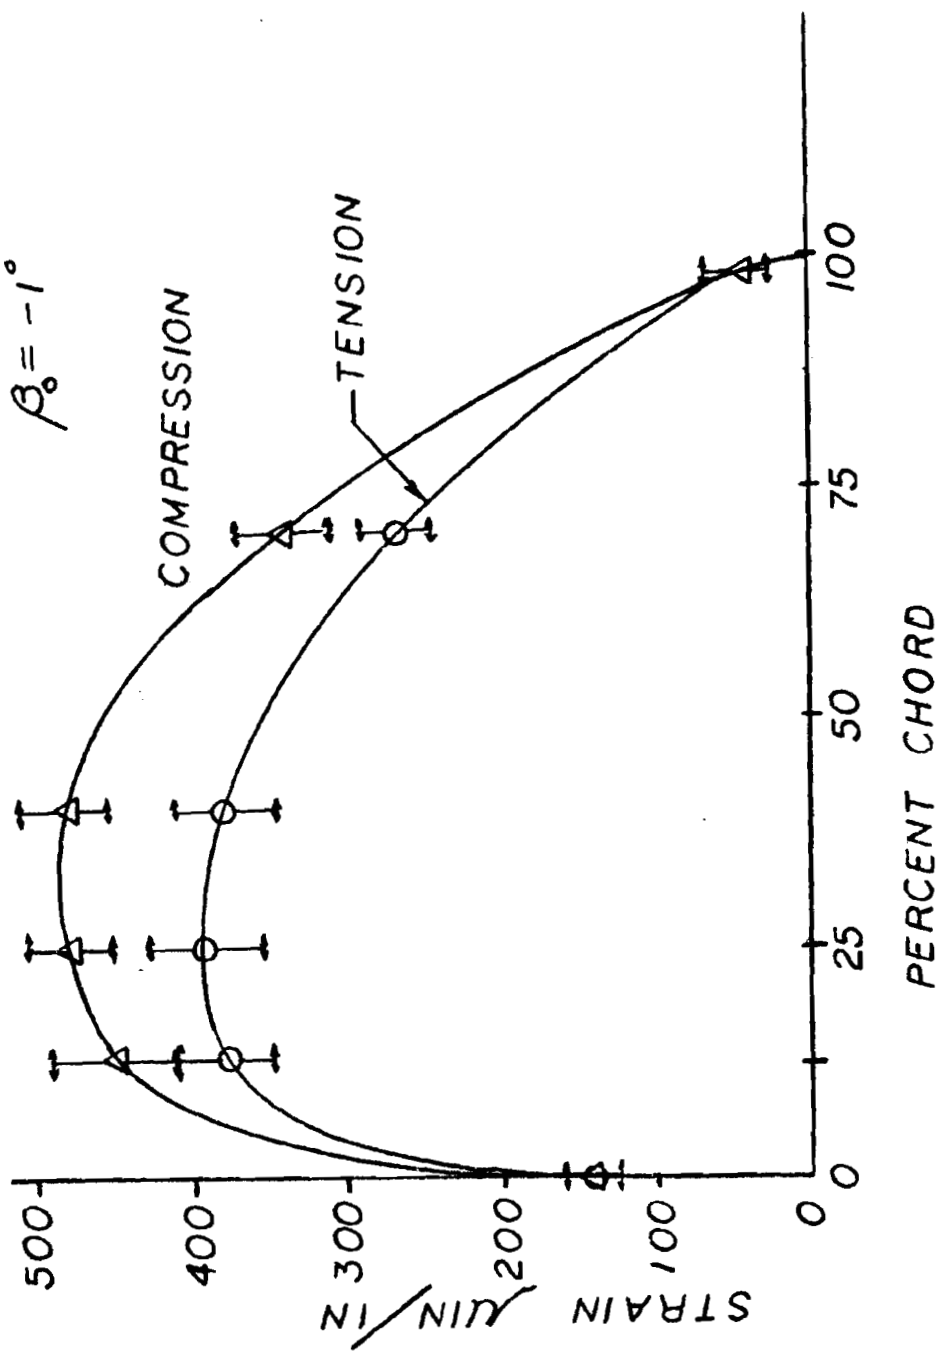
FIGURE 2

SURFACE STRAIN WF-1 BLADE

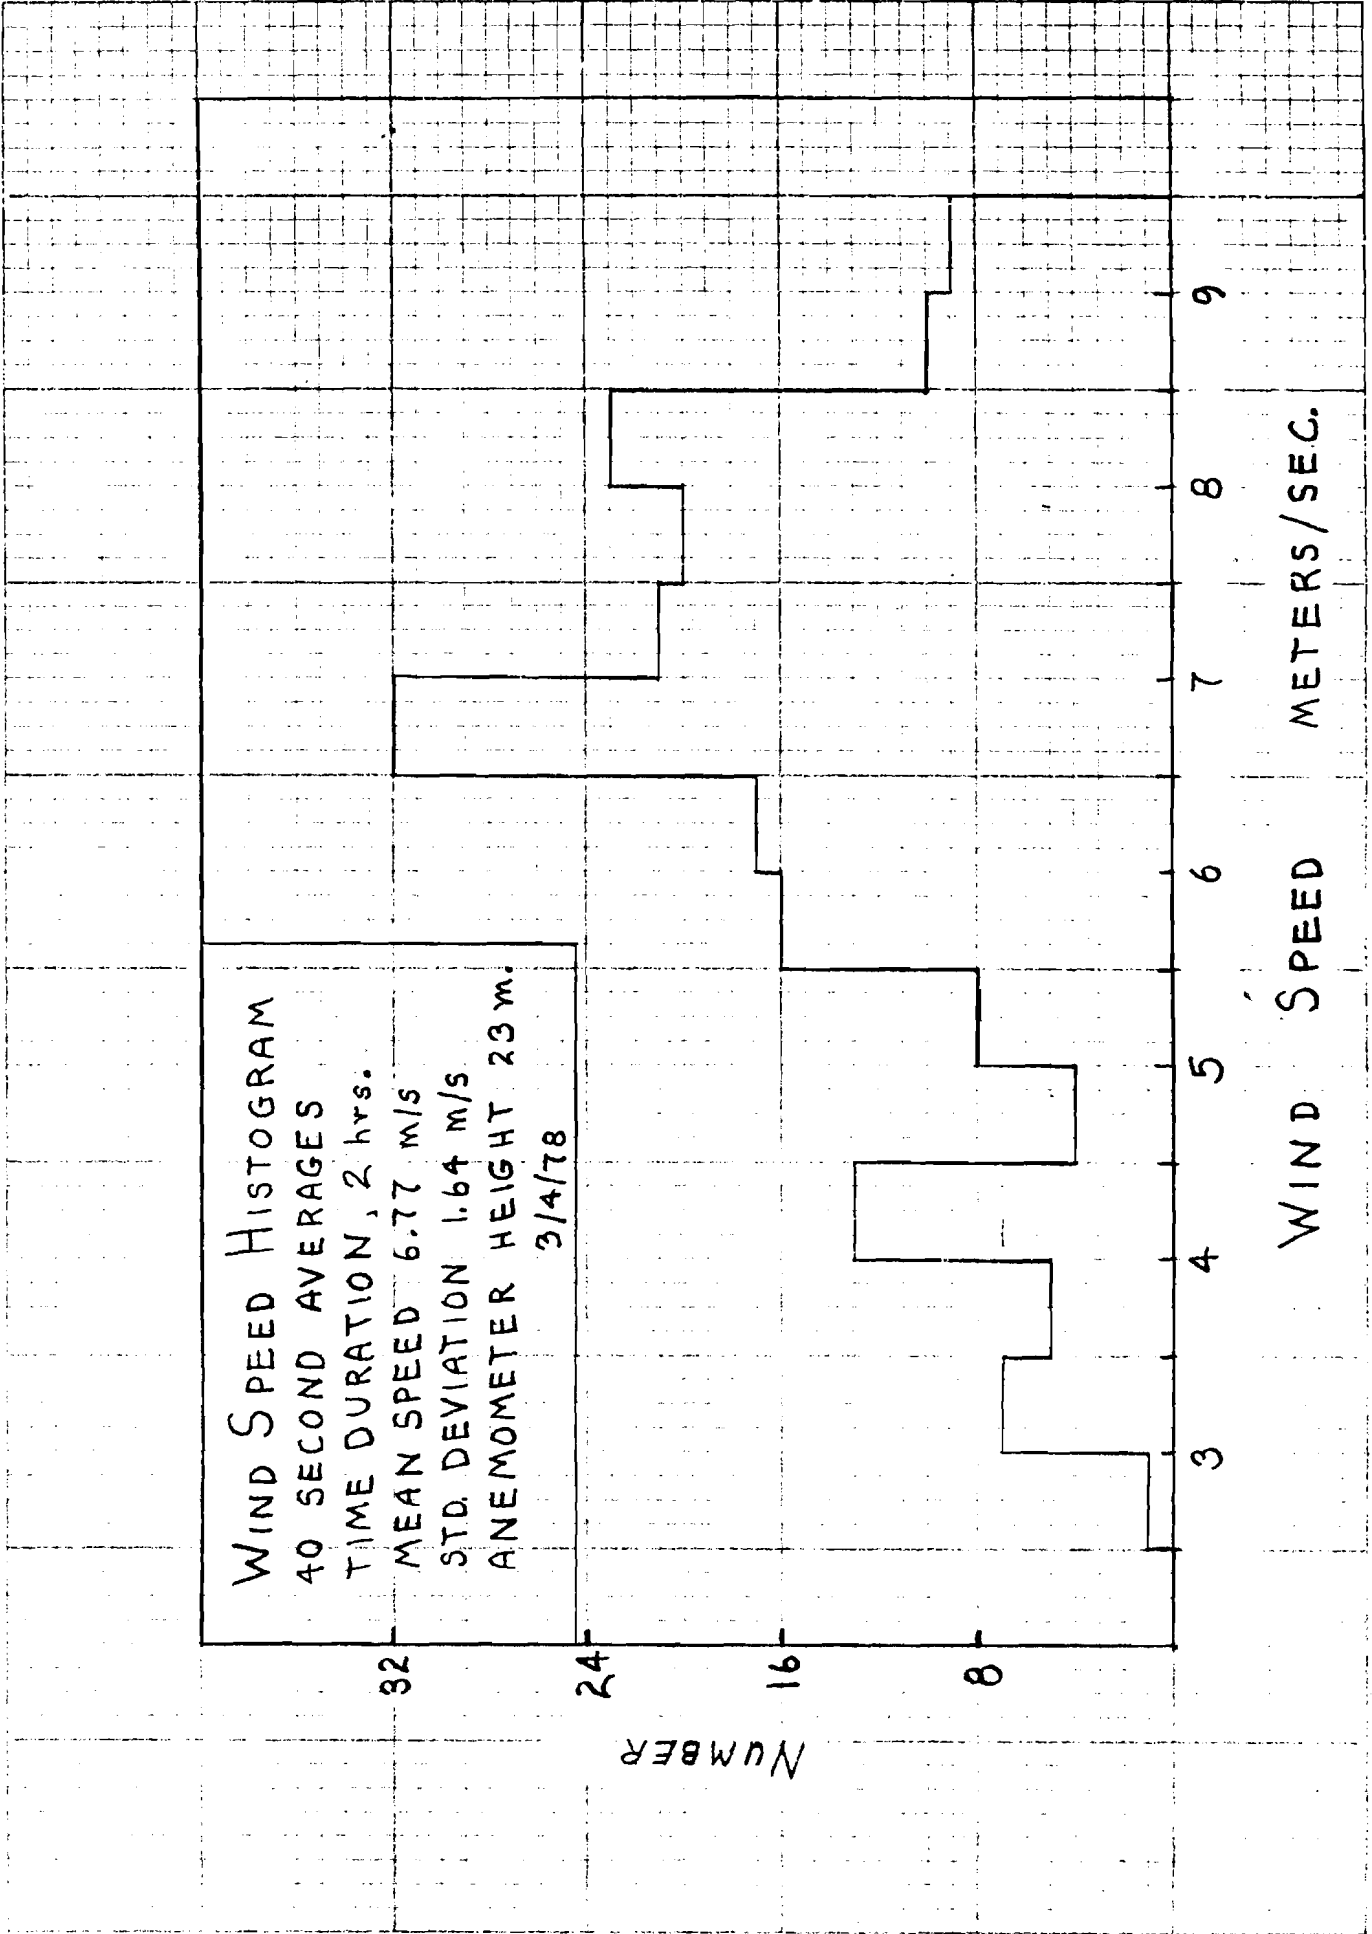
WIND SPEED HISTOGRAM

40 SECOND AVERAGES

TIME DURATION, 2 hrs.

MEAN SPEED 6.77 M/S

STD. DEVIATION 1.64 M/S

ANEMOMETER HEIGHT 23 M.

Figure 2 is a wind speed histogram from one of the anemometers at the 23 meter height. The time duration was only 2 hours for this histogram. It would be difficult to fit an analytical profile to this histogram. It is believed that windspeed averages over more time are necessary to produce a smooth curve amenable to analytical description. Future histograms will be obtained for longer durations.

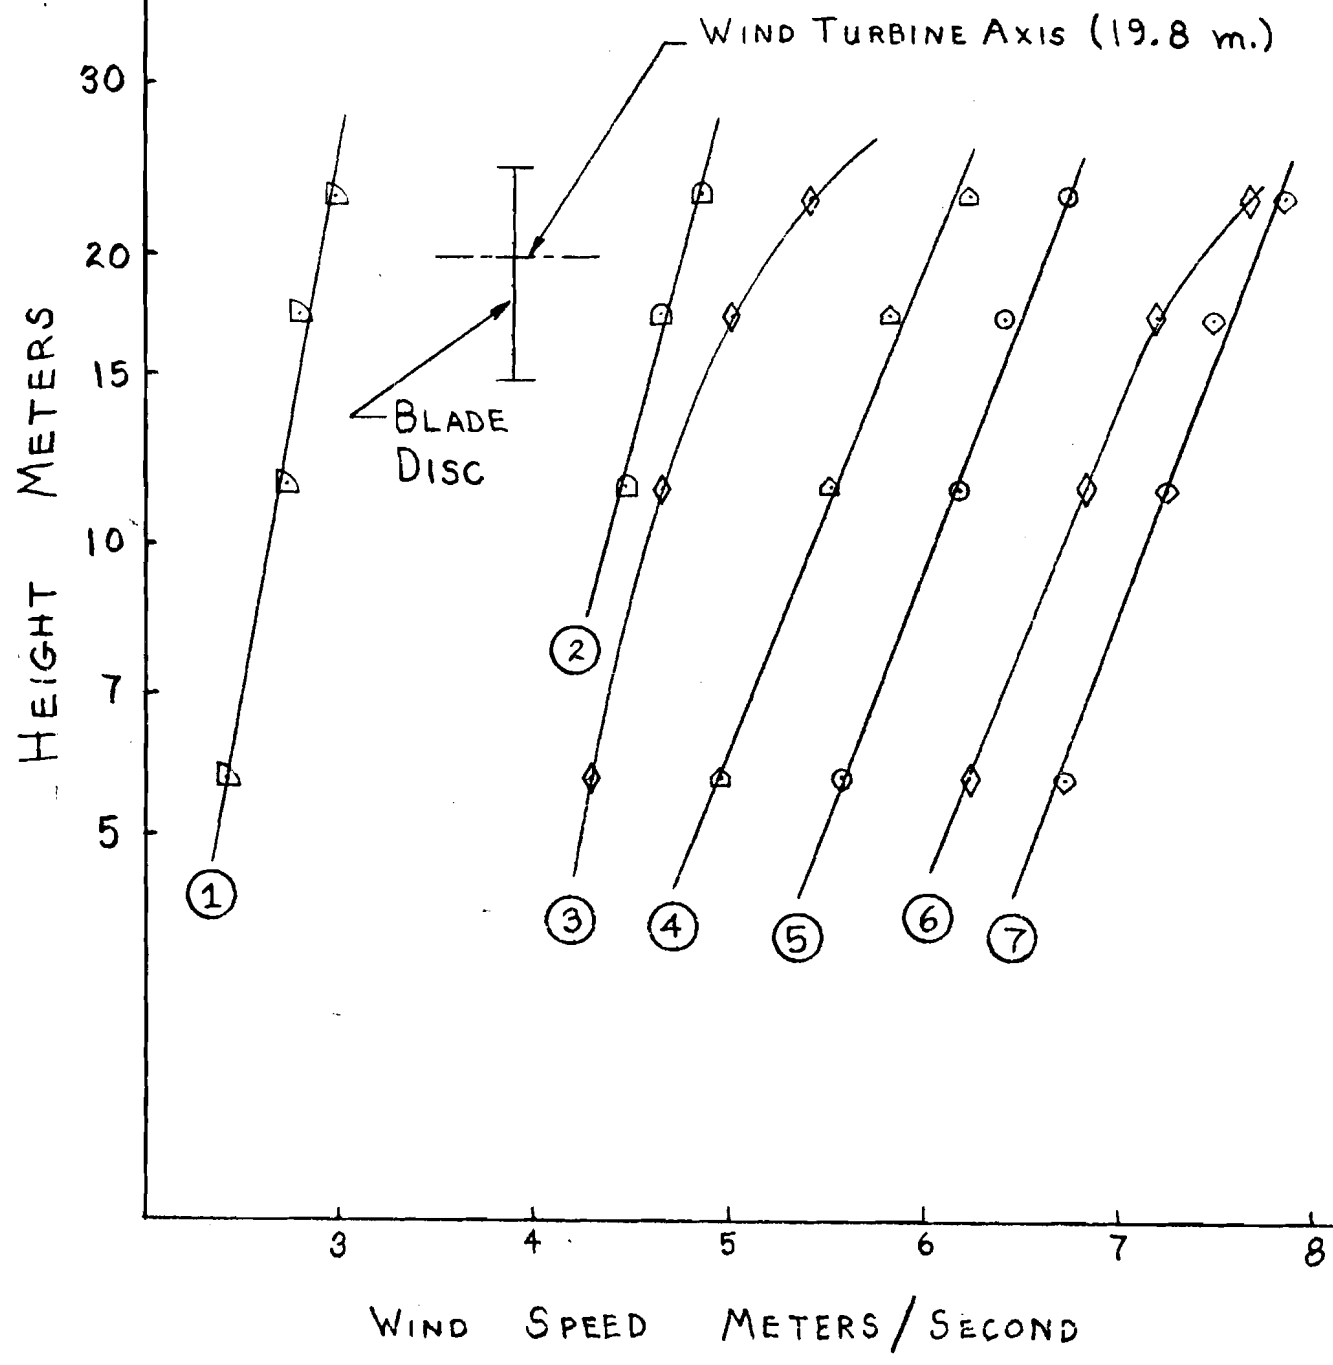
WIND PROFILES AT
U MASS SOLAR HABITAT I
MARCH 1978

Figure 1 is a plot of wind speed versus the logarithm of height. The data were obtained from four R.M. Young propeller type anemometers mounted at vertical locations of 5.75, 11.5, 17.25 and 23 meters above the ground plane. The anemometers were mounted on tower number 2 which is located at a distance of five blade radii upstream of the wind turbine as shown on the attached site plan. Test dates and other information relative to these data are given in Table 1. As can be seen on Figure 1 most of the profiles can be fit to a straight line on the semi-log plot. Using the standard log-linear profile equation for the mean wind speed u

the data from profiles 4, 5, and 7 were fit to this equation. The result was a value of $u^* = 0.336$ m/s which is in reasonable agreement with values reported in the literature (Sutton, Micrometeorology).

The importance of these data for wind turbine operation is that they indicate the shear in the wind profile approaching the blade disc. The maximum wind speed difference between the maximum and minimum blade heights appears to be 0.45 m/s. The lower wind speed profiles 1 and 2 indicate a lower shear of approximately 0.2 m/s.
