## Impact of Soil Conservation and Eucalyptus on Hydrology and Soil Loss in the Ethiopian Highlands

# Impact of Soil Conservation and Eucalyptus on Hydrology and Soil Loss in the Ethiopian Highlands

**Abstract:** The Ethiopian highlands suffer from severe land degradation, including erosion. In response, the Ethiopian government has implemented soil and water conservation practices (SWCPs). At the same time, due to its economic value, the acreage of eucalyptus has expanded, with croplands and pastures converted to eucalyptus plantations. The impact of these changes on soil loss has not been investigated experimentally. The objective of this study, therefore, is to examine the impacts of these changes on stream discharge and sediment load in a sub-humid watershed. The study covers a nine-year period that included installation of SWCPs, a three-fold increase from 1.5 ha in 2010 to 5 ha in 2018 in eucalyptus, and the upgrading of an unpaved to the paved road. Precipitation, runoff, and sediment concentration were monitored by installing weirs at the outlets of the main and four nested watersheds. A total of 867 storm events were collected in the nine years. Runoff and sediment conce

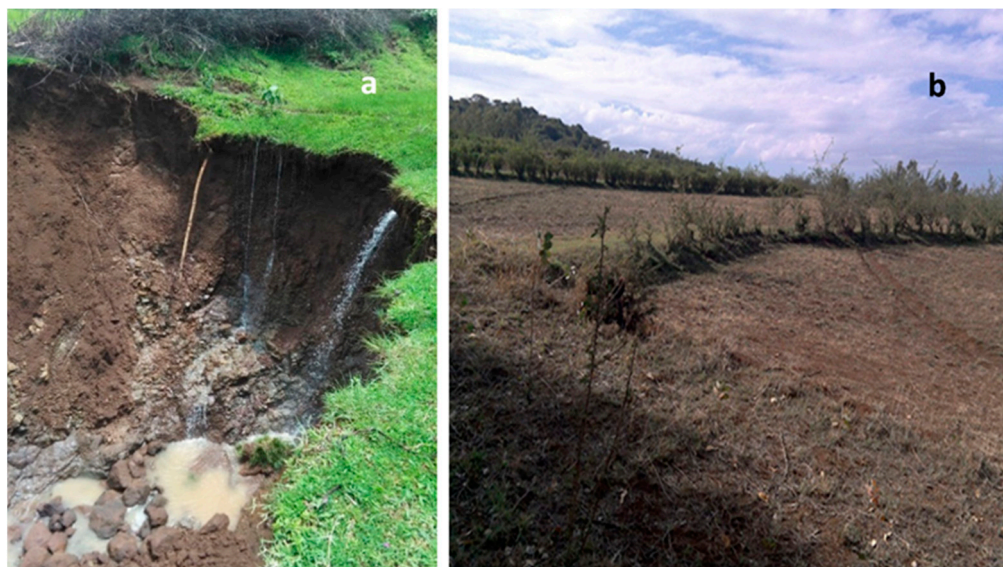
**Figure 3.** Photos depicting features in the Debre Mawi watershed: (a) Five-meter deep gully in the saturated bottomland of the Debre Mawi watershed. (b) Bund with *Sesbania grandiflora* in 2017. The bund, together with the infiltration furrow, was constructed in 2012. The infiltration furrow was filled with sediment in 2018 and is not visible.

Five-meter-deep and twenty-meter-wide gullies can be seen in the valley bottomlands (Figure 3a). Formation of the gullies in the Debre Mawi watershed started in the 1980s following the removal

Starting early in 2012 and ending in 2014, the government mandated SWCPs to be implemented by farmers as part of a national campaign. The SWCPs consisted of bunds with infiltration furrows that were installed on the contour on cultivated and grazing lands with slopes ranging from 3% to 32% according to guidelines of the Ethiopian Ministry of Agriculture. The infiltration furrows were 0.5 m deep and 0.5 m wide. The bunds varied in height from 0.3 to 0.6 m. The horizontal spacing between the bunds was 32 m. The spacing was reduced on steep lands so that the maximum difference in elevation was 1.5 m. *Sesbania grandiflora* was planted on the bunds as animal fodder and for the strengthening of the sides (Figure 3b).

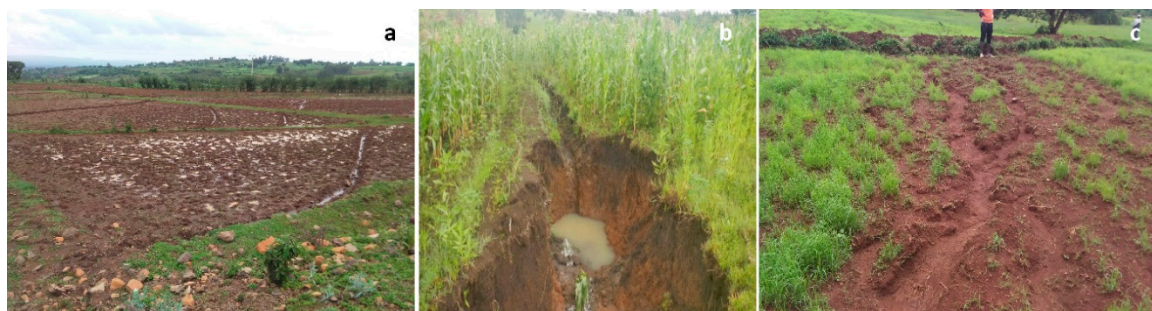
**Figure 4.** Soil and water conservation practices. (a) Fesses (plowed off-contour furrows; 20–30 cm wide and 10–15 cm deep) and 20–30 cm high bunds (green strips) in the Debre Mawi watershed in July 2018. Water is ponded at the surface, and the fesses carry off the excess water. Infiltration furrows uphill of the bunds have been filled with sediment and are not visible. (b) Infiltration furrow installed in 2012 in the saturated bottomland carries off interflow from the upland and caused the 2.5 m deep gully in the foreground. The photo was taken in August 2015. (c) Fifty to sixty centimeter wide rills formed by runoff concentrated by a bund on 18 July 2017.

As we observed from Google Images at the end of the implementation period in 2014, 70% of the watershed was treated with SWCPs. However, they were not maintained. Consequently, in the saturated bottomland areas within a three-year period, most furrows were filled with sediment, and only the bunds were visibly covered with grass (Figure 4a). In one case, where the rate of filling was less than the transport capacity of the sediment out of the furrow, the furrow acted as a cutoff drain. The concentrated flow resulted in a gully (Figure 4b) that formed in 2013 and then cut out a path downstream in the remainder of the years. The infiltration furrows on the sloping lands in the remainder of the watershed filled with sediment more slowly. By 2018, all were filled with sediment, and only the bunds remained visible as green strips (Figure 4a). In addition, without government support, farmers voluntarily installed off-contour traditional furrows (or fesses in Amharic) after the plowing was finished. These served to remove excess rainfall. The dimensions were determined by the size of the local ox-driven plows (*Marsha*) and were approximately 20–30 cm wide and 10–15 cm deep. Local farmers report that fesses were preferred because, unlike deep furrows, they do not hinder tillage operation.

**SWCPs:** After the implementation of SWCPs, sediment concentrations and load significantly decreased in all the five watersheds. The decrease in sediment load, especially during the SWCPs implementation years (2012–2014), was caused by the decrease in runoff that has been trapped by the infiltration furrows. This agrees with [10] and [37] that indicated SWCPs were effective in the short-term in humid watersheds. However, in the long term, infiltration furrows were not effective in reducing soil loss because most infiltration furrows were filled with sediment, as shown in Figure 4a. The bunds concentrated the flow and caused rill formation downstream of the bunds (Figure 4c).
