Doctoral Dissertations

October 2021

# A Comprehensive Protocol for Inspection and Assessment of Aging Steel Bridges: Experiments, Computations and 3D Laser Scanning of Field Corroded Girders

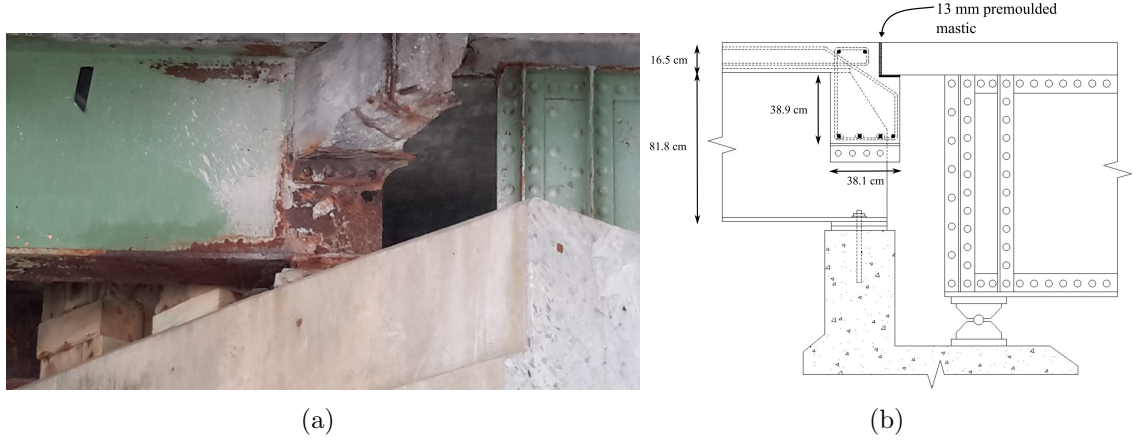
Figure 3.2: (a) Typical, in service, configuration and (b) construction details for Bridge A (Specimens 1 to 3)

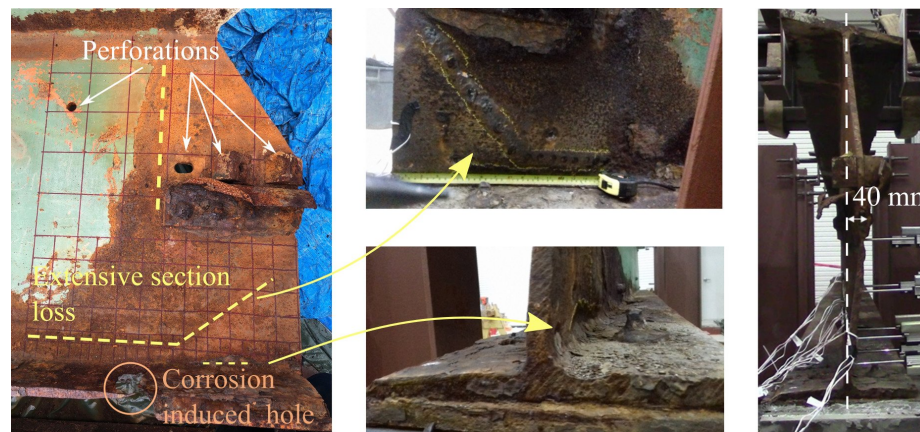
3.3 Corrosion characteristics of Specimens (a) 1, and (b) 2. Both girders are 84 cm deep obtained from Bridge A. Their defining feature is a corrosion-induced hole formed longitudinally at the base of the web, and the initial web deviation from straightness, respectively. . . . .	18

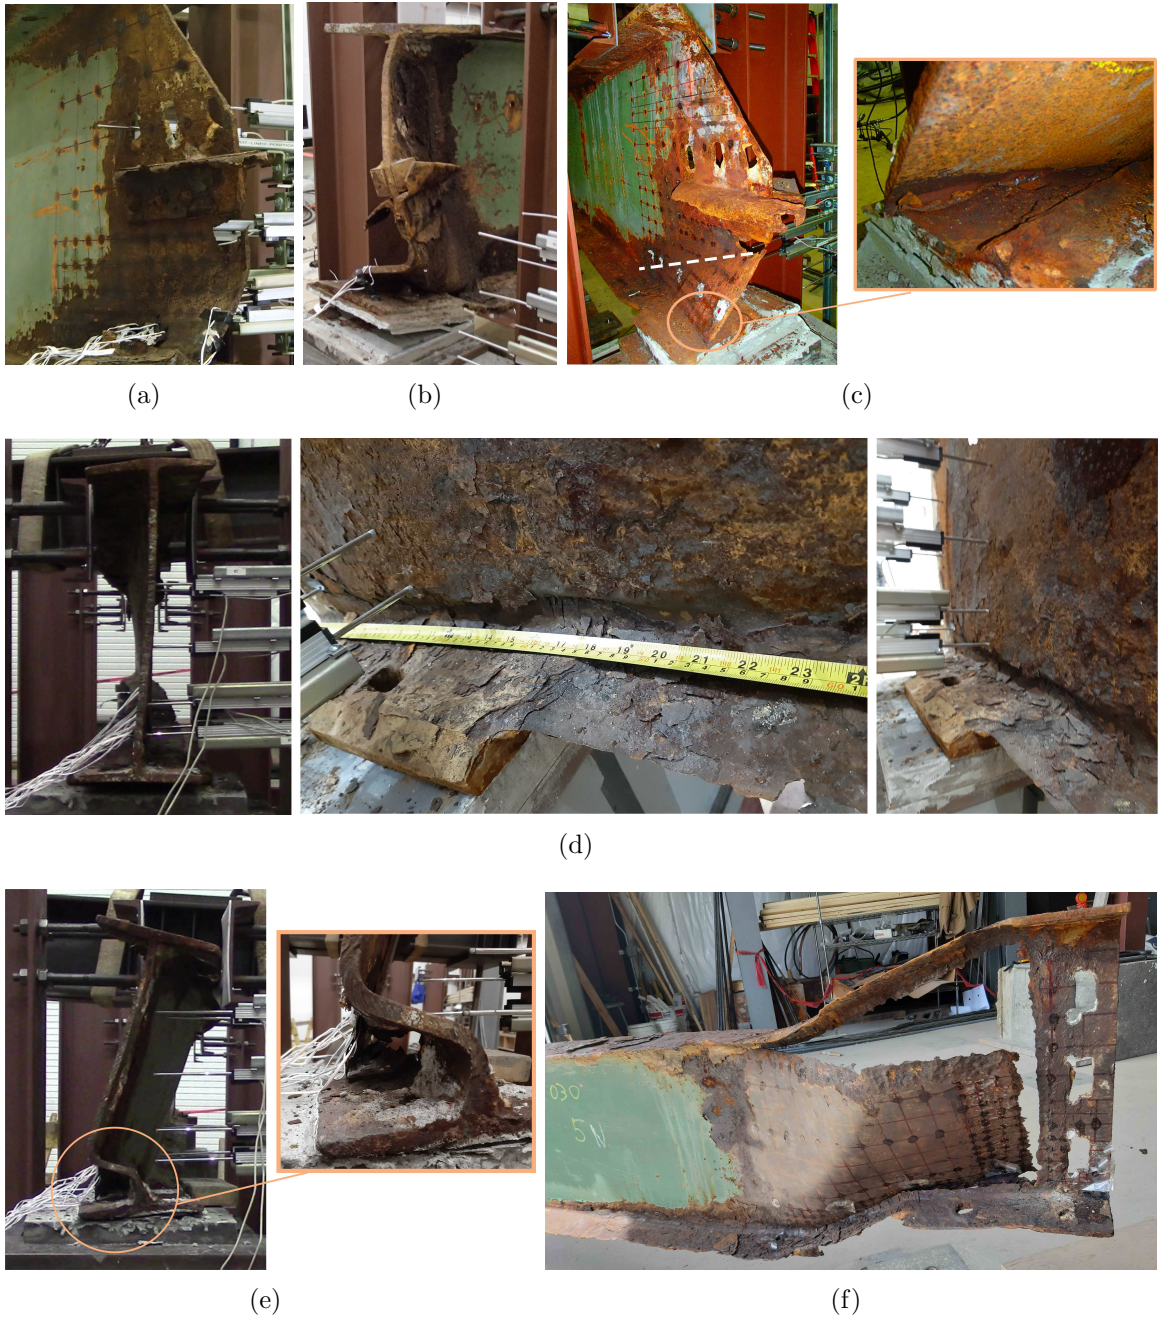
Figure 3.13: Final condition of Specimens (a) 1 to (f) 6. The hole closed during the experiments for Specimens 1, 3, 5 and 6. The failure mode of Specimen 2 was governed by the initial web deviation from straightness. Crippling was observed for Specimen 4. Figure obtained from [1]

3.13	Final condition of Specimens (a) 1 to (f) 6. The hole closed during the experiments for Specimens 1, 3, 5 and 6. The failure mode of Specimen 2 was governed by the initial web deviation from straightness. Crippling was observed for Specimen 4. Figure obtained from [1] . . .	38

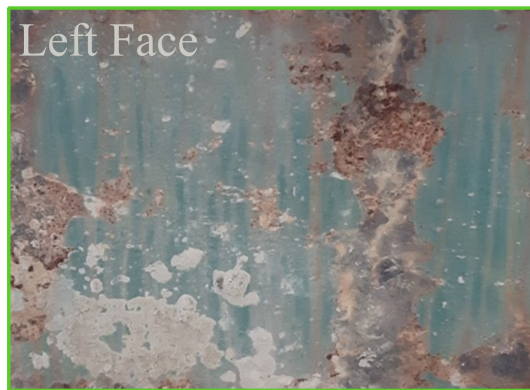
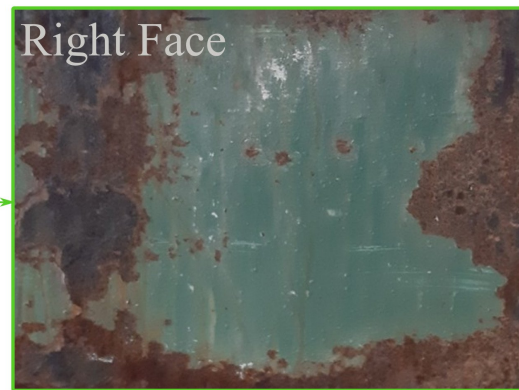
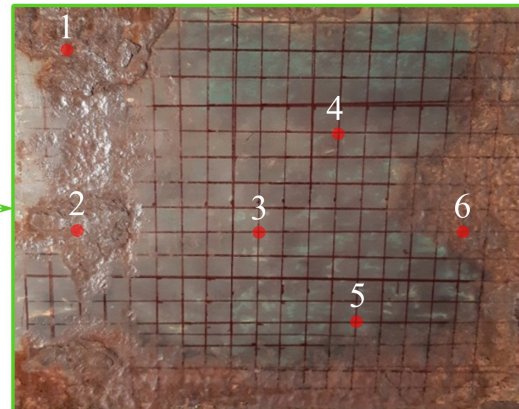
Figure 8.1: a) The scanned girder obtained from Bridge A. The rectangular area (in green) selected for thickness measurements is illustrated b) prior and c) after steel was exposed. Thickness estimations for points 1 to 6 are presented in Fig. 8.3.

Based on these defined criteria, after scanning the whole beam a rectangular web area with dimensions 45.7 cm by 35.6 cm was selected close to midspan. Fig. 8.1

Even though the thickness gauge is placed on a clean surface, a challenge of this method is varying instrument readings. A common aftermath of the uneven section loss is bumpy steel surfaces which result in a significant variation of the measured thickness. To eliminate problems with local surface imperfections, and for reference to the thickness loss data, a grid with 2.5 cm spacing was drawn on both web faces, and combined measurements from both faces were obtained from 283 locations, Fig. 8.1c.

To better interpret the comparison output, thickness estimations are presented in Table 8.1 at six representative locations (Figs. 8.1 and 8.3). Point 3 which represents the intact web condition, has been captured with just 2% discrepancy, depicting an excellent agreement between the two methodologies. Point 6 is located in a region with section loss detected only at the right face of the web (Fig. 8.1c). The residual thickness estimation between the two methodologies varies only by 0.4 mm or 6%. Points 4 and 5 are located in the corroded area crossing vertically the left web face (Fig. 8.1c). At Point 4 where the beam surface is similar to Point 6, the thickness estimations by the two instruments vary only by 5%. On the other hand, it can be seen in Fig. 8.1b that points 1, 2 and 5 are located in areas where deposits and extensive delamination were covering the web faces, prior to removal of paint and scale, when the specimen was scanned. Their discrepancy with the measurements obtained by the gauge over the exposed steel rises up to 39%, highlighting the importance of a clean surface.

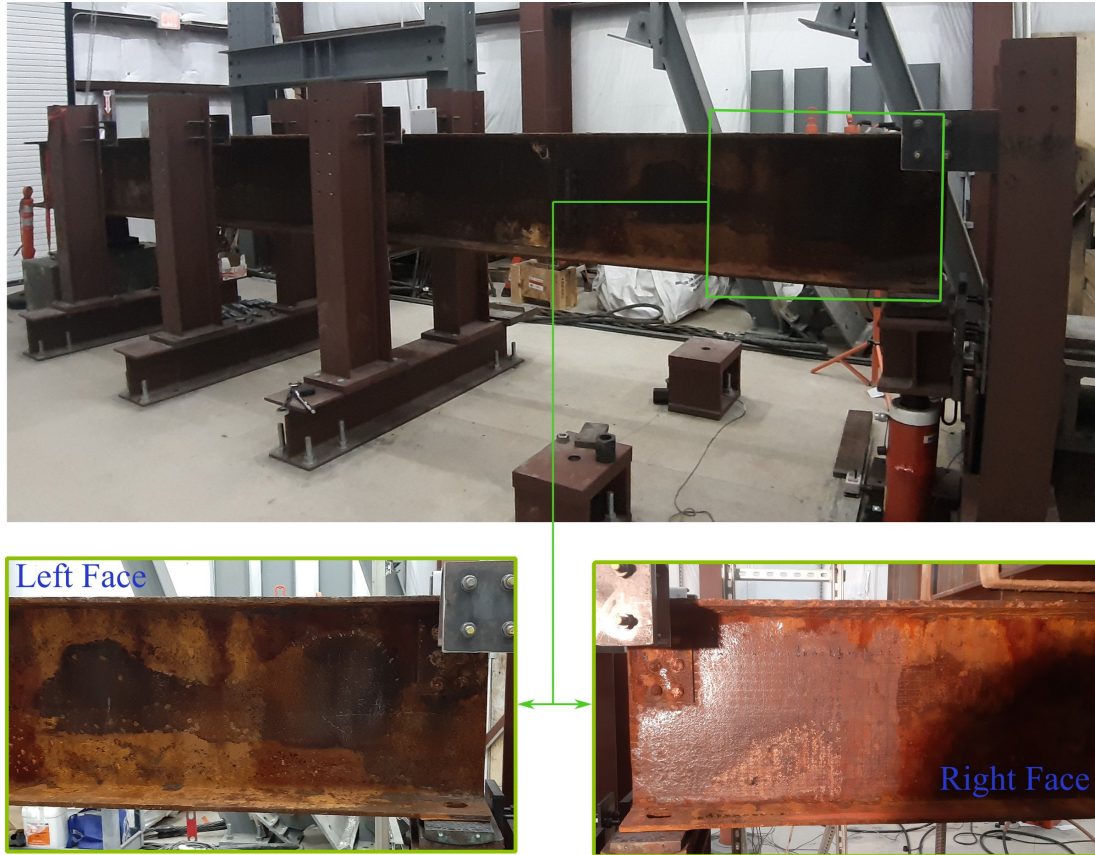
Figure 9.1: The deterioration condition of the specimen obtained from Bridge B was characterized by section loss close to the support.

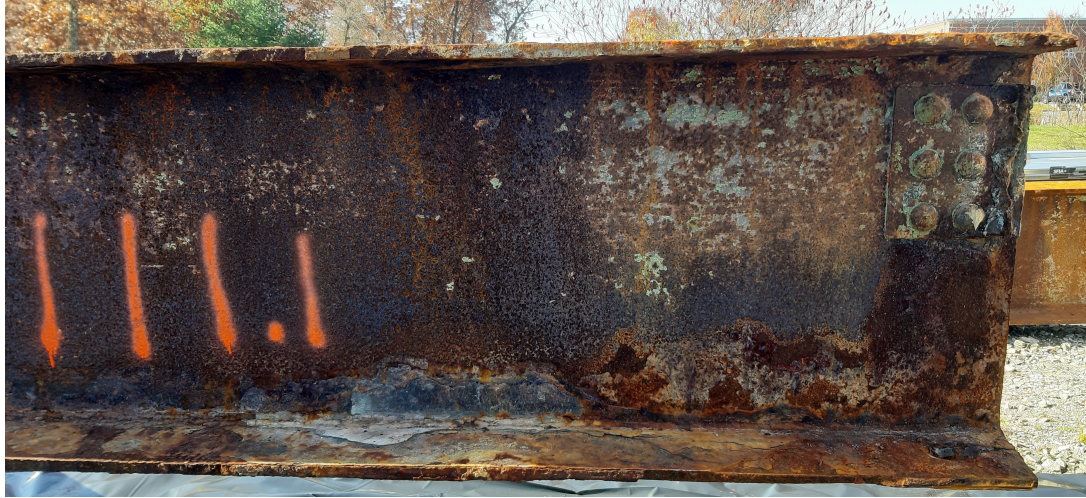
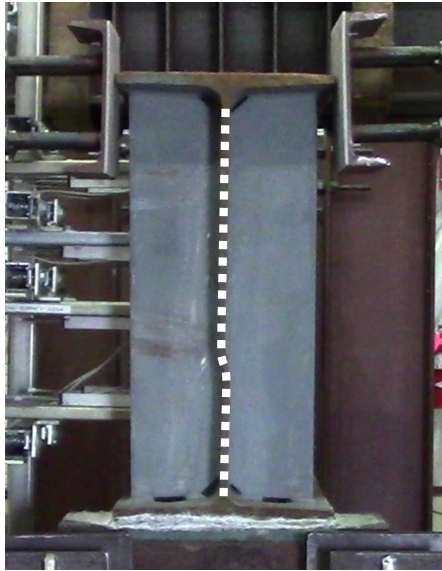
To quantify the remaining thickness on the deteriorated beam end, the beam was scanned making use of a Riegl VZ-2000 laser scanner, [61]. Scans were performed from both sides of the specimen and the acquired point clouds were referenced to a unique coordinate system making use of reflective targets placed in the laboratory. Following a methodology previously developed by the author in Part II, contour maps capturing the remaining material along the web were created and presented in Fig. 13.2c. An area with extensive section loss extended diagonally from the end to the bottom flange, while initial web deviation is noticed at the outer part of the web, with maximum magnitude of 1.1 cm, Fig 13.1b.
