## Session A3: Ljubljana Connects - Enabling Fish Migration

# LJUBLJANICA CONNECTS

## enabling fish migration

Restoration of the Ljubljana River corridor and improvement of the river's flow regime

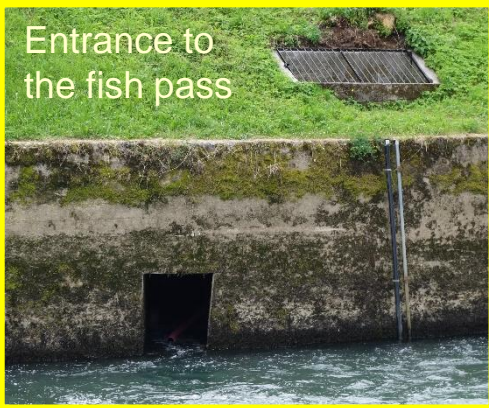
Entrance to  
the fish pass

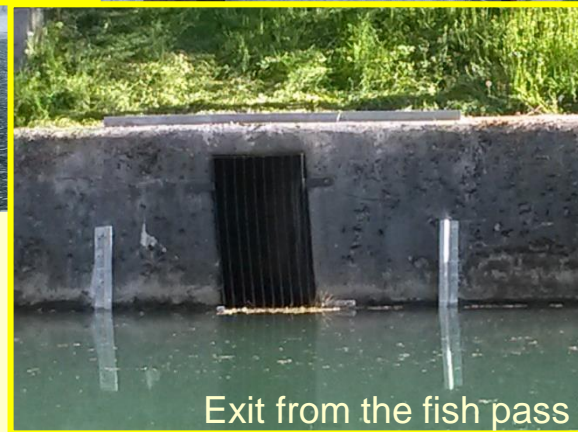
Exit from the fish pass

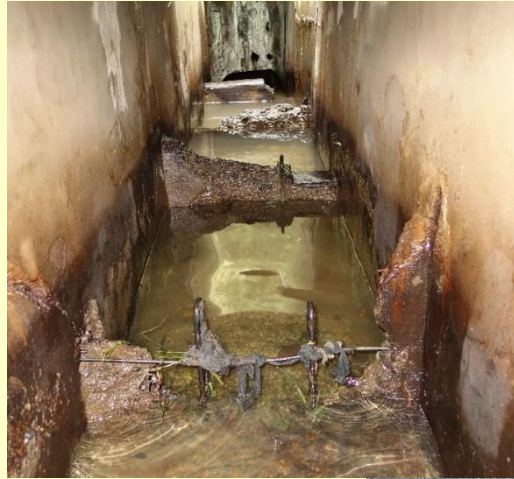
The damaged interior of the fish pass

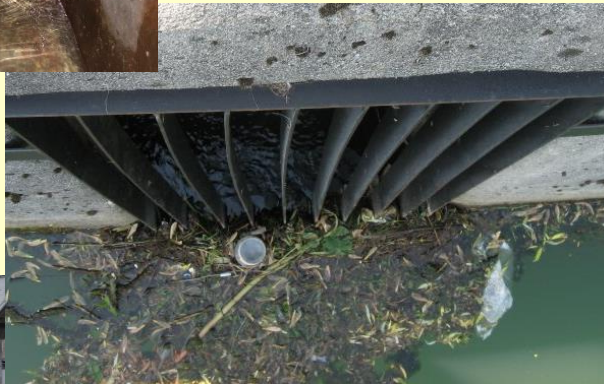
Floating debris on the barrier at the exit from the fish pass

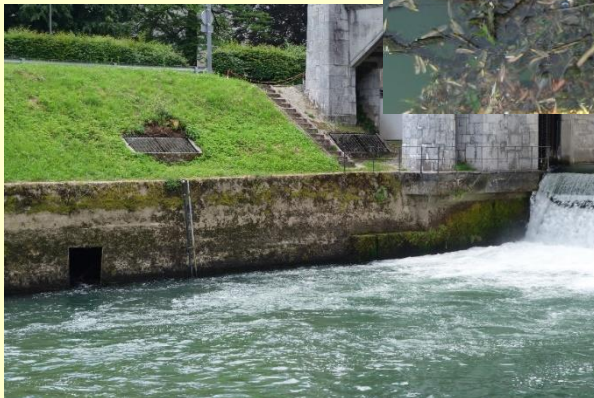
Water falling over the barrier makes it difficult to find the entrance to the fish pass

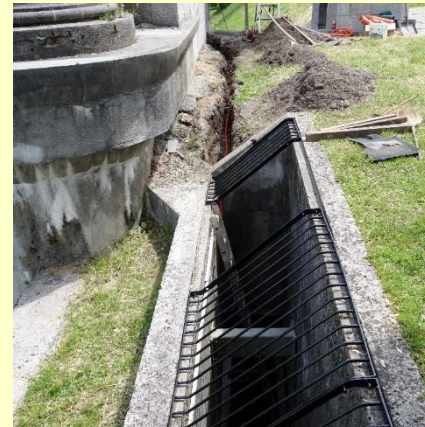
Barriers on the openings above the fish pass were restored

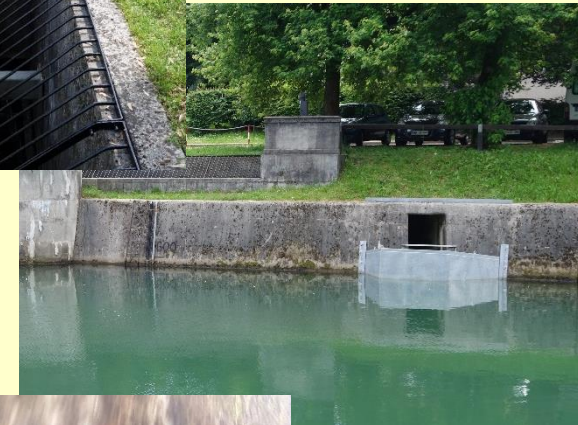
Element for preventing accumulation of floating debris

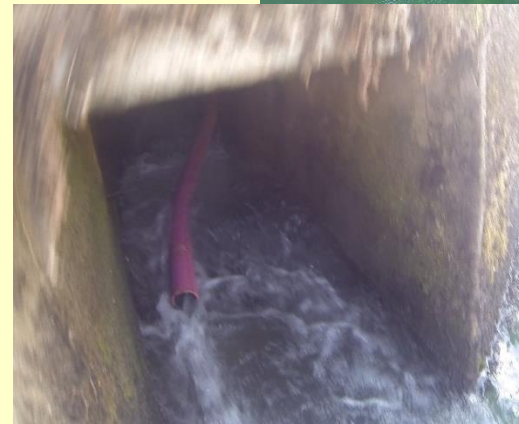
The new pipe which attracts fish to the entrance

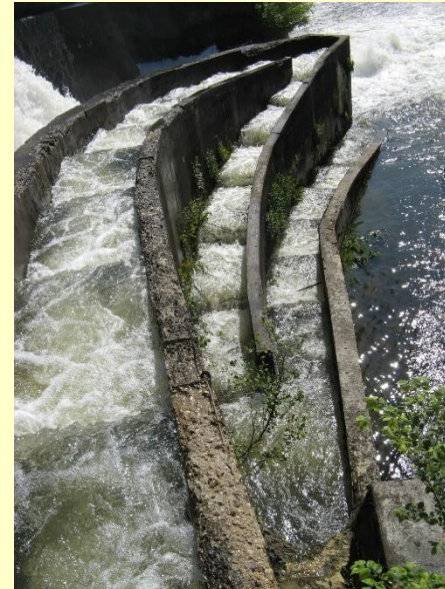
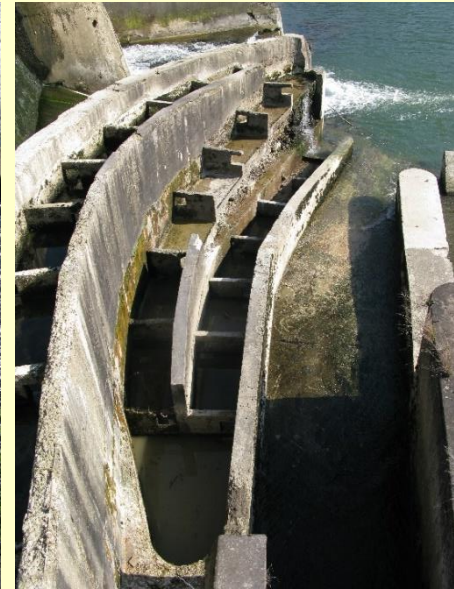
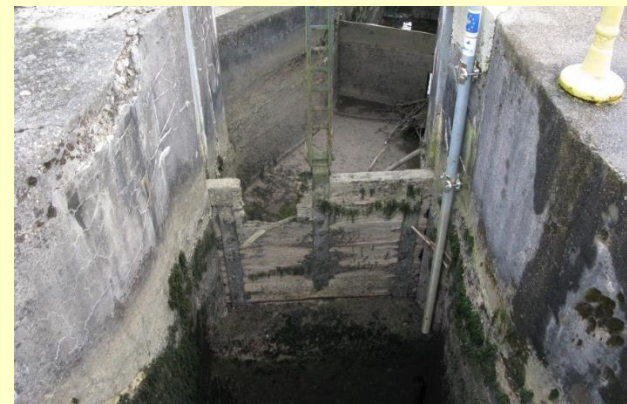
Fish pass has collapsed during the high flow in November 2013

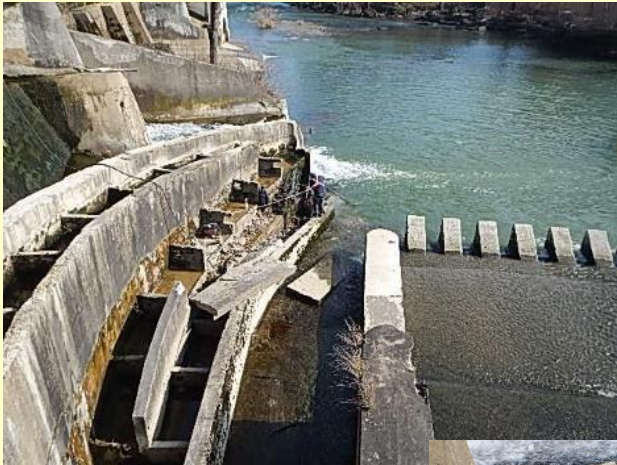
Cleaning of the fish pass

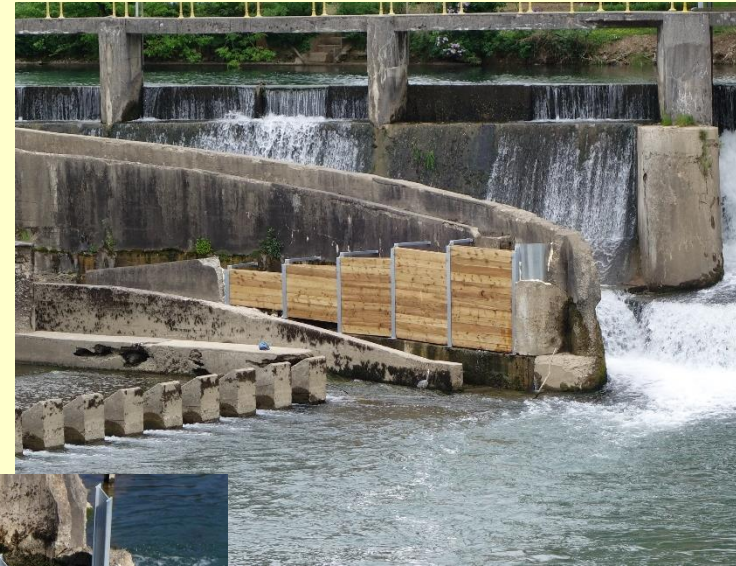
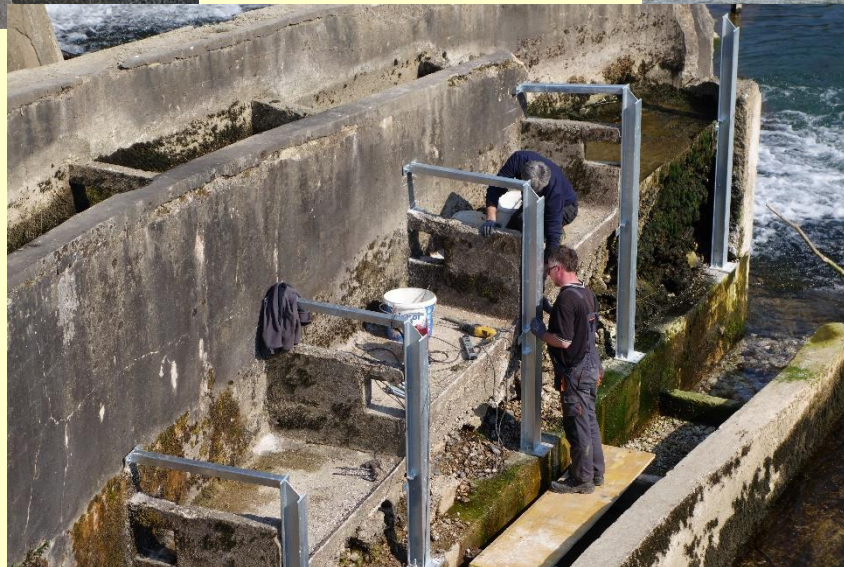
The collapsed part of fish pass was reconstructed using steel pylons filled with wood wall

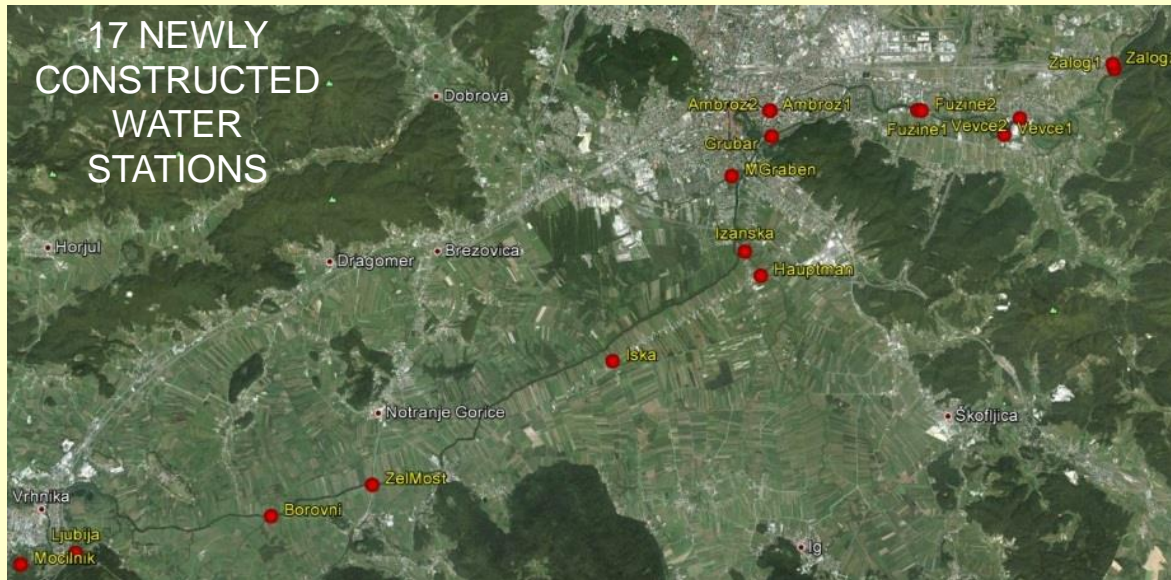
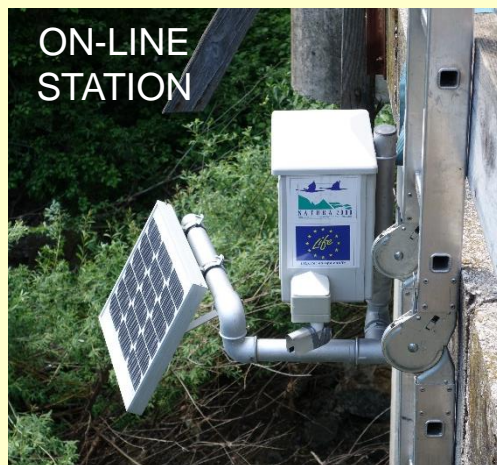
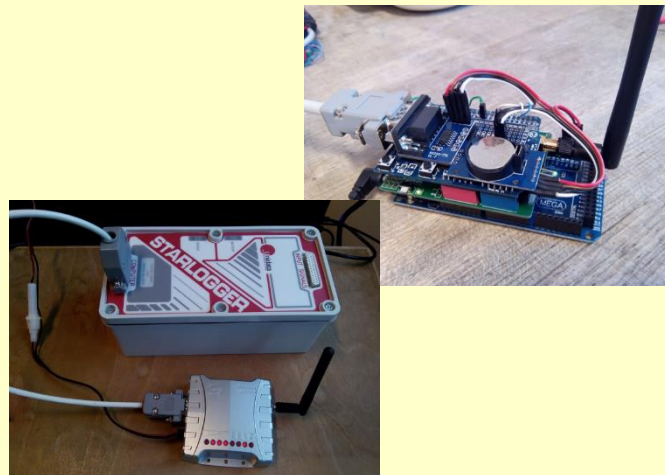
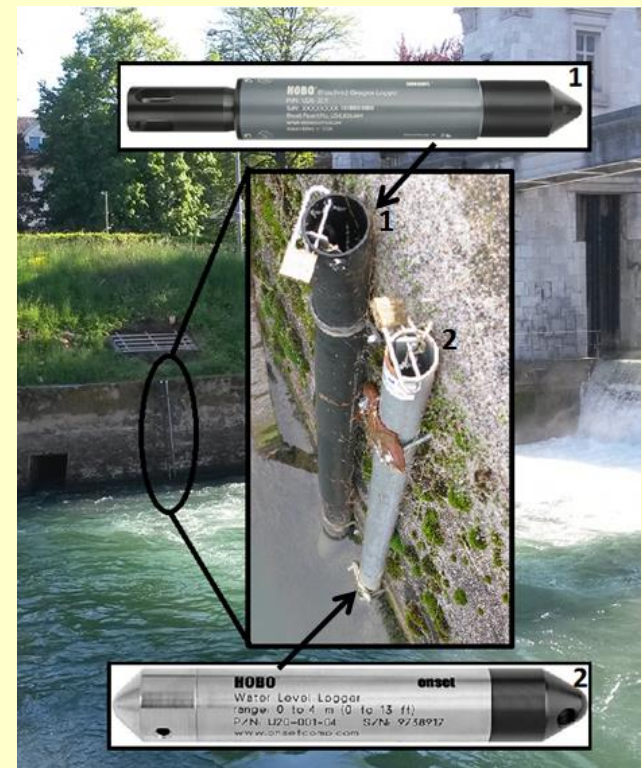
Measurements of temperature and oxygen concentration (1) and of water level (2)

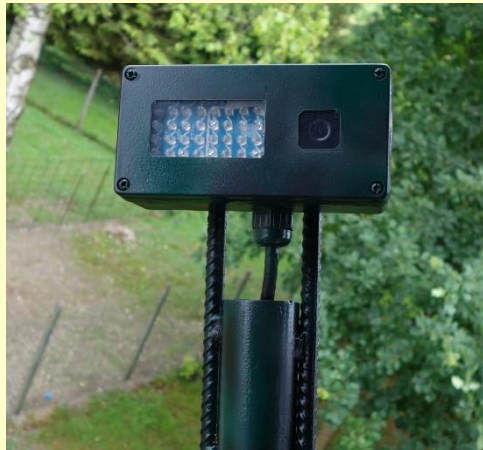
Camera for monitoring migration of fish through the fish pass

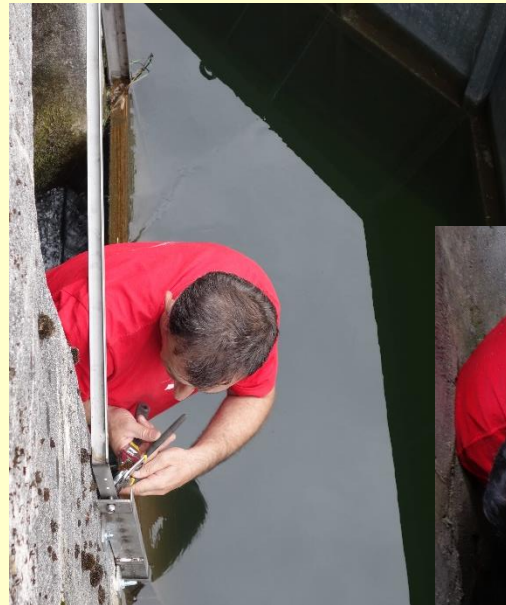
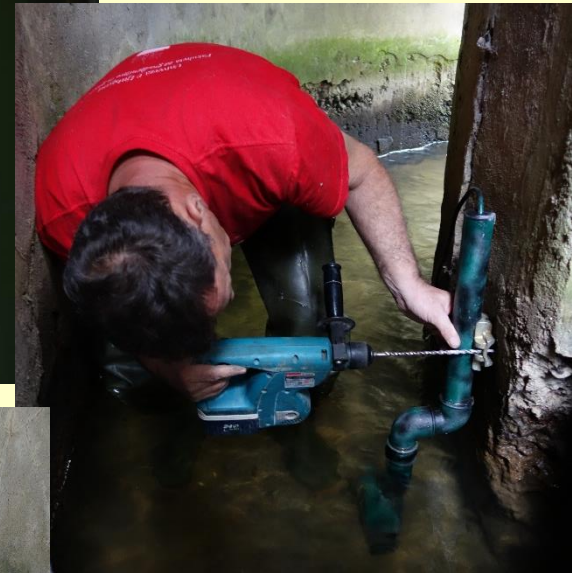
Installation of camera in the fish pass
