## Technical Developments in Materials and Techniques for Fish and Debris Passage: The Iron Gate Dam Experience

# Technical Developments in Materials and Techniques for Fish and Debris Passage

## The Iron Gate Dam Experience

# Barrier Curtains

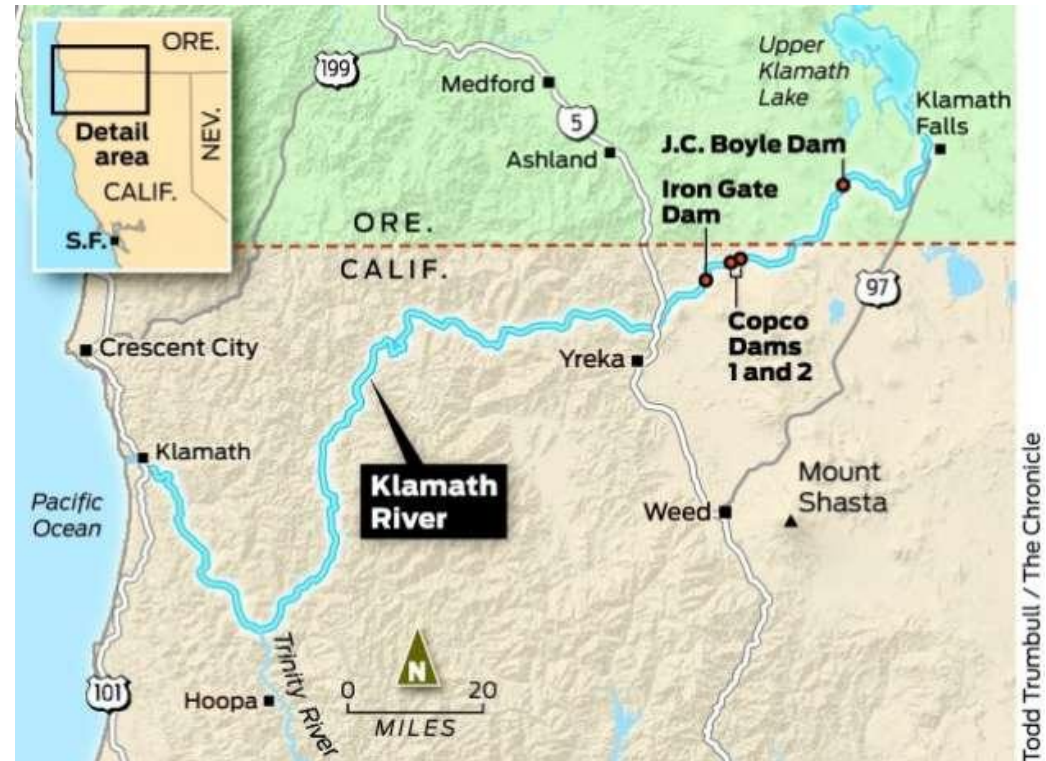
# Iron Gate

- Earth fill hydroelectric dam
- The lowermost of a series of power dams on the Klamath river
- Poses the first barrier to migrating salmon in the Klamath.

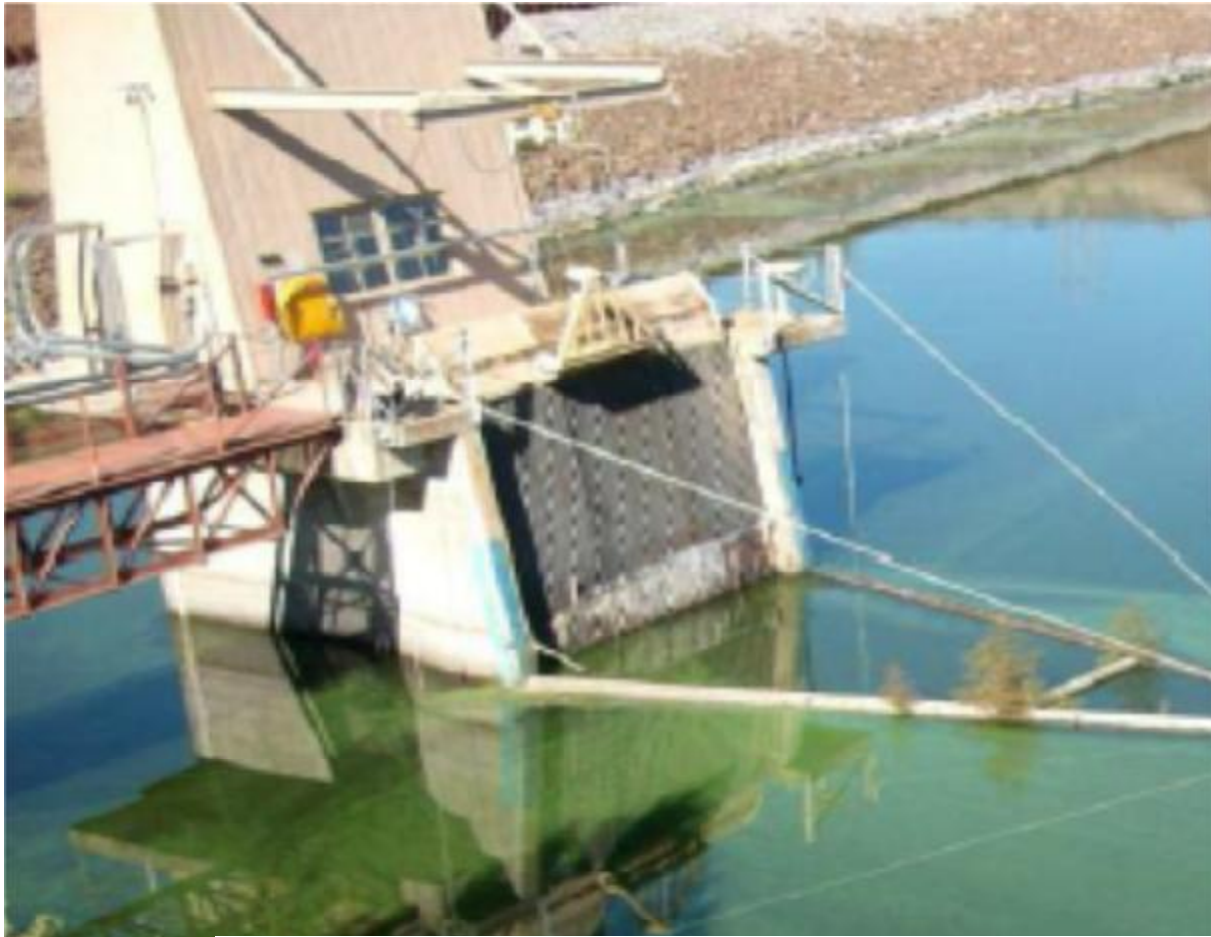
Iron Gate Reservoir Intake Tower, Trash Rack, and A-frame Debris Boom. (Photo Date: September 10, 2008.)

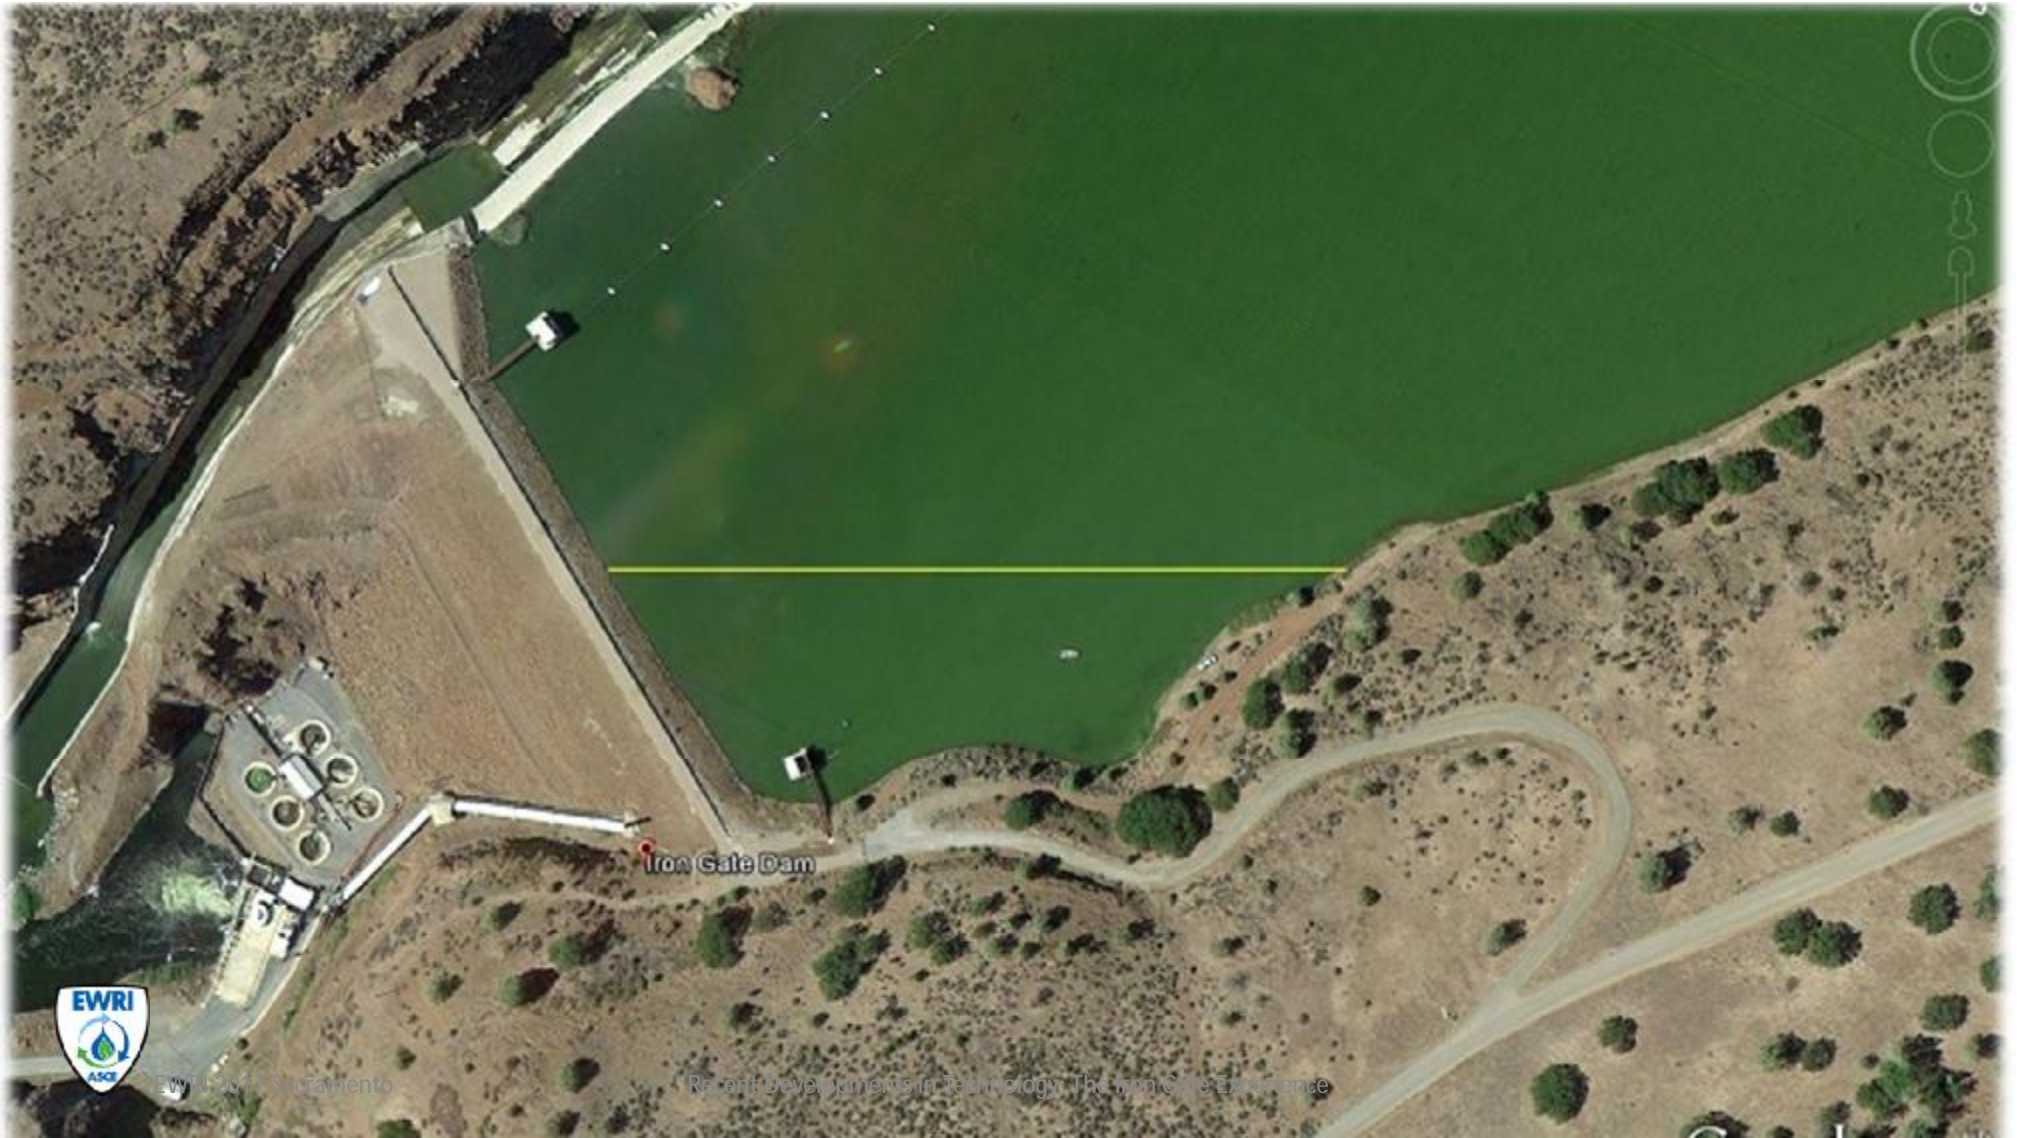
# 2015 Intake Barrier Curtain Installed

- Segregate reservoir surface waters with higher blue-green algae
- Create a preferential flow from below the surface photic zone to the reservoir intake to prevent the surface waters with higher blue-green algae concentrations from being entrained into the intake and released downstream
- Potentially facilitate movement of cool water from the lower depths of the reservoir toward the conduit intake, releasing cooler water downstream.
- Improve water quality conditions downstream

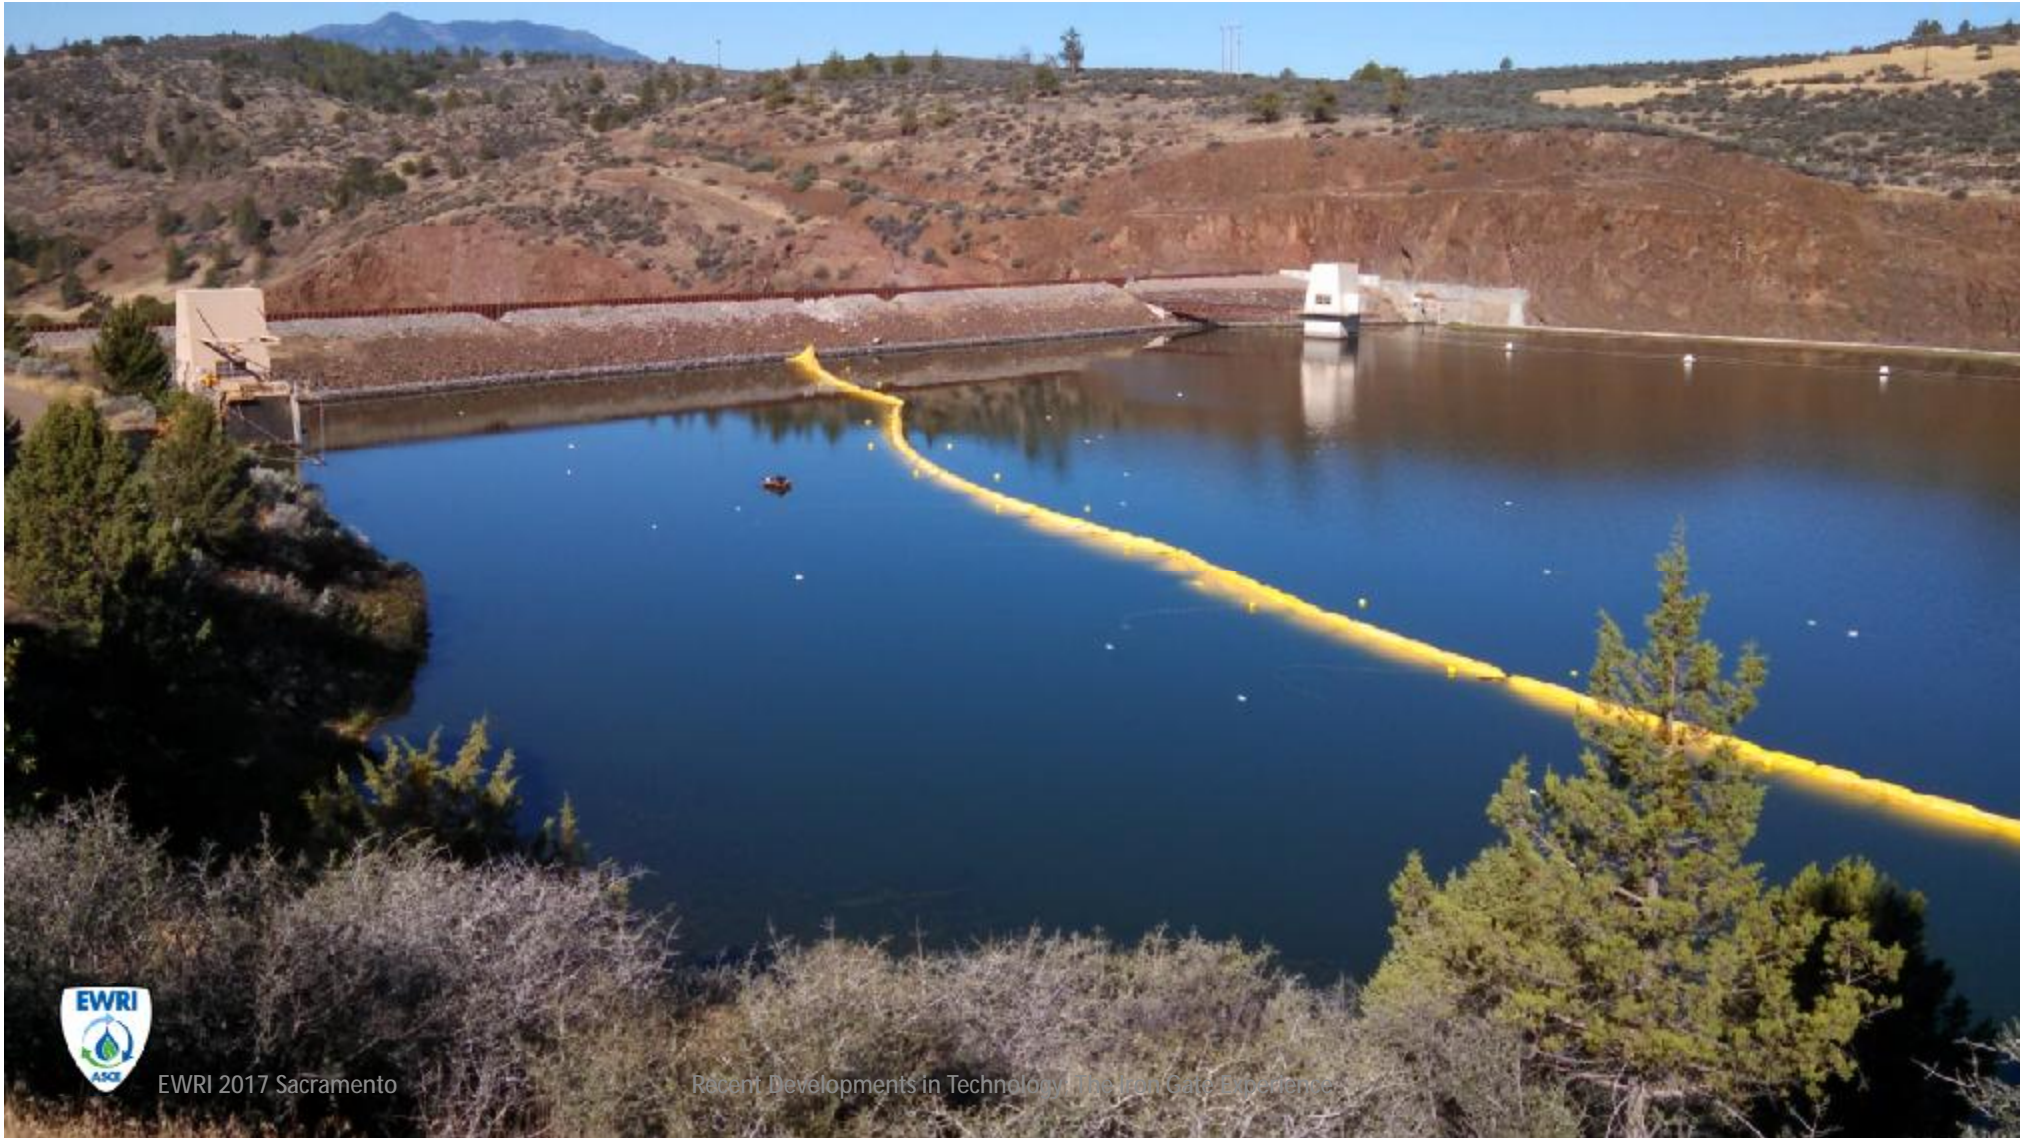
# Curtain Design

- Strength and flexibility to function over a total reservoir water surface elevation fluctuation of 16 ft. (from 2,330 ft. to 2,314 ft.), reflecting recent reservoir operating levels.
- Curtain depth need to be adjustable during trials.
- The connection between the floats, netting, and fabric panels is as impermeable as practical to improve chance of success.
- Curtain was designed to improve on the a previous trial curtain, 2014.

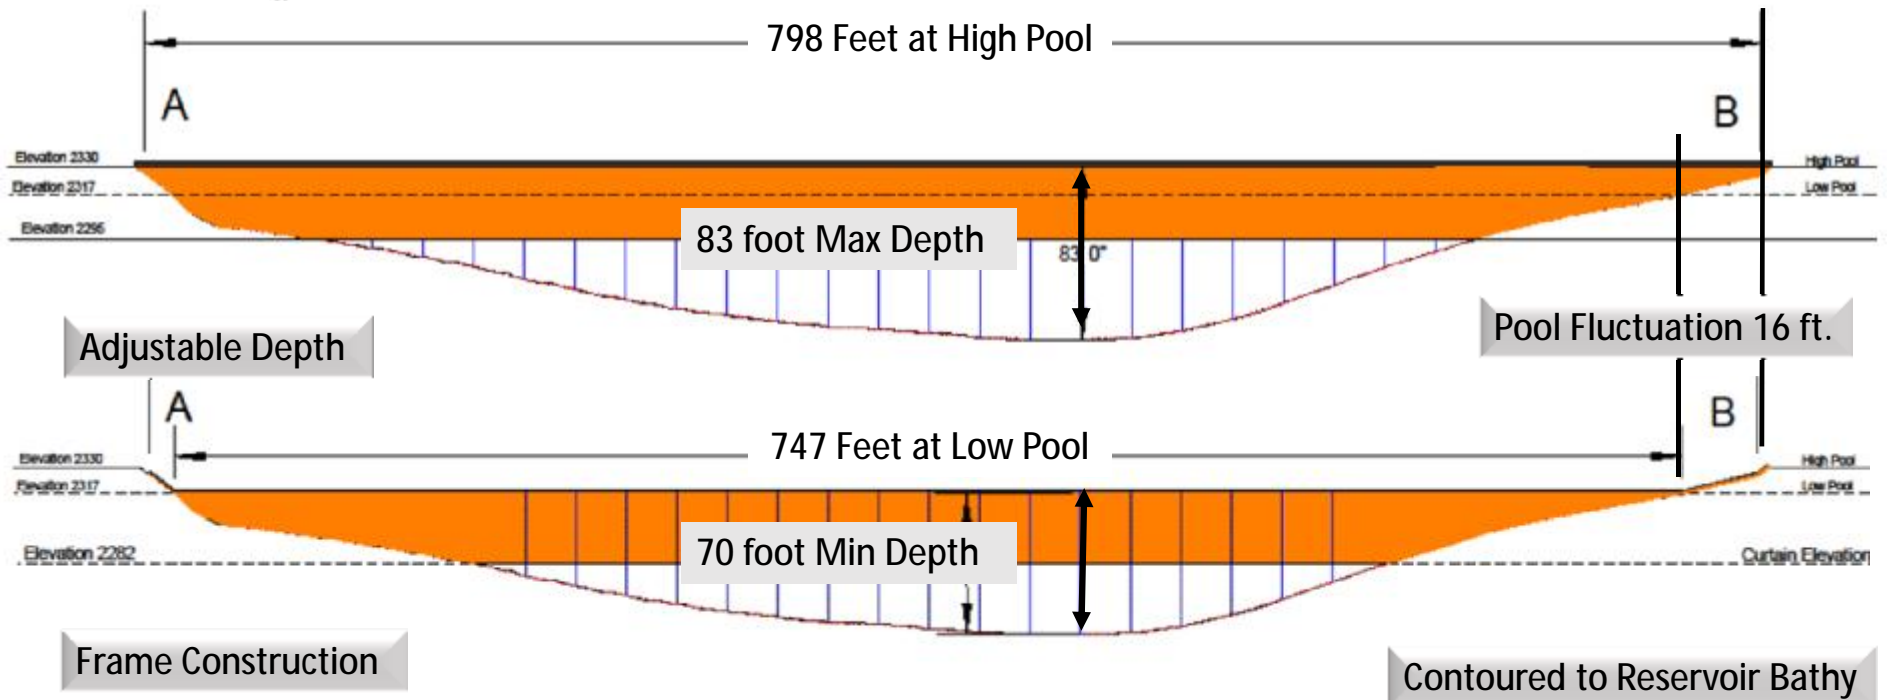
# Curtain Design

<b>Pacific Netting Products Inc</b>			
Iron Gate Dam Algae Barrier			
<b>Typical Barrier layout</b>			
Drawn: 1/15/2015	Design: PC-IGD-004 Rev-0	Scale: None	<b>Not For Construction</b>

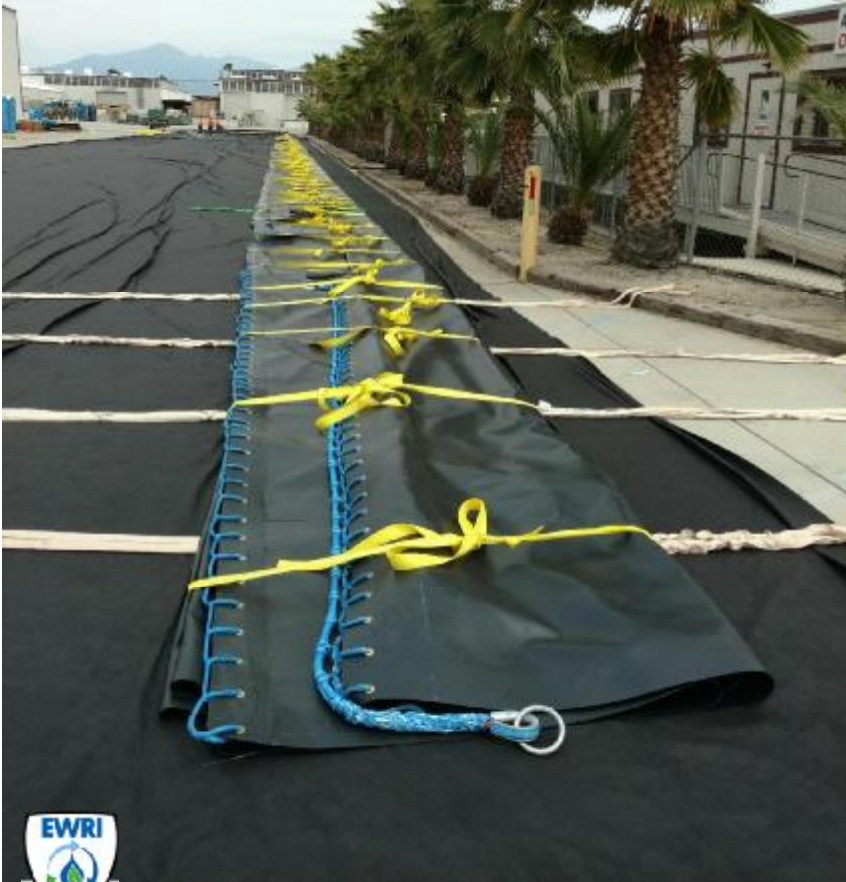
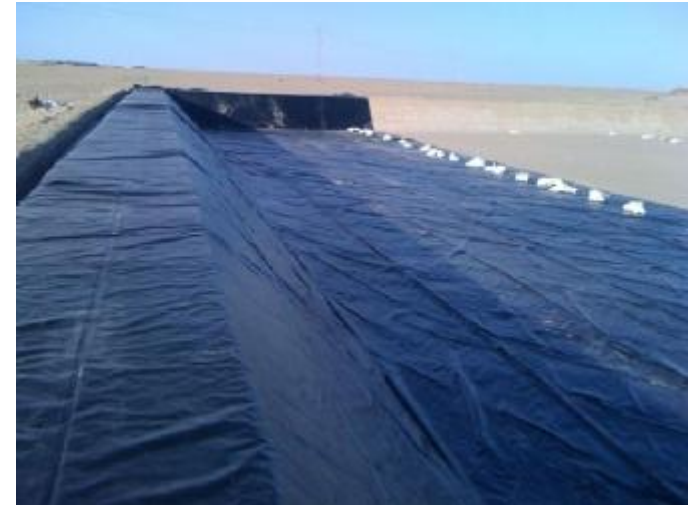
# Impervious Surface

## Seaman Corp. XR-5

- Synthetic reinforced geomembrane
- High Puncture Resistance: 30 mil thick 868lbs
- Fabric inhibits damage spread if torn or punctured
- Flexible, prefabricated panels (15,000+ square feet) practical.
- Material is not subject to environmental stress cracking

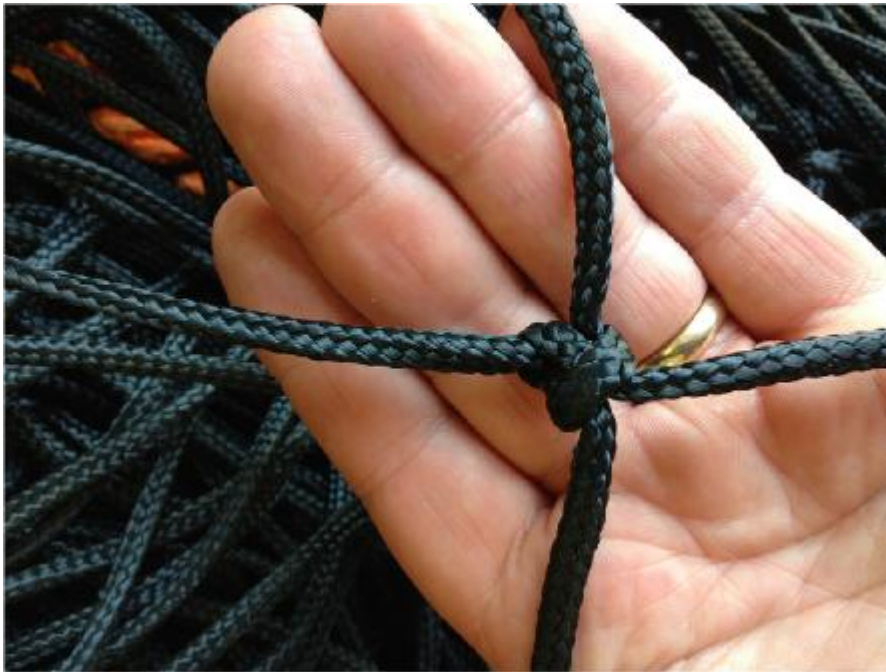
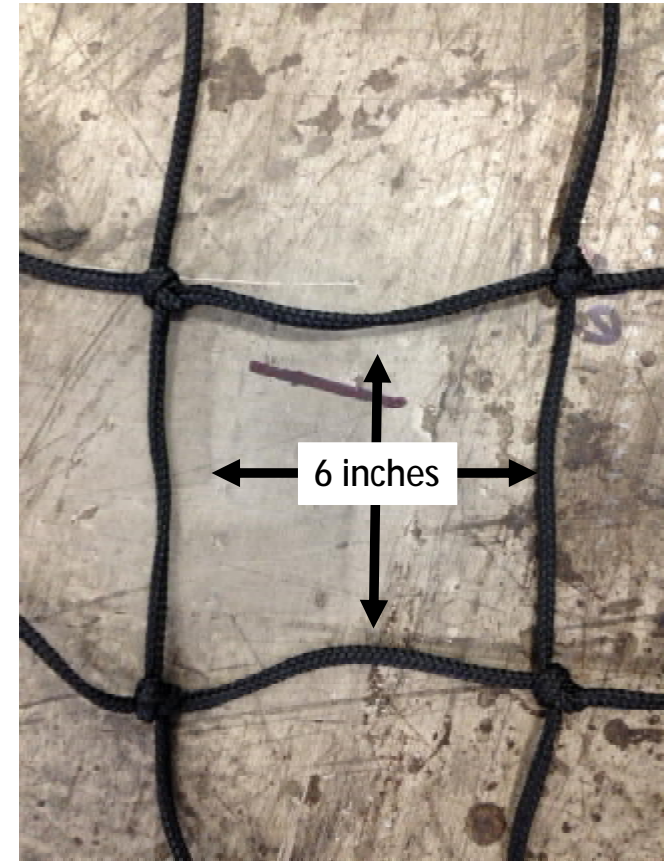
# Strength and Shape: Polyester Net, 6 Inch mesh

- Slightly stronger than Nylon
- Unlike nylon
  - Does not lose strength when wet
  - Is not stretchy.
- Combines good strength and durability, relatively low stretch and reasonable prices.
- Specific gravity of 1.38
- Low creep under load.
- Excellent abrasion resistance

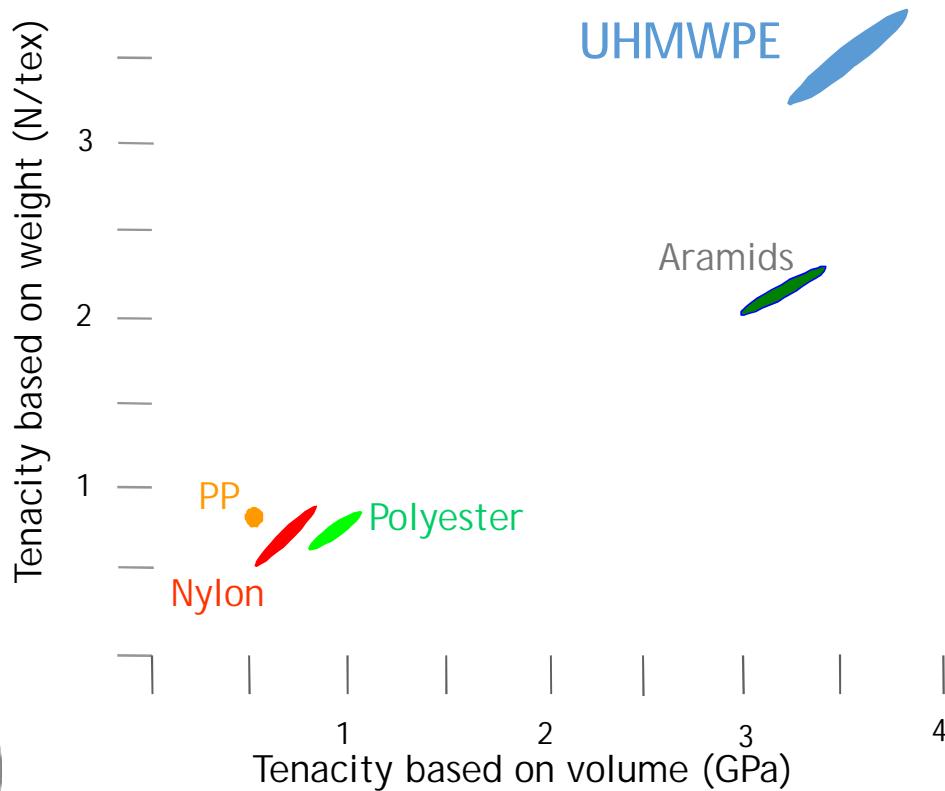
# Comparison of Polyester Properties

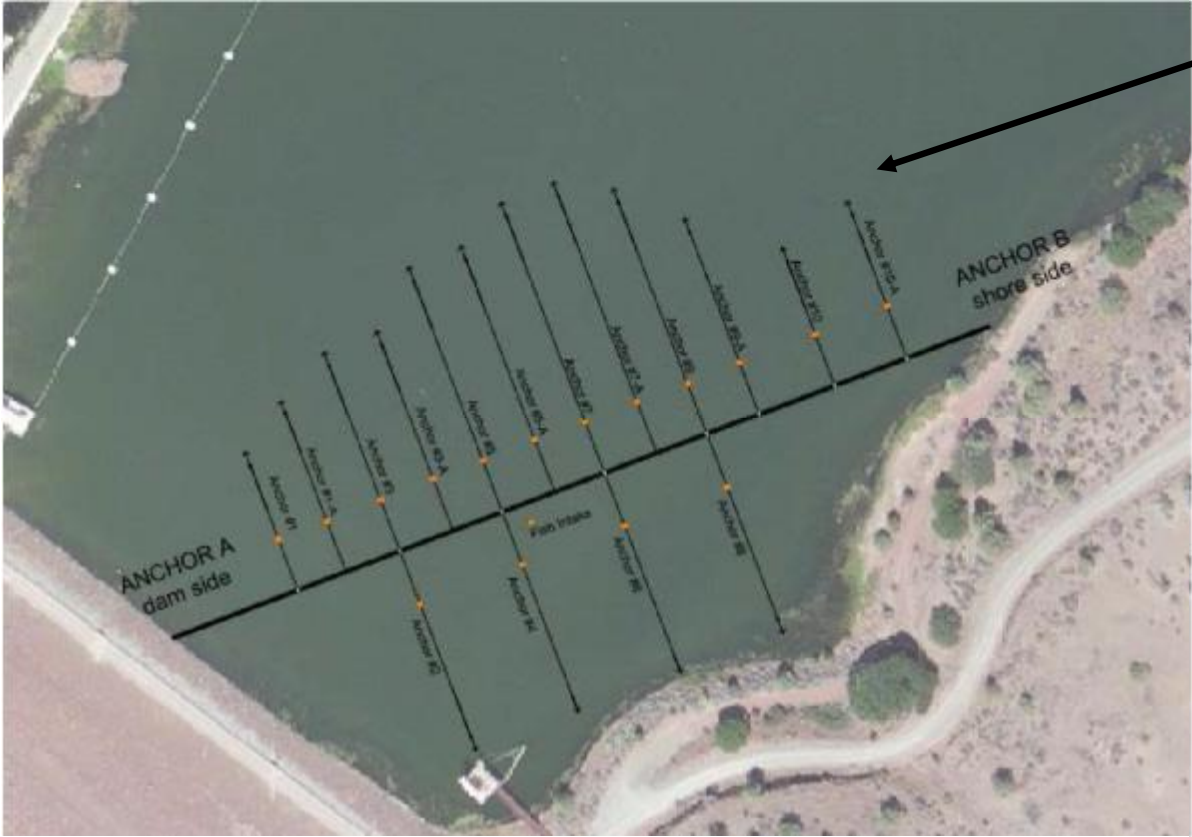
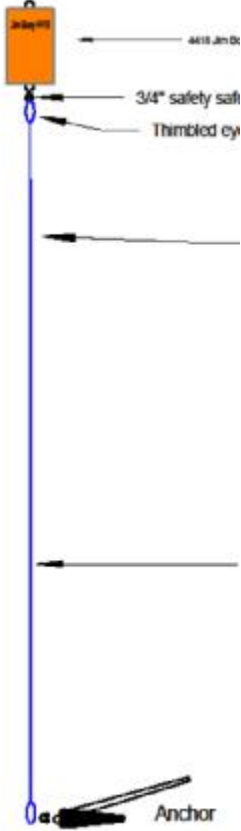
# Anchor Design

- Anchors located along the length of the curtain and have sufficient capacity to hold the curtain and net system in place.
- Danforth-type anchors are used to provide the curtain with lateral stability to maintain its position and resist wind-driven loading and reservoir currents.
- Steel crown floats are located approximately 50 ft. from the curtain to separate vertical anchor load forces from the curtain system.
- Shoreline anchors are located at the upstream dam face and at the northeast shoreline.

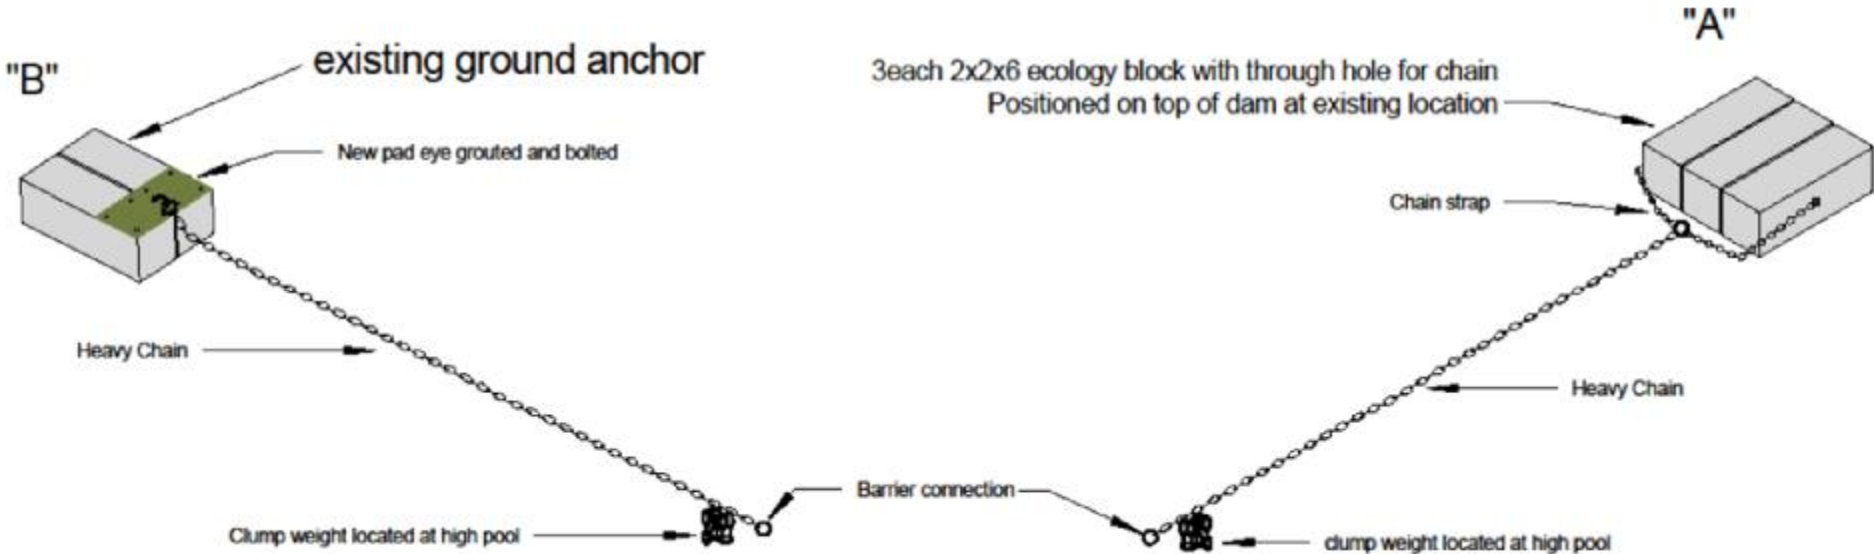
# Shore Anchors

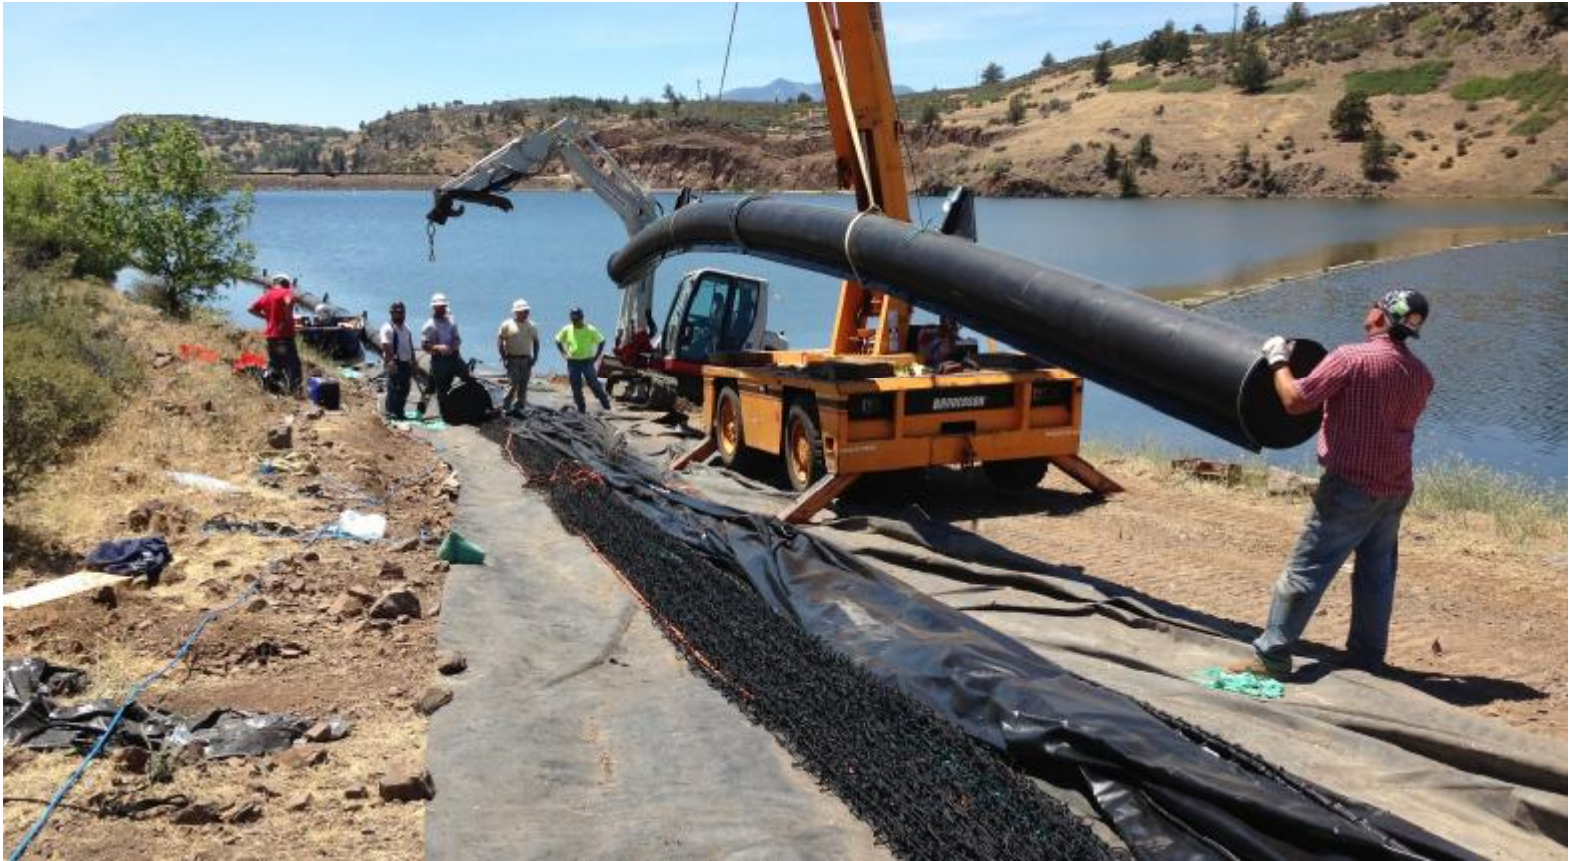
# Flotation

- Rigid float system.
- 18-in.-diameter and 25-ft-long, high-density polyethylene (HDPE), foam-filled MultiFunction Booms
- Each section flange bolted to the next to form a continuous boom
- Provide sufficient buoyancy to maintain the top of the float at a minimum of 12 in. above the water surface at all times.
- Hand winches fitted above boom sections with through-hull fittings below them to allow operators to adjust the temperature curtain to proper depth.

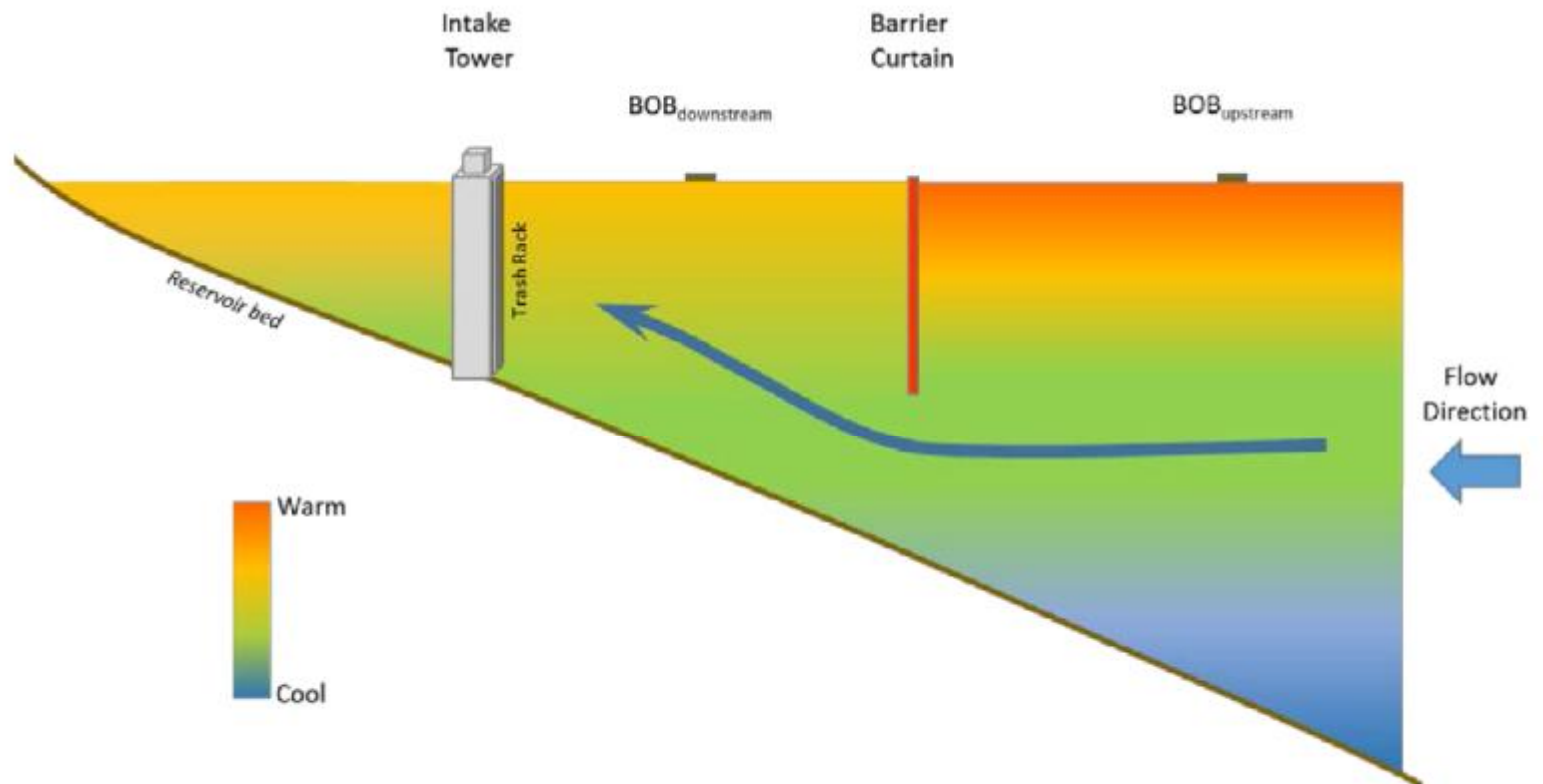
Figure 60. Conceptual Profile View of Thermal Conditions in Iron Gate Reservoir Showing the Location of the BOBs, Curtain, and Intake Tower.

- The shallow, near-surface water upstream of the curtain essentially stopped moving toward the powerhouse intake.
- The water velocities approaching the curtain were highest near the bottom of the curtain and a flow envelope formed below the photic zone upstream of the curtain.
- This resulted in the withdrawal of deeper waters from Iron Gate reservoir.

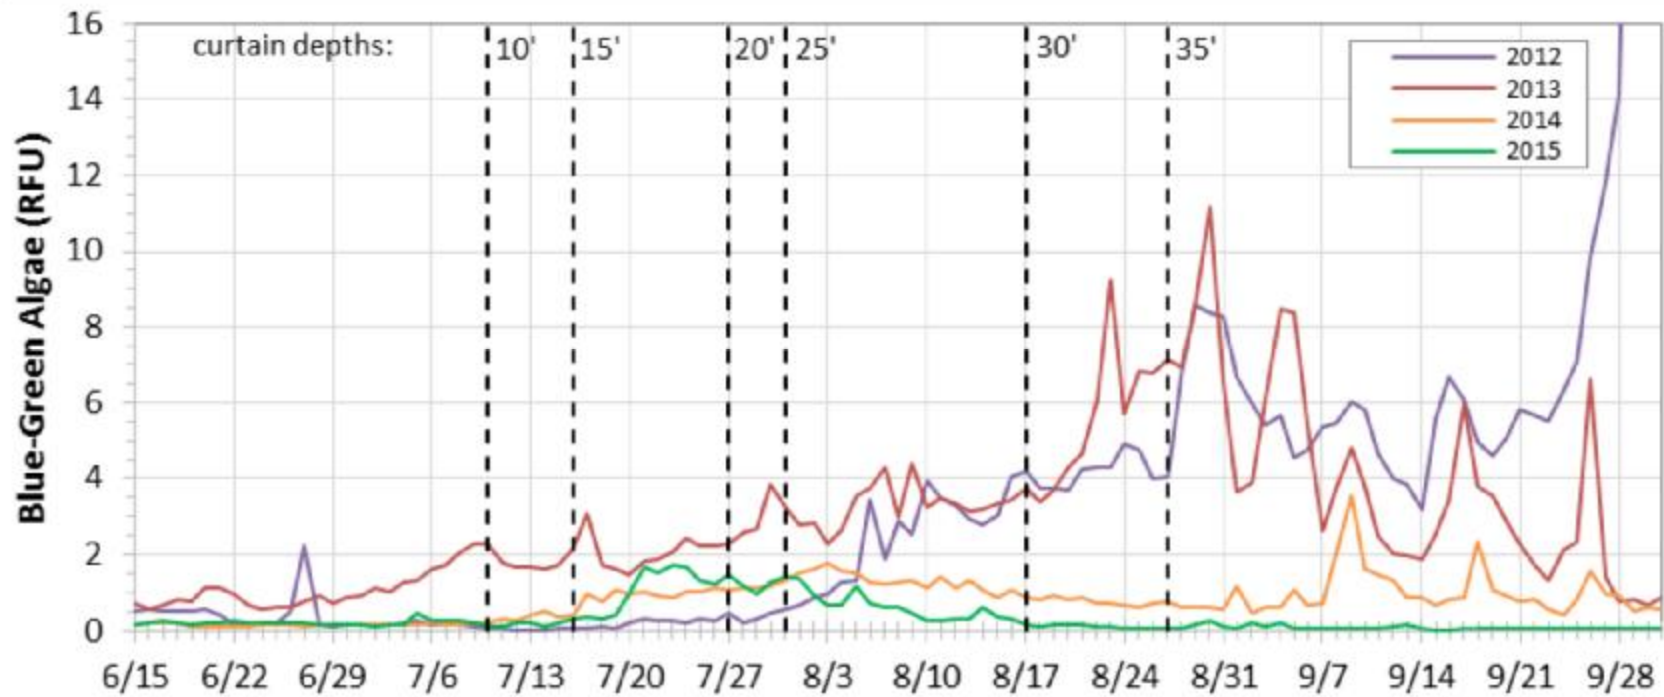
Daily Average BGA Concentration (RFU) as Measured by PacifiCorp Data Sonde in the Klamath River Below Iron Gate Dam (near the Hatchery Bridge) from June 15 to September 15 During Years 2012, 2013, 2014, and 2015.

- Compared surface samples collected 0.5 meter depth upstream of the barrier curtain with downstream samples and indicated downstream reductions in
  - Microcystin (70 percent)
  - *Microcystis aeruginosa* (82 percent)
  - *Aphanizomenon flos-aquae* (97 percent)
  - Chlorophyll-*a* (61 percent)
- Downstream water temperatures and dissolved oxygen levels were similar to *deeper waters* upstream of the curtain

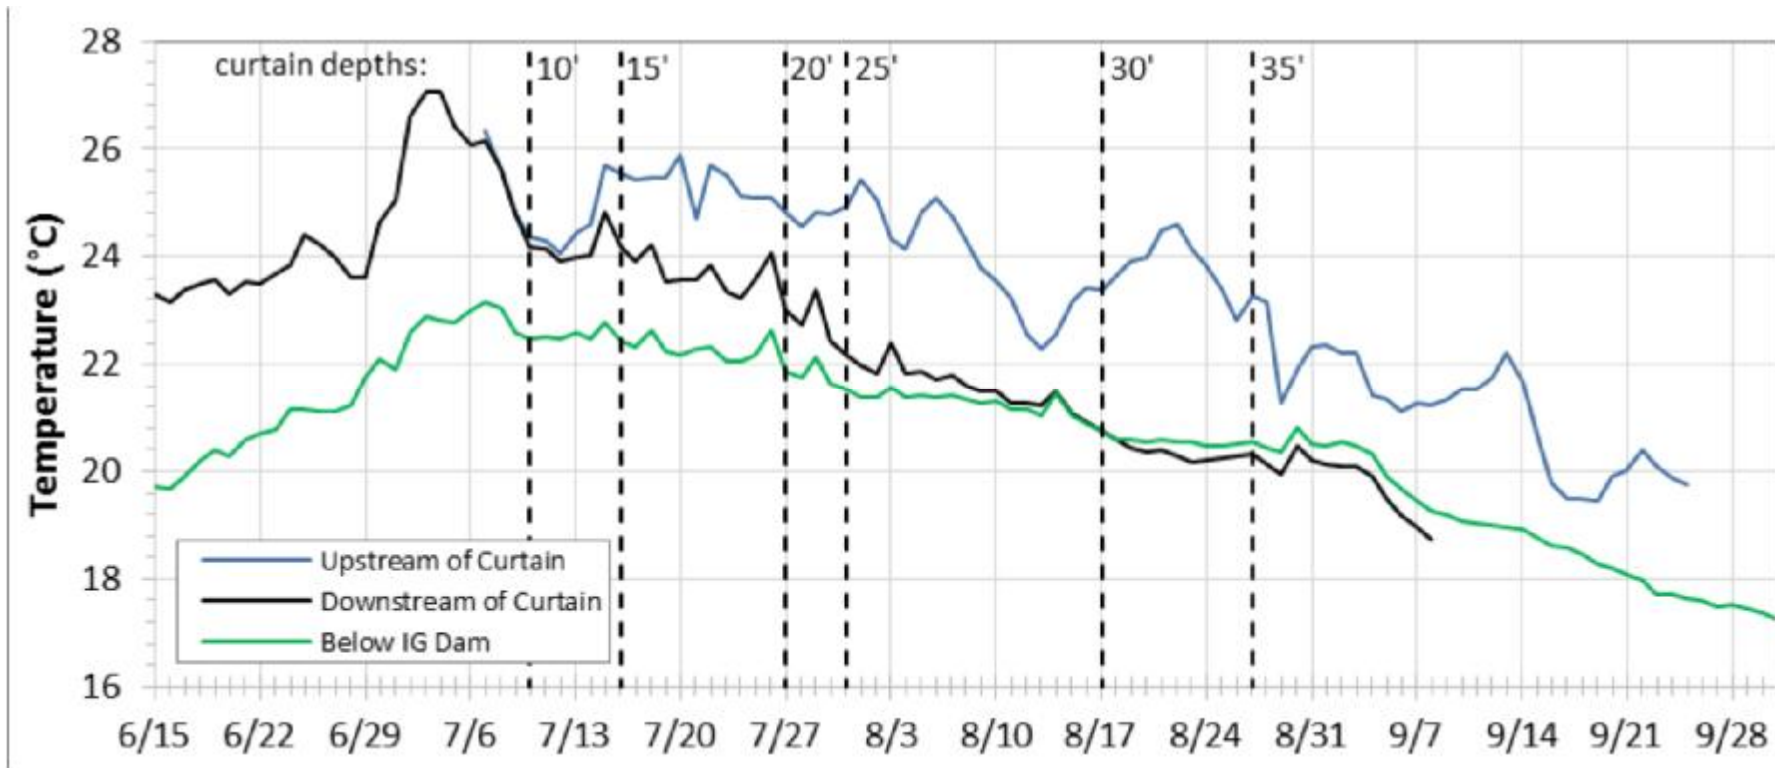
Daily Average of Near-surface (0.1 to 1.3 m) Water Temperatures Measured by Data Sondes Upstream and Downstream of the Curtain in Iron Gate Reservoir, and in the Klamath River Below Iron Gate Dam (near the Hatchery Bridge) from June 15 to September 30, 2015. Vertical hatched lines indicate dates during 2015 when the curtain was lowered to specified depths.

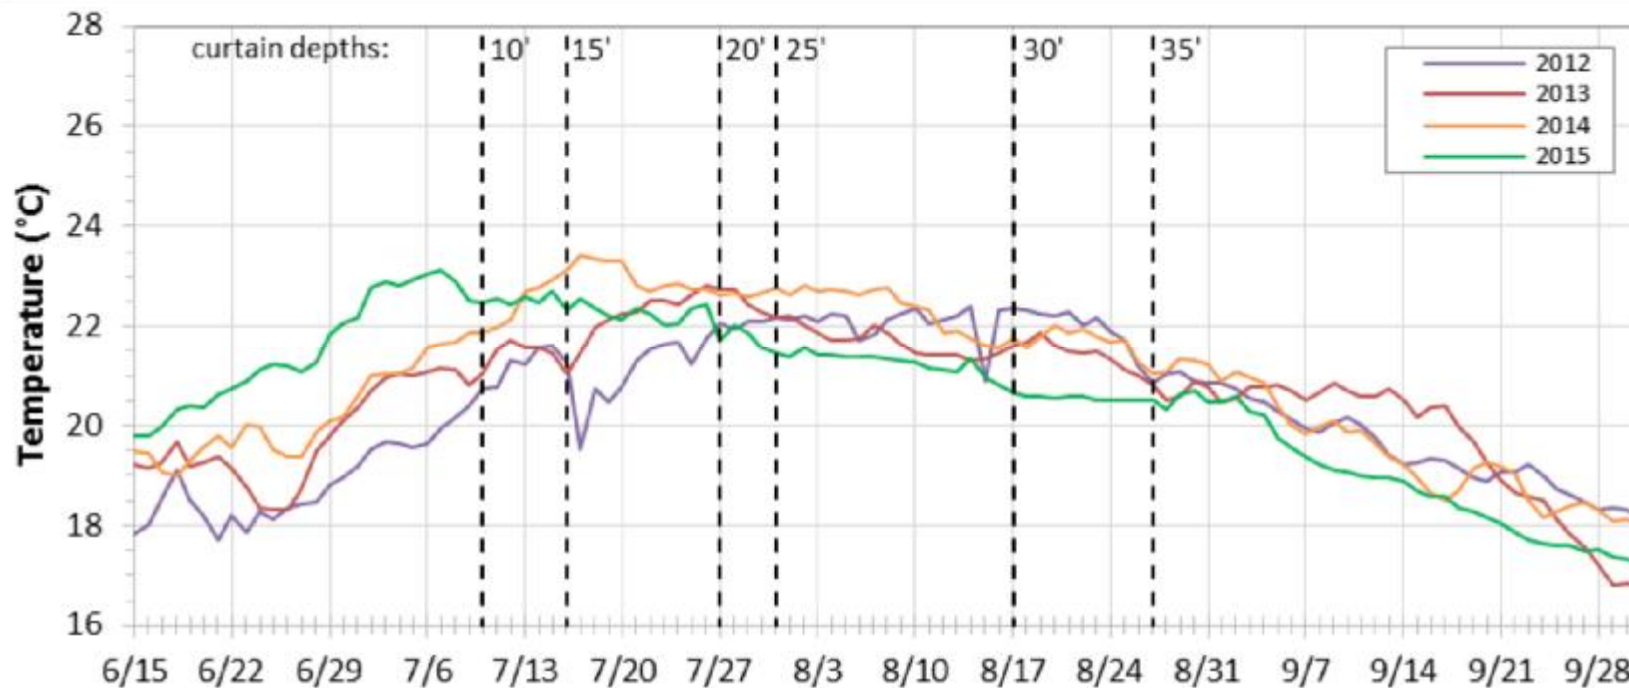
Daily Average Water Temperature as Measured by PacifiCorp Data Sonde in the Klamath River Below Iron Gate Dam (near the Hatchery Bridge) from June 15 to September 15 During Years 2012, 2013, 2014, and 2015.

Note: Vertical hatched lines indicate dates during 2015 when the curtain was lowered to specified depths. Vertical hatched lines are not shown for the curtain deployment in 2014 (which was initiated on August 12, 2014, unfurled to a maximum depth of 35 ft. on August 28, 2014, and subsequently removed on September 8, 2014).

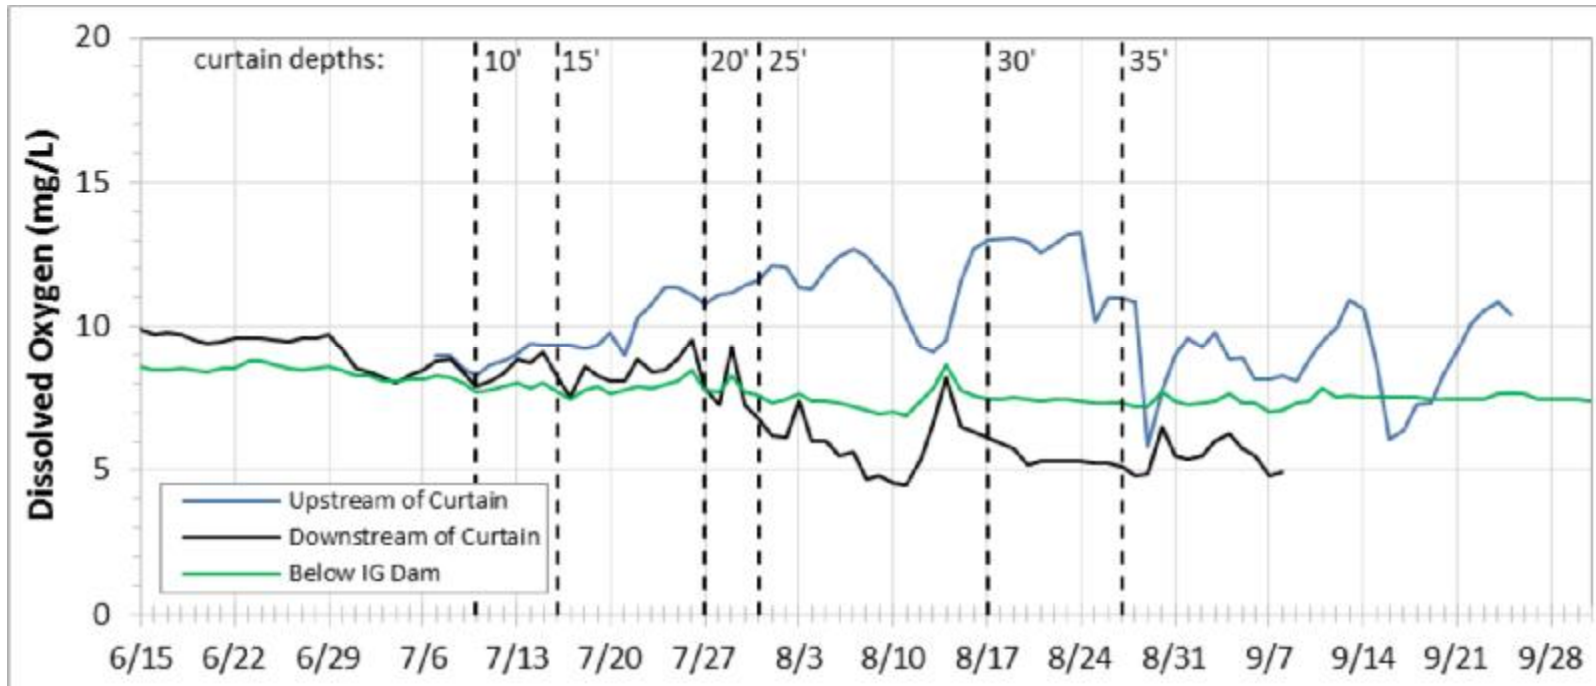
# Dissolved Oxygen

- Dissolved oxygen concentrations upstream and downstream of the curtain diverged under curtain deployment
- Upstream of the curtain, there was higher dissolved oxygen as a result of primary production in near-surface waters.
- Downstream of the curtain, waters from depth had lower dissolved oxygen concentrations.
- Dissolved oxygen concentrations were higher in the Klamath River below Iron Gate dam because of reaeration through the powerhouse.
- A comparison of 2012-2015 dissolved oxygen concentrations below Iron Gate dam suggests that dissolved oxygen levels following curtain deployment were comparable to prior years.
