## Technical Developments in Materials and Techniques for Fish and Debris Passage: The Iron Gate Dam Experience

# Technical Developments in Materials and Techniques for Fish and Debris Passage

## The Iron Gate Dam Experience

# Barrier Curtains

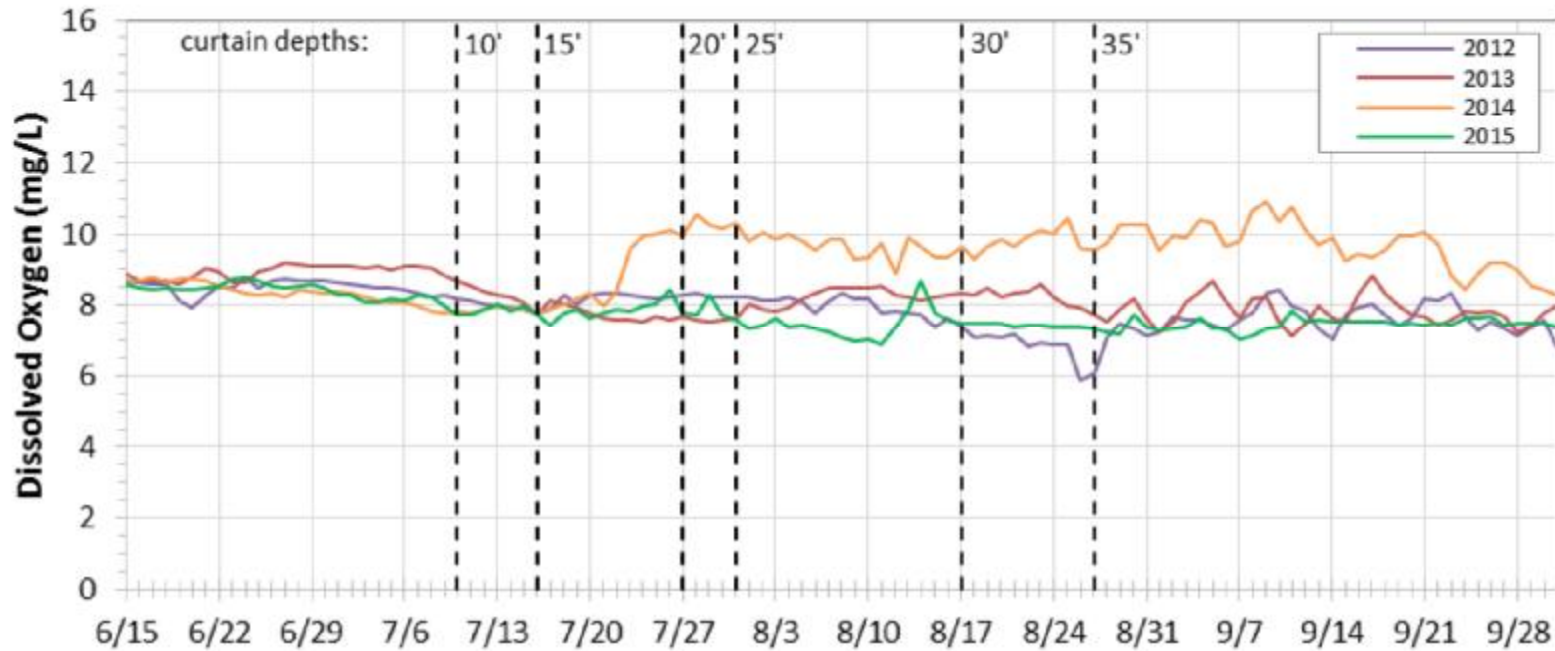
Figure 11. Daily Average Dissolved Oxygen as Measured by PacifiCorp Data Sonde in the Klamath River Below Iron Gate Dam (near the Hatchery Bridge) from June 15 to September 15 During Years 2012, 2013, 2014, and 2015. Note: Vertical hatched lines indicate dates during 2015 when the curtain was lowered to specified depths. Vertical hatched lines are not shown for the curtain deployment in 2014 (which was initiated on August 12, 2014, unfurled to a maximum depth of 35 feet on August 28, 2014, and subsequently removed on September 8, 2014).

- Dissolved oxygen concentrations upstream and downstream of the curtain diverged under curtain deployment
- Upstream of the curtain, there was higher dissolved oxygen as a result of primary production in near-surface waters.
- Downstream of the curtain, waters from depth had lower dissolved oxygen concentrations.
- Dissolved oxygen concentrations were higher in the Klamath River below Iron Gate dam because of reaeration through the powerhouse.
- A comparison of 2012-2015 dissolved oxygen concentrations below Iron Gate dam suggests that dissolved oxygen levels following curtain deployment were comparable to prior years.
