Dam Removal I: Ecological and Geomorphic Adjustments to Dam Removal in an Upland Mesic Catchment

Ecological and Geomorphic Adjustments to Dam Removal in an Upland Mesic Catchment

Pelham Dam (Amethyst Brook), MA

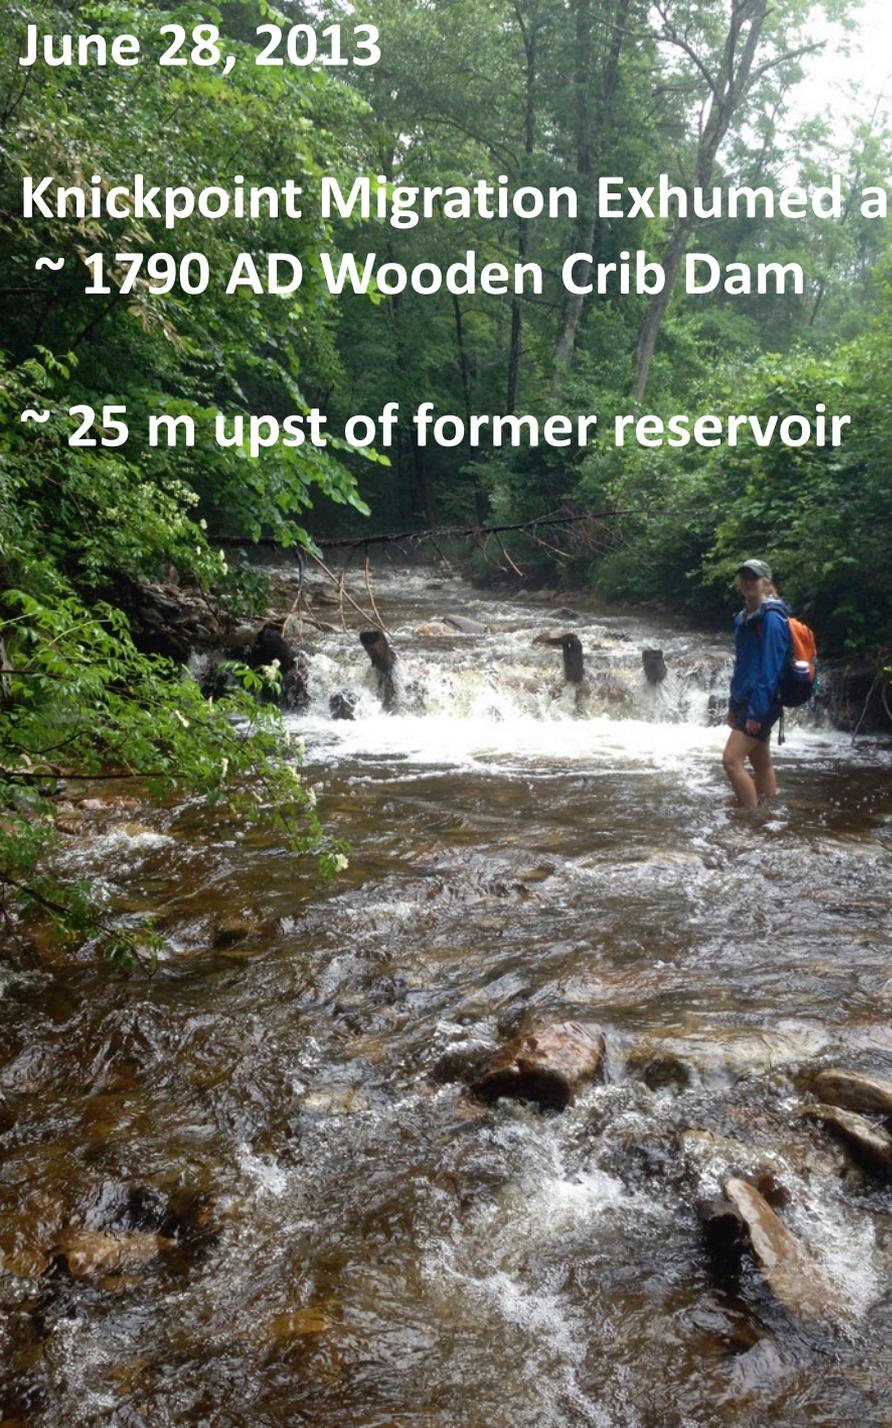
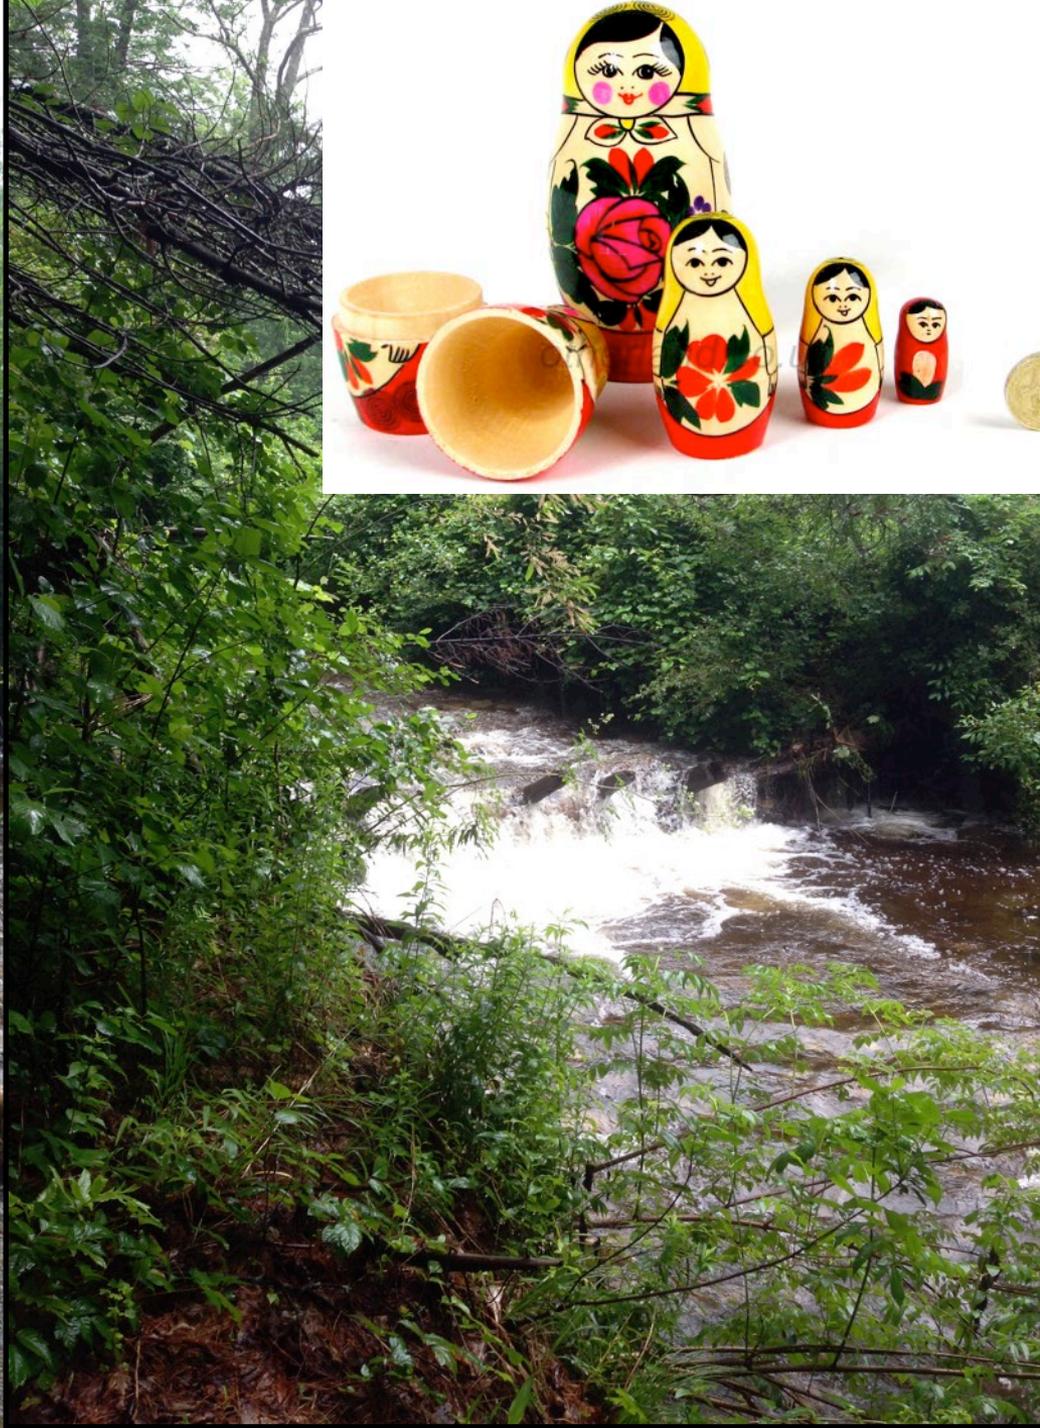
June 28, 2013

Knickpoint Migration Exhumed a
~ 1790 AD Wooden Crib Dam

~ 25 m upst of former reservoir

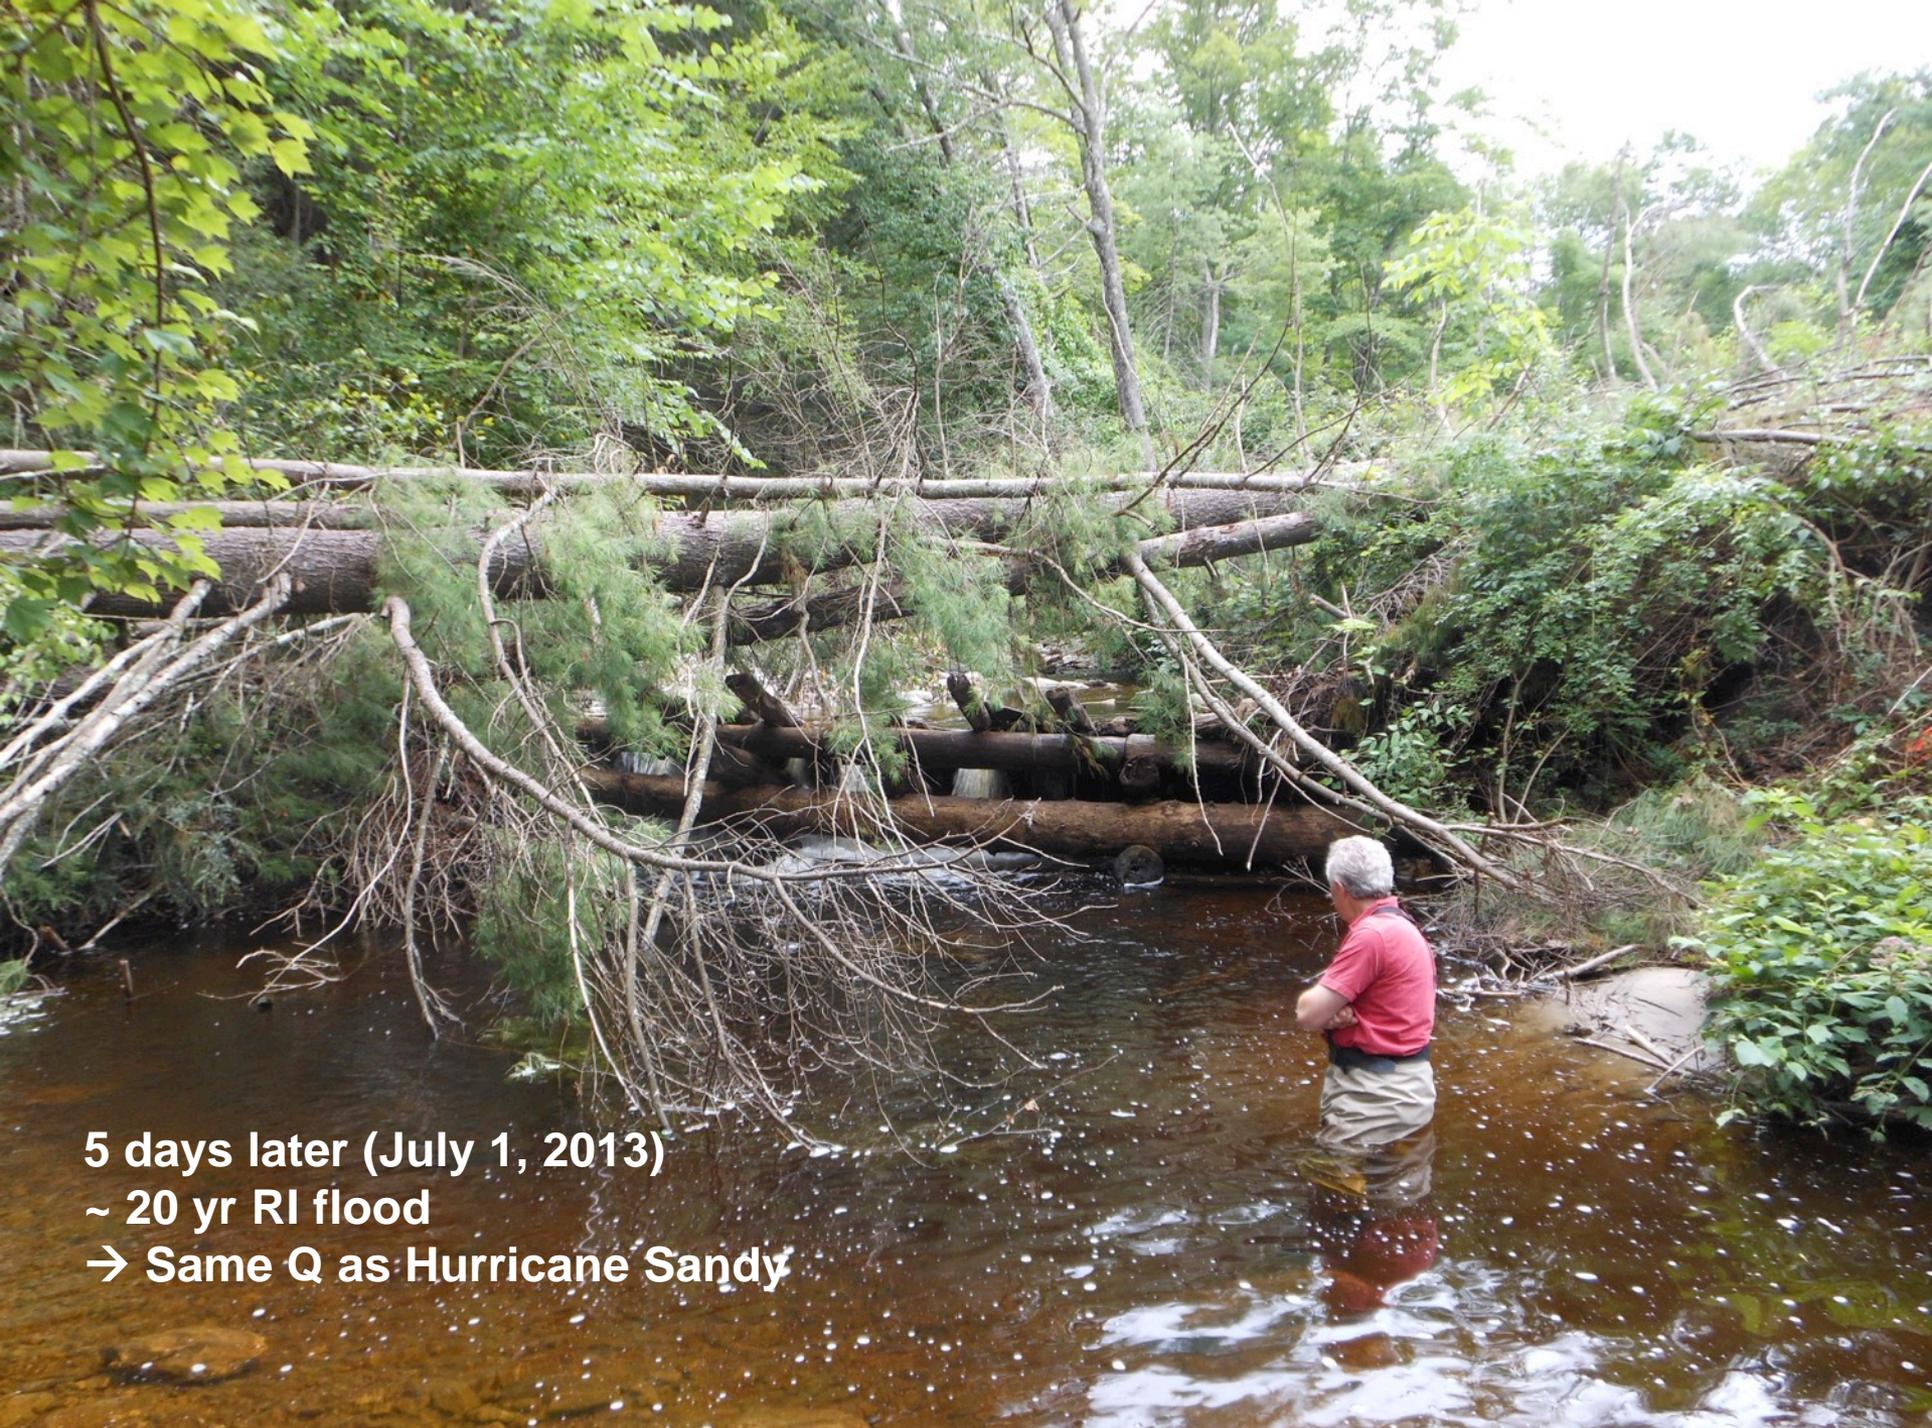
5 days later (July 1, 2013)
~ 20 yr RI flood
→ Same Q as Hurricane Sandy

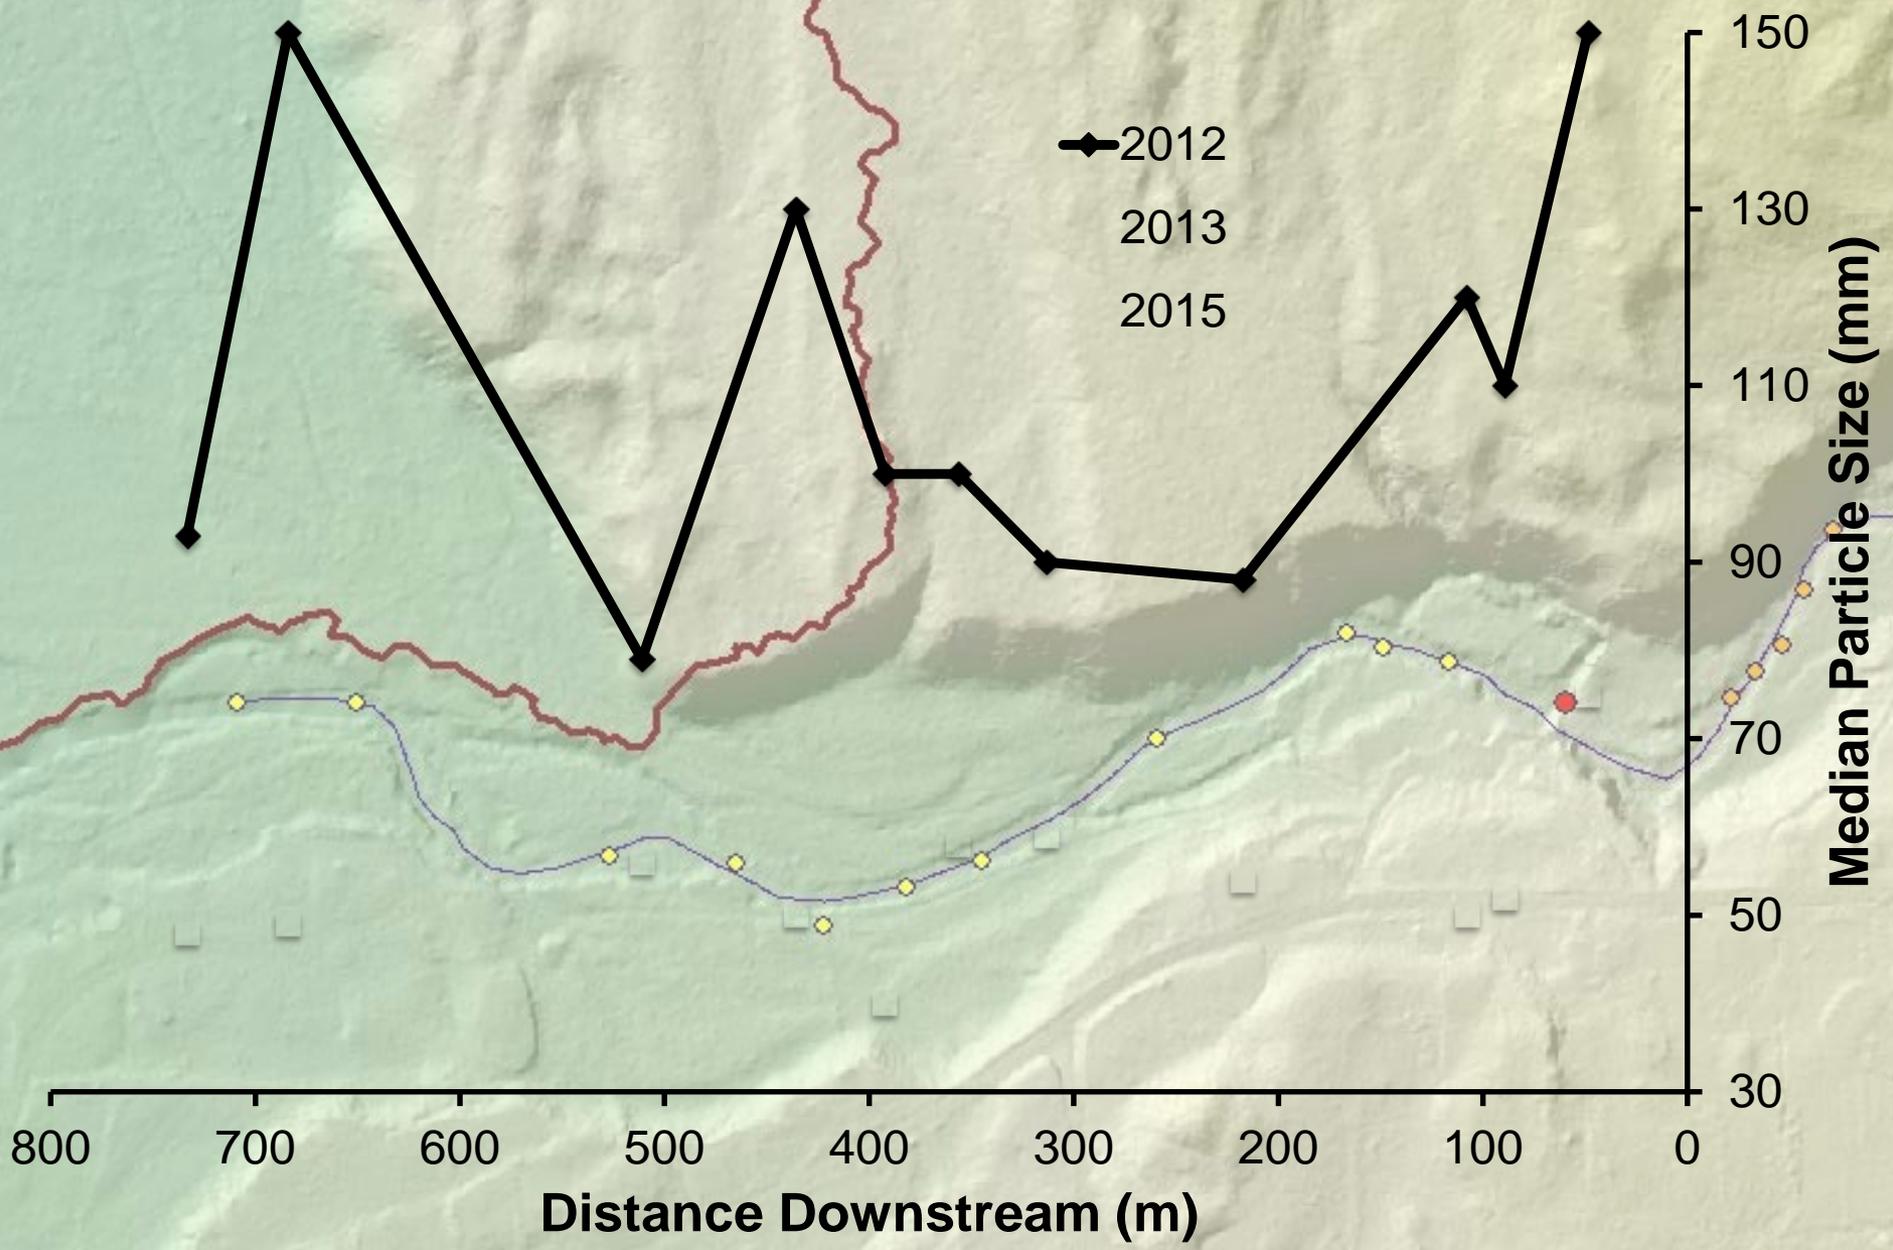
Downstream Changes in Median(D_{50}) Bed Particle Size

- Bed aggradation & significant fining downstream of former dam; channel adjustment associated with dam removal/flood interaction in dam proximal sections
- Lamprey nests increase in #, especially in dam proximal locations, and spawning observed above the former dam
- Fish species richness increases upstream as species move above the dam
- In sections experiencing major channel adjustment, abundances of some species was reduced

- Bed coarsens slightly but still finer than pre-dam condition
- Lamprey nests increase in #, especially in dam proximal locations
- Species whose abundance was reduced in dam/flood impacted reaches recover
- Bed fining is dominant and persistent response relative to other channel changes
- Downstream bar formation expands

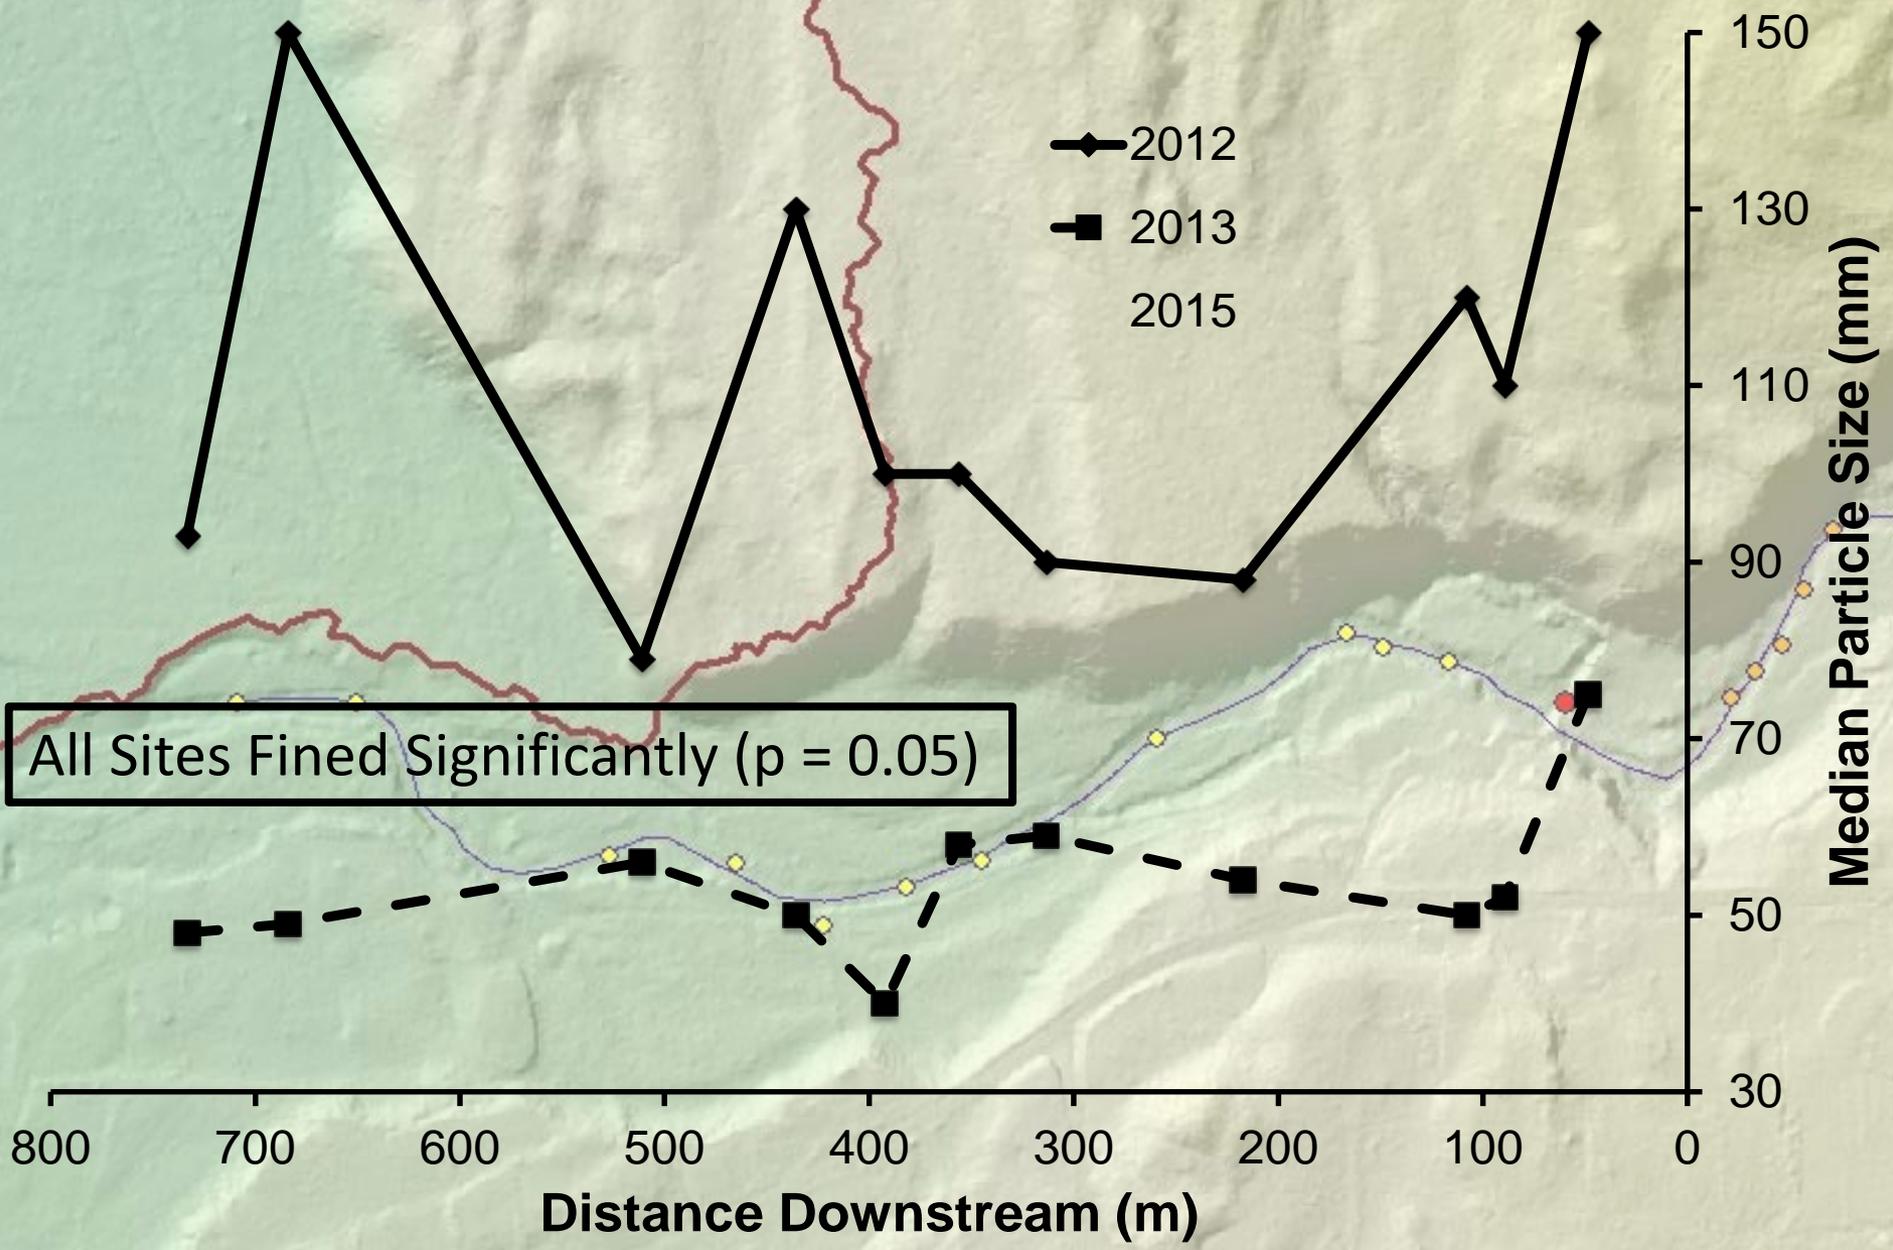
Downstream Changes in Median(D_{50}) Bed Particle Size

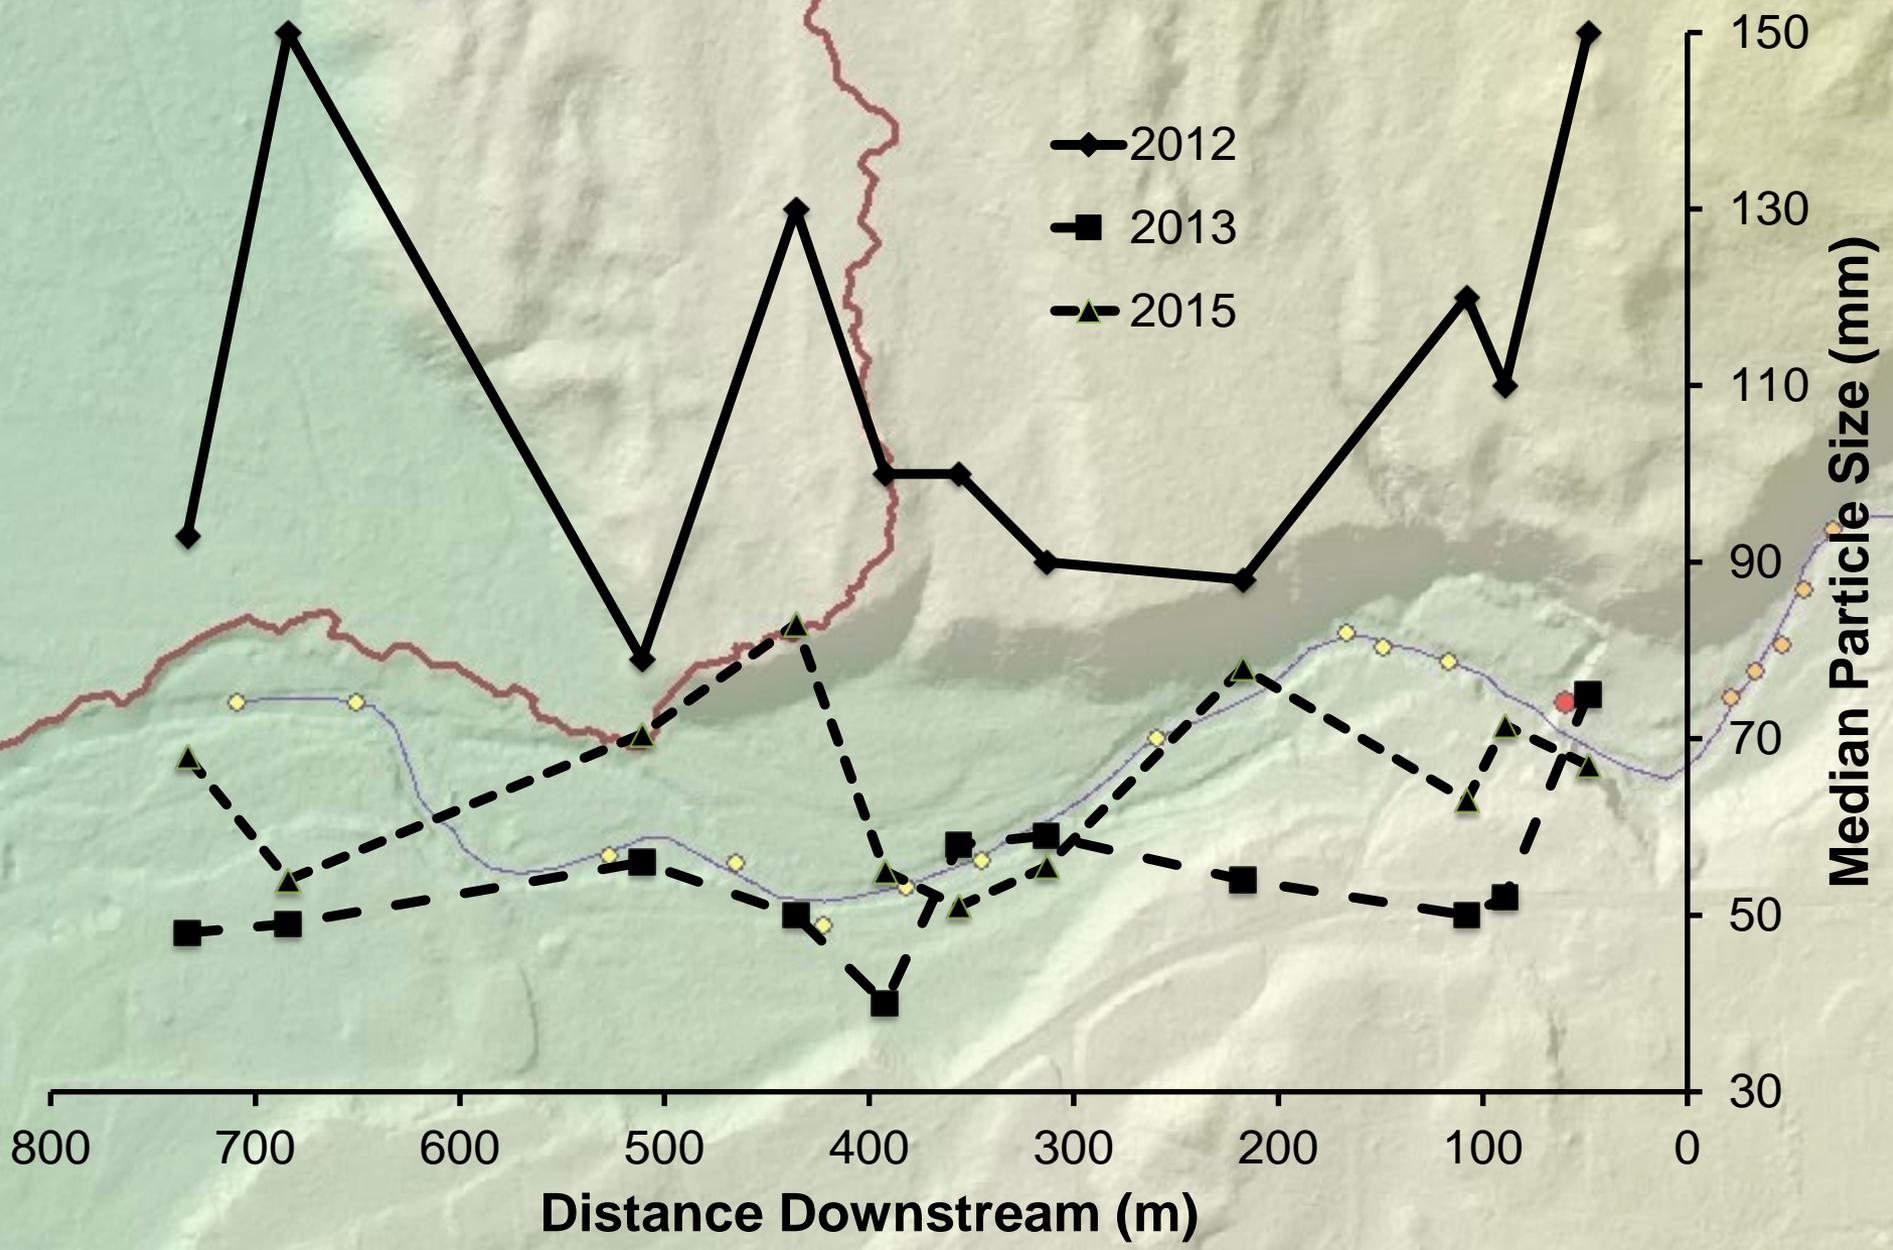
Downstream Changes in Median(D_{50}) Bed Particle Size

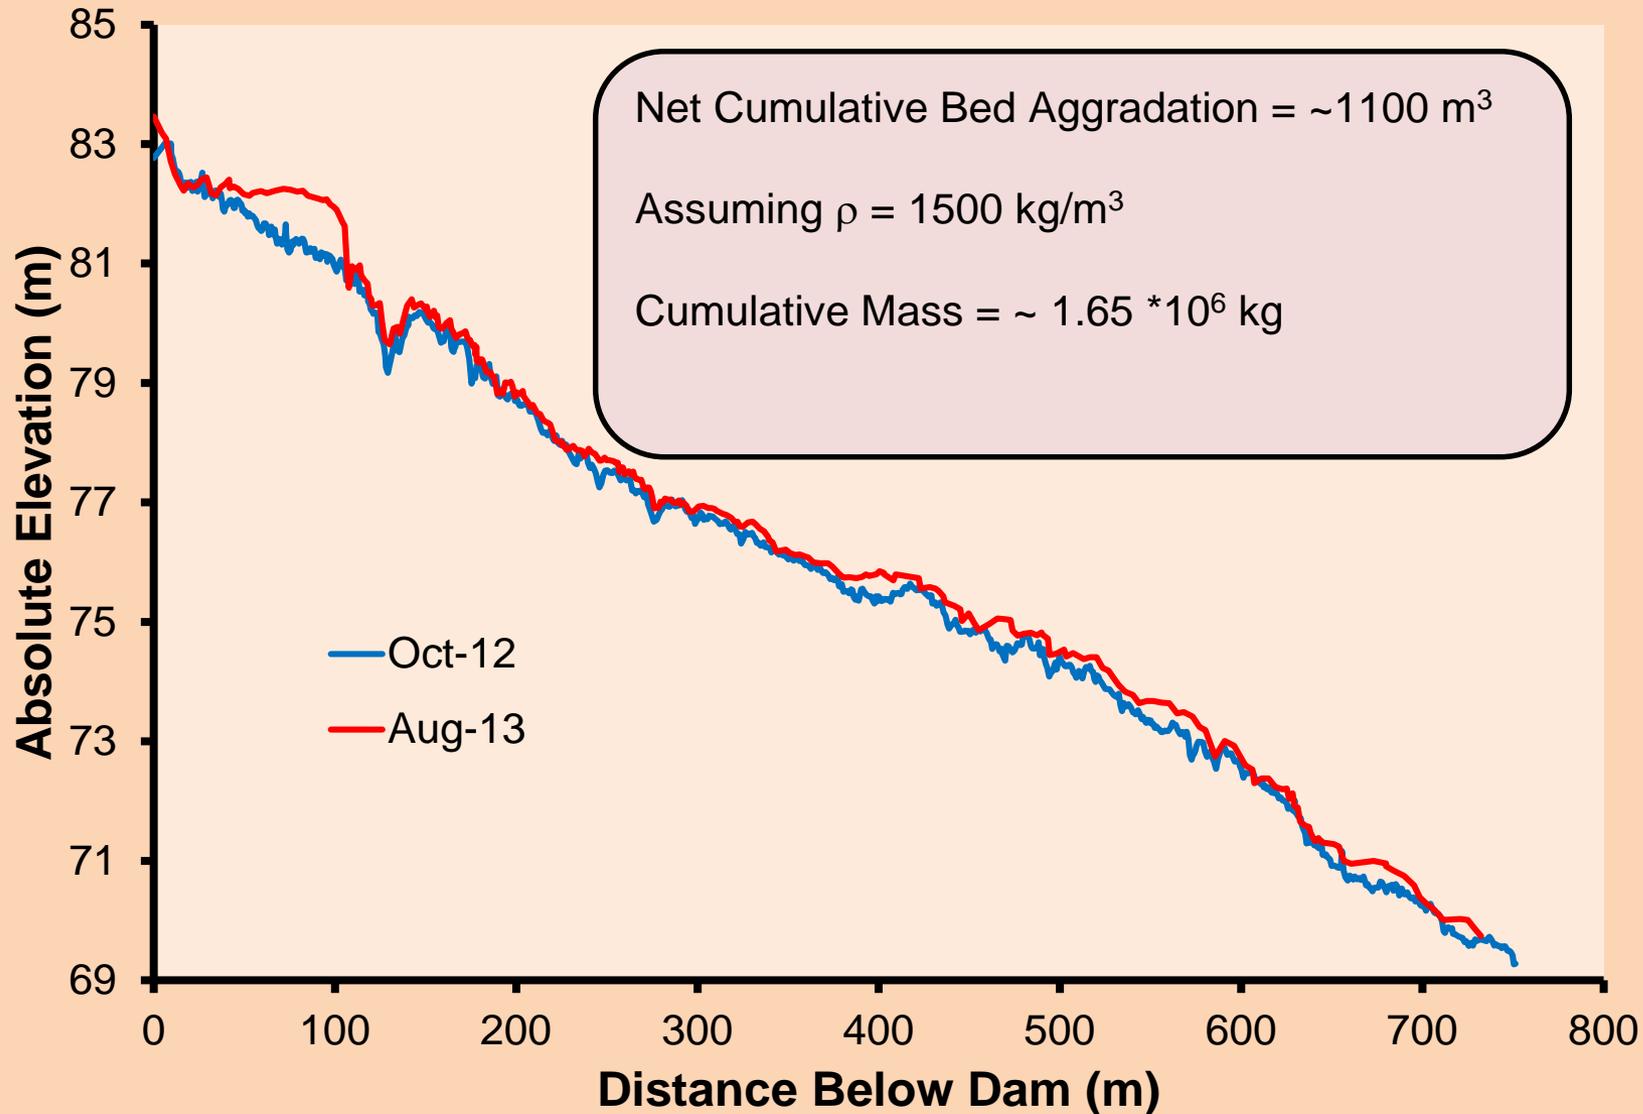
Channel Bed Elevation Change 2012-2013

2012 - 2013: Average bed aggradation = $\sim 25 \text{ cm}$

2013 - 2015: No Appreciable Net Change

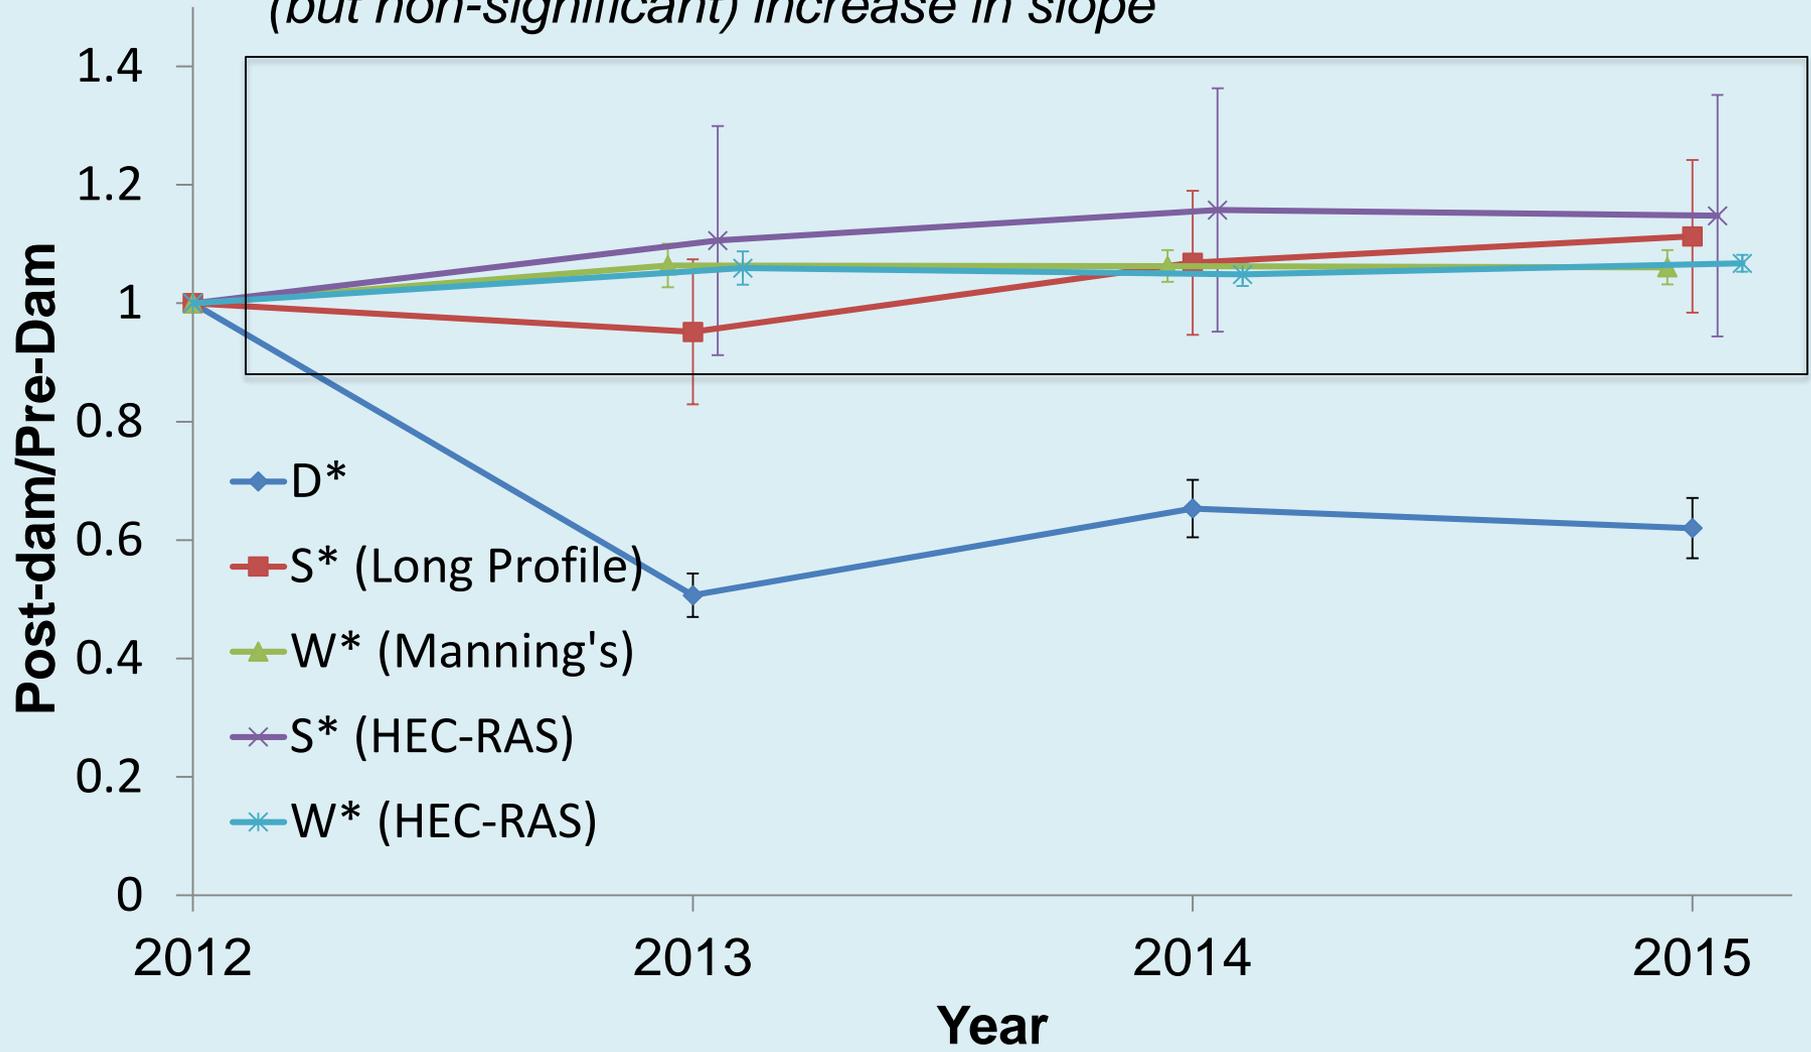
Time Series of Geomorphic Adjustments Following Dam Removal

Channel adjustments have been minimal other than a slight (but non-significant) increase in slope

$D = D_{50}$; $S = \text{Slope}$; $W = \text{Width}$; * indicates ratio to pre-removal

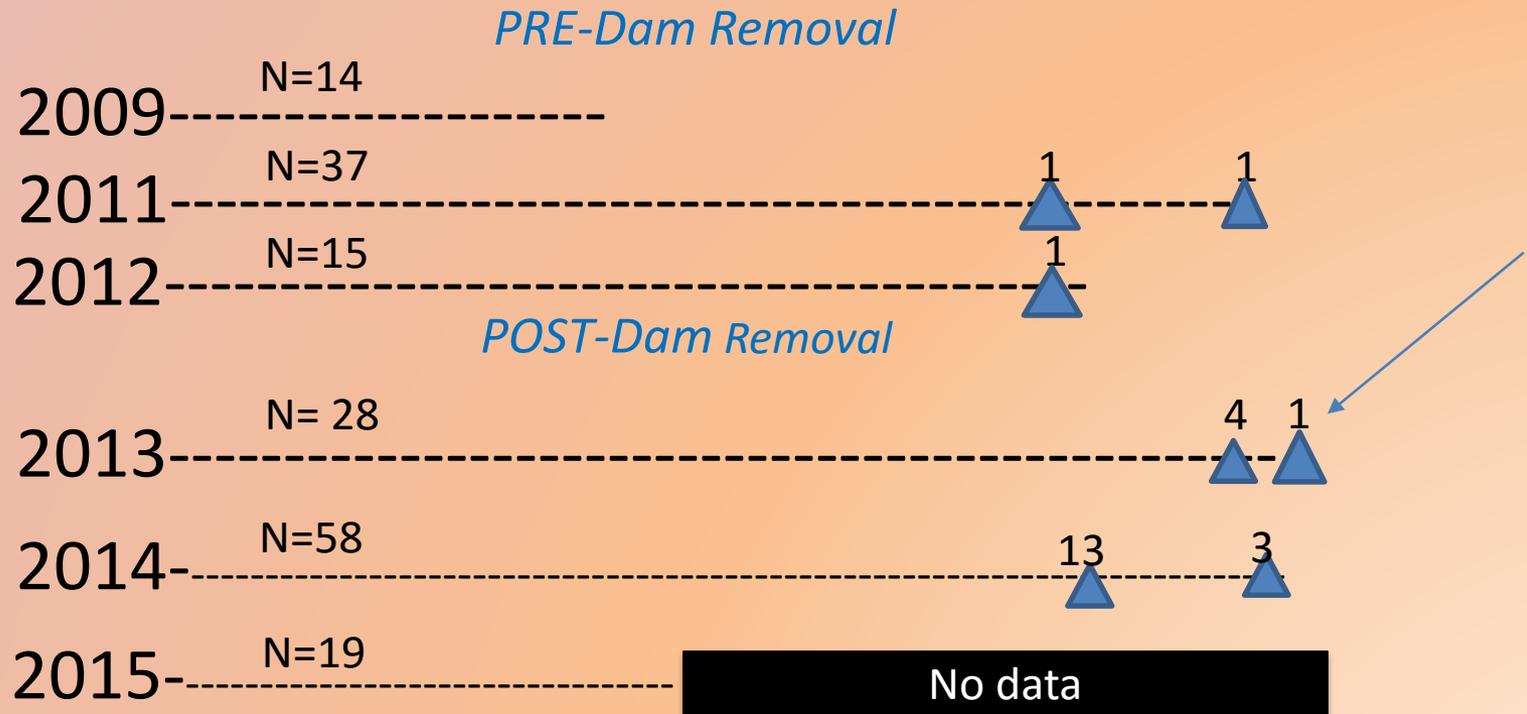
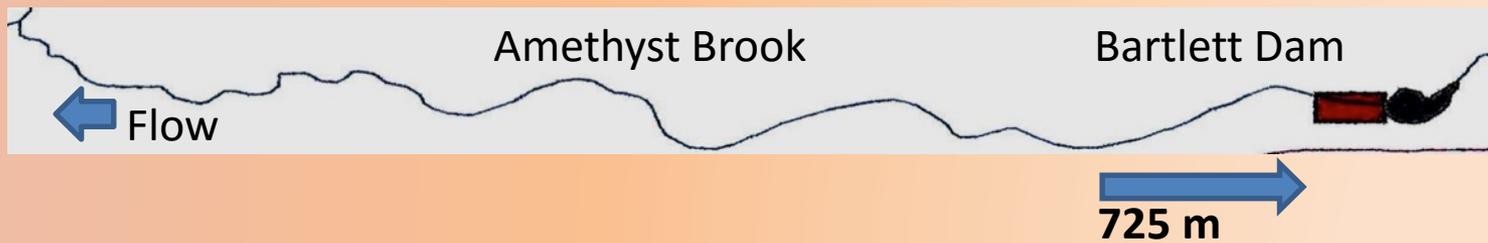
and location of sea lamprey spawning nests by Yr: pre- and post-dam removal

YEAR --- N= Total # nests ; ▲ = # nests within 725 m of dam

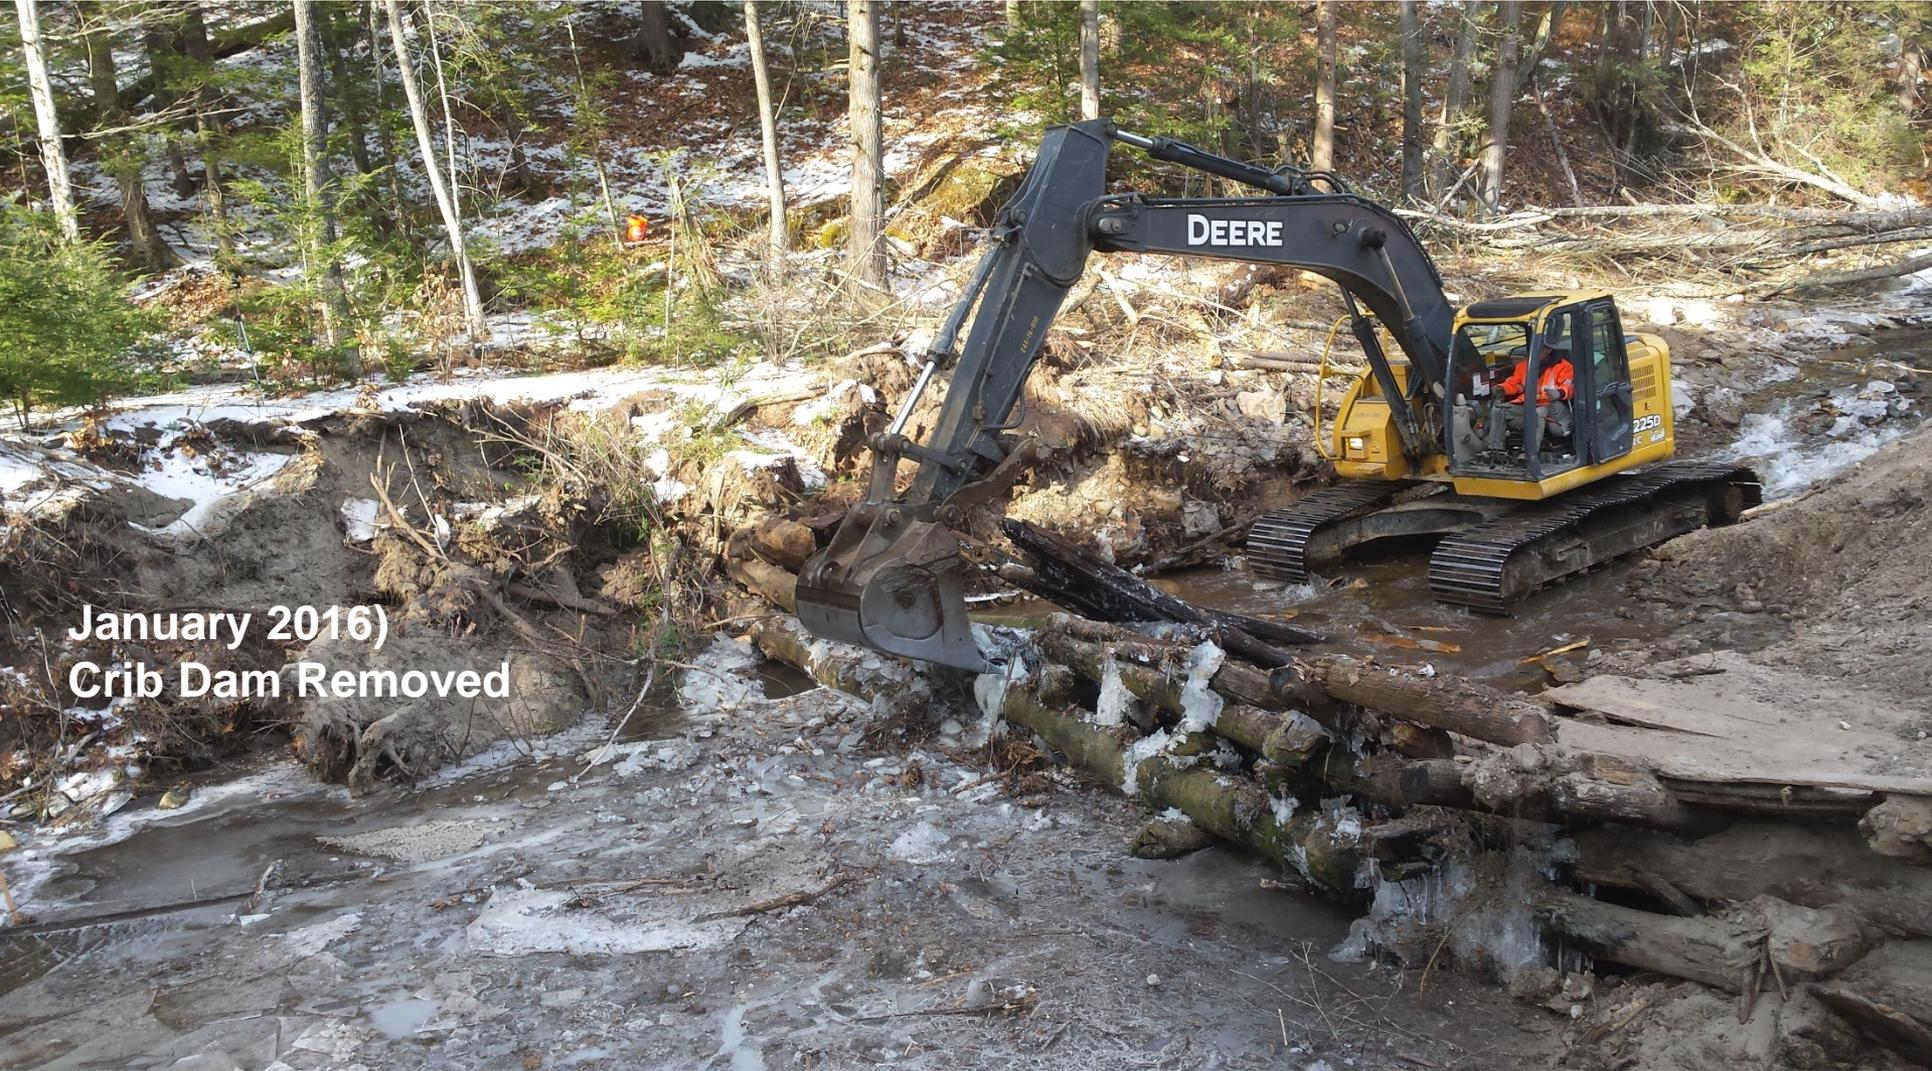
Re-connected Supply of Fine Bed Material Has Led To Aggradation and Progressive (Alternate) Bar Formation
