Policy shift in reviving migratory fish stocks - examples from RESTORE Life+

Jukka Jormola

FISH PASSAGE 2015

International Conference on Connectivity Best Practices and Innovations
Groningen, Netherlands June 22-25 2015

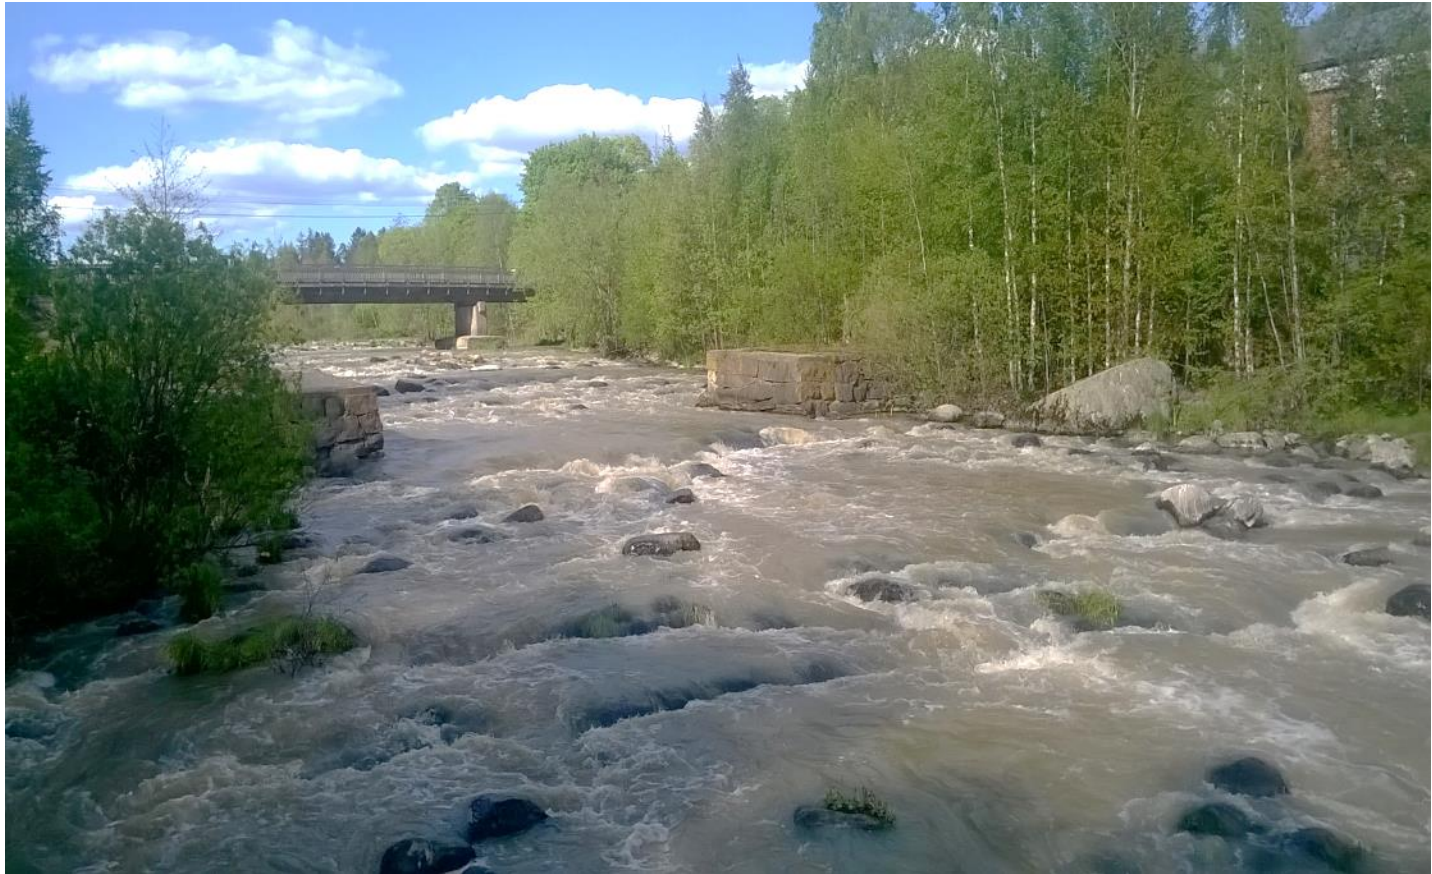
Koskenkylänjoki, Finland

Dam removals

- Best option for restoration of connectivity
- Cultural history must be considered

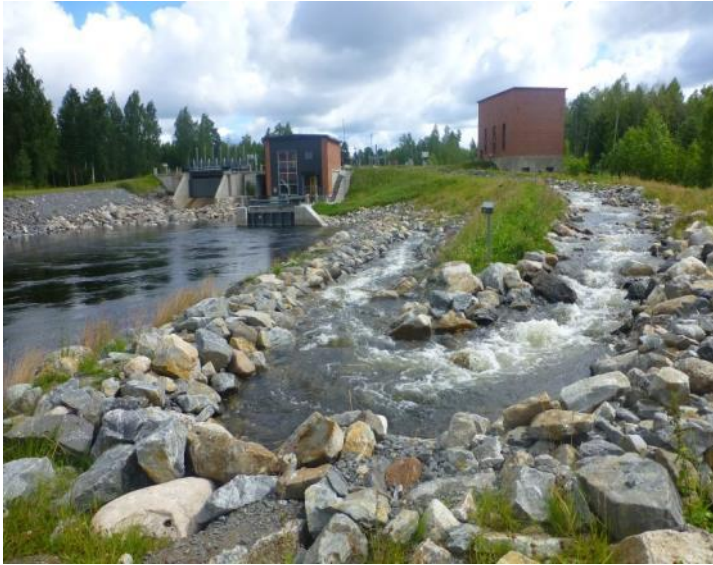
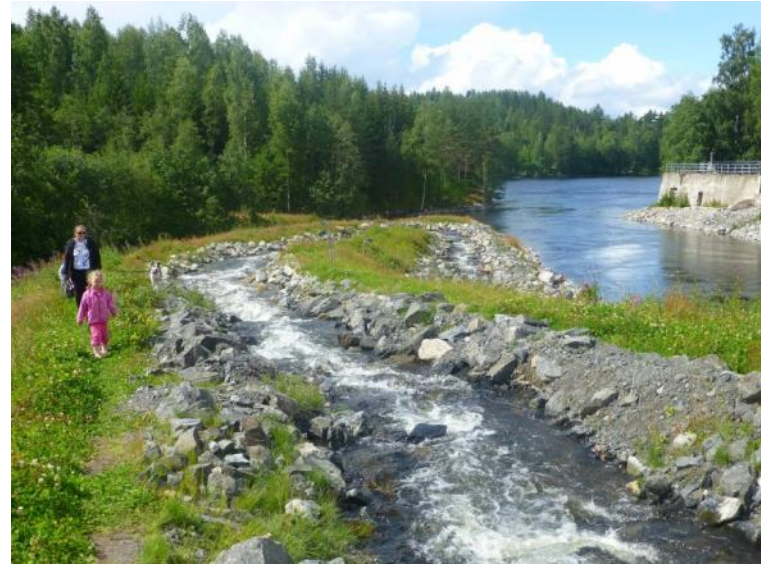
Kissakoski,
Finland

Measures for existing or new hydro power – best fish pass types

- Best practice of fish passes: Nature-like bypass channels
- Several ecosystem services can be gained
 - Migration for all species, also weak swimmers
 - Ecological corridors for mammals and bird juveniles
 - New habitats for spawnign and rearing can be created
 - Landscape values and tourism benefits by good design

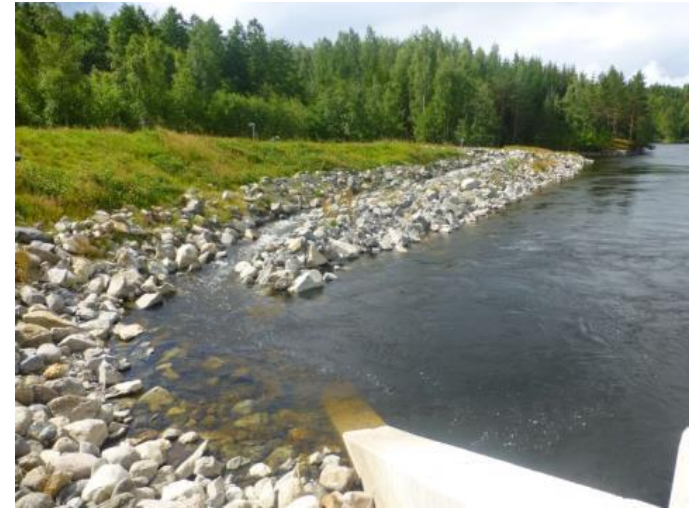
Kissakoski
Planner: Ecoriver

Combining all functions in a bypass channel - Entrance

- Good location of entrance near to the obstacle

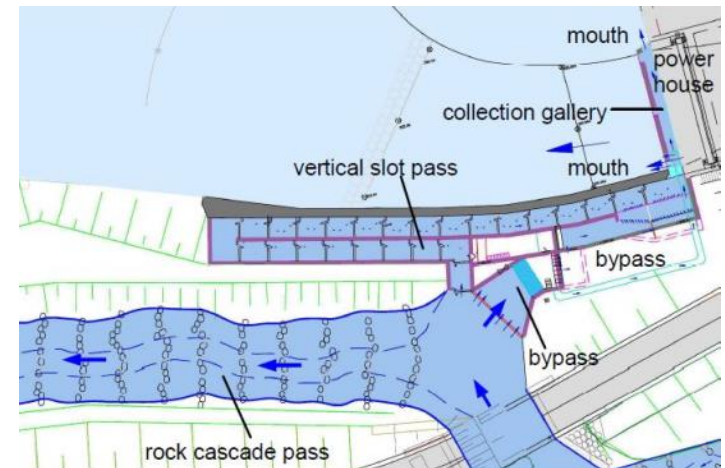
Albruck-Dogern, Rhine
Planner: R.J.Gebler

- Connection from a bypass channel to a fish pass, if needed

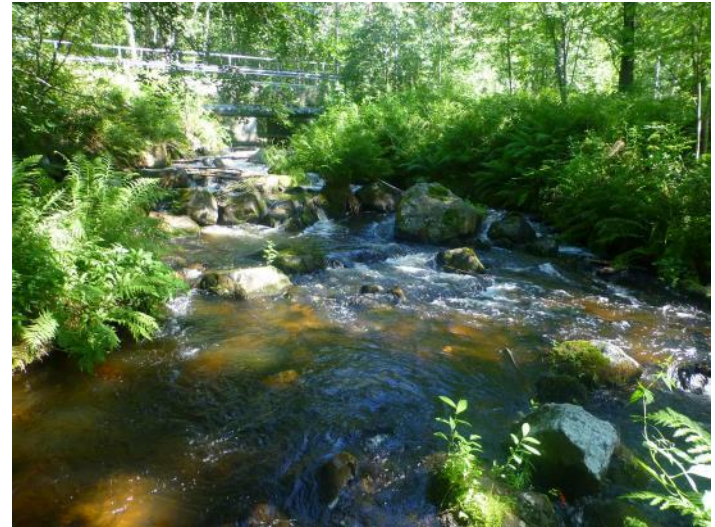
Kämärinkoski,
Finland

1. Bypasses with function as fish pass and habitats

Special sections with low gradient for habitats and steeper sections to allow migration

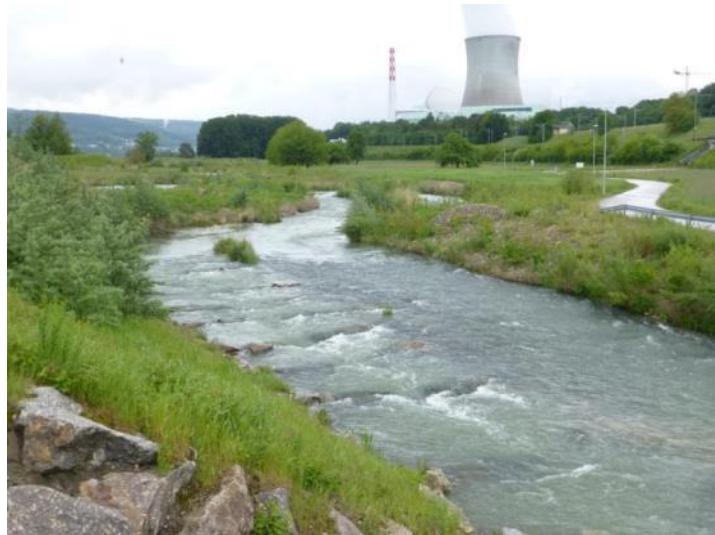
Albruck-Dogern
Switzerland, Rhine

Parallel parts or arms for migration and habitats

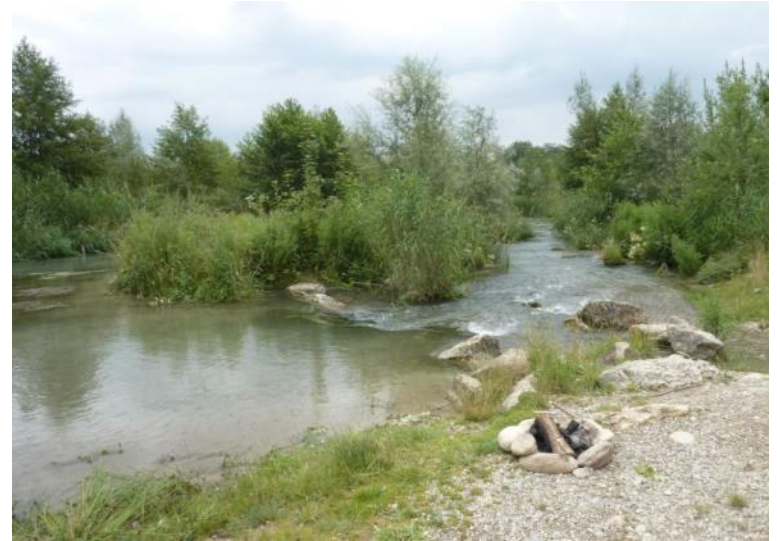
Ruppoldingen
Switzerland

2. Channels with main function as habitats

Separate arm for reproduction

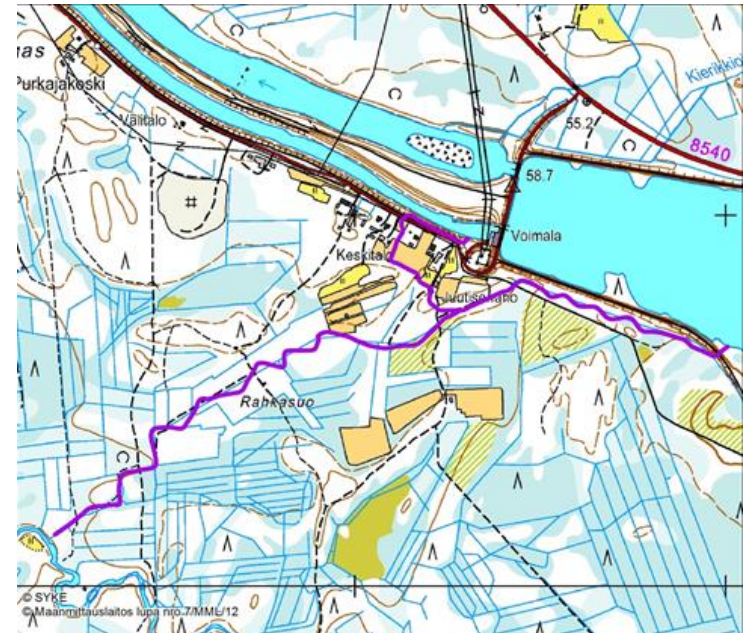
Plan for
Ijoki, Finland

Combination of bypasses with
natural streams

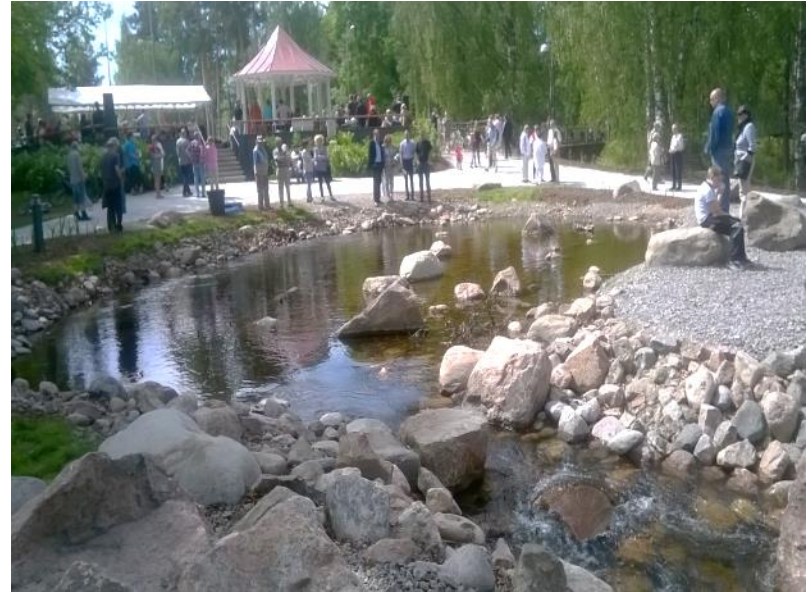
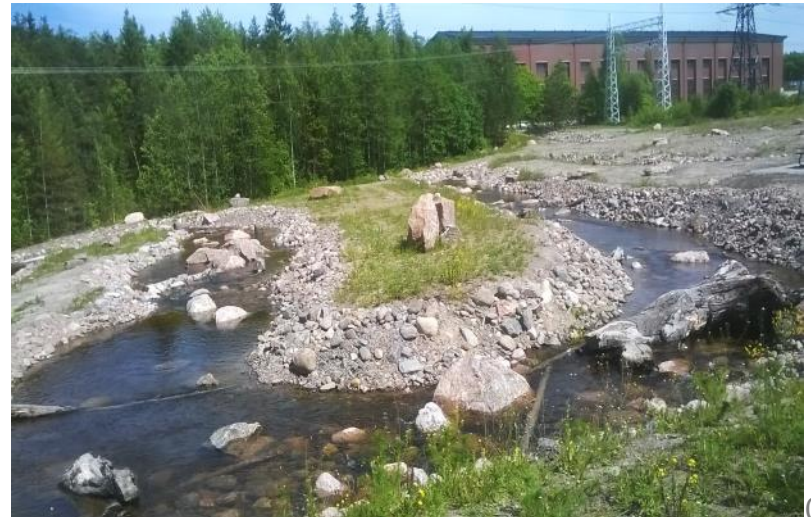
Imatra urban brook, Finland

3. Reproduction channels

- Not necessarily any fish pass function
- Common in Canada

- Serves as a compensative habitat for trout and as a touristic attraction
- Opened June 2015
- Design: MA-arkkitehdit, SYKE

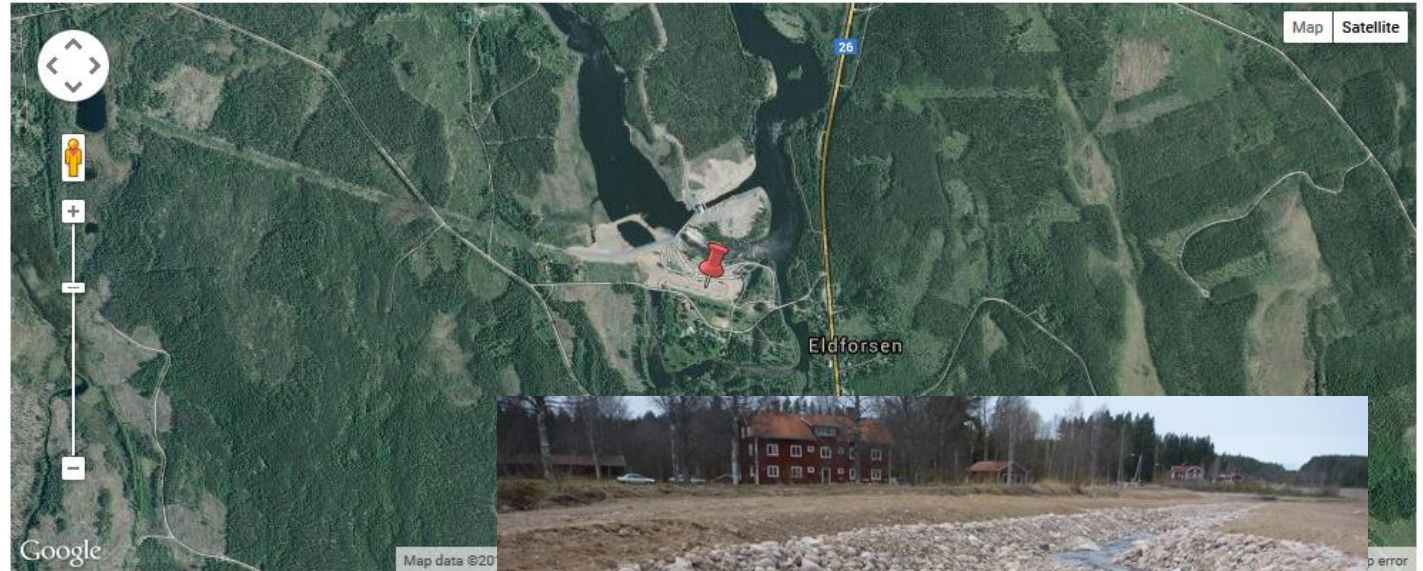
Case study: Eldbäcken

- Biocanal, compensative habitat for trout and pearl mussel

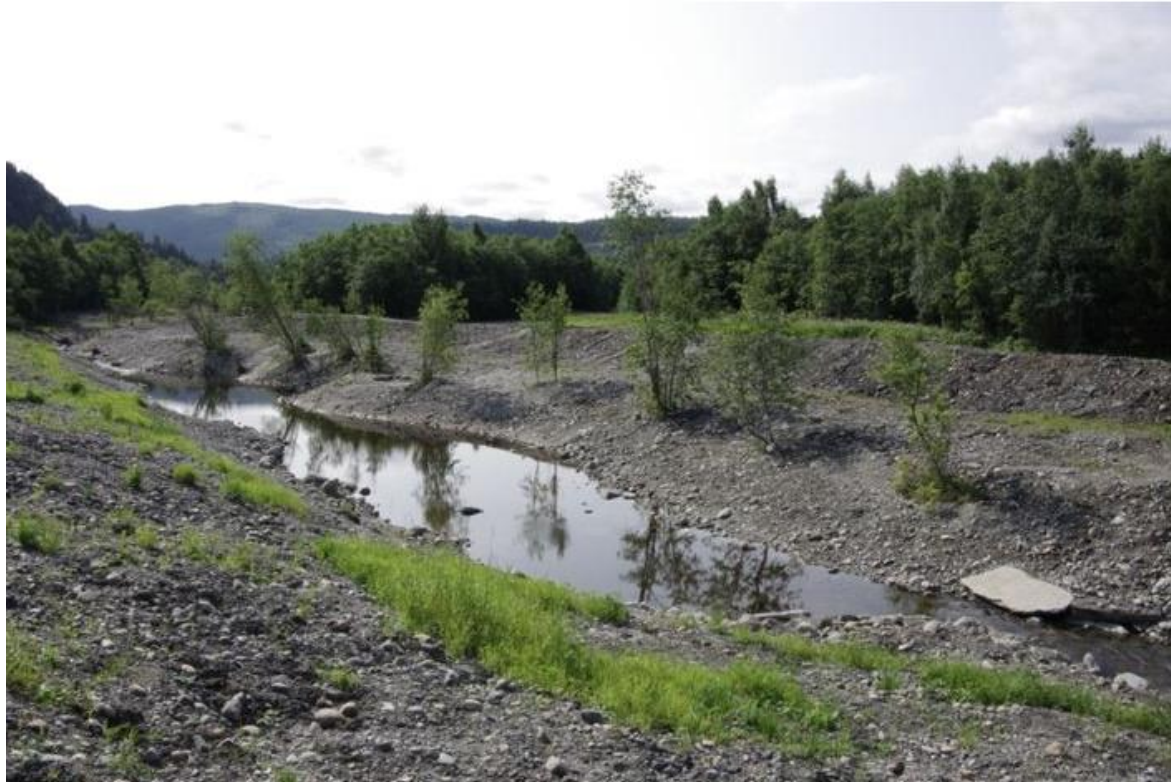
Case study: Built Kjøsnesbekken in the river Stjørdalselva

- Constructed side channel for habitat compensation

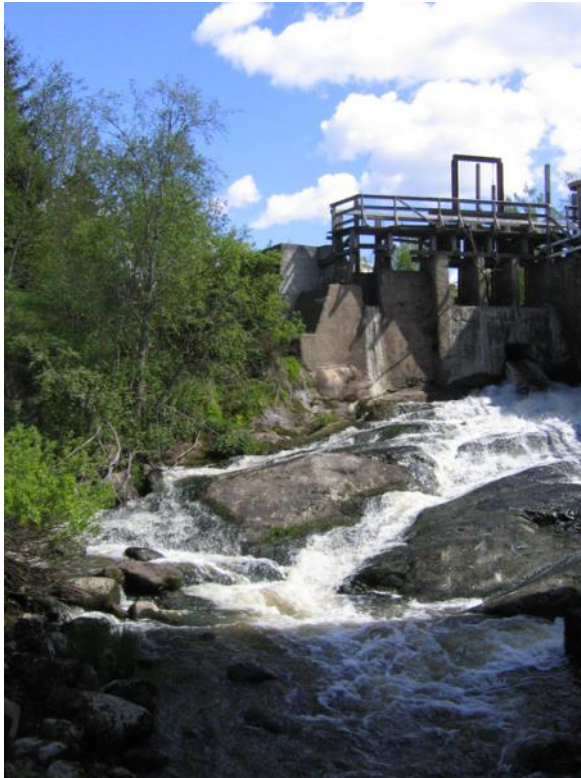
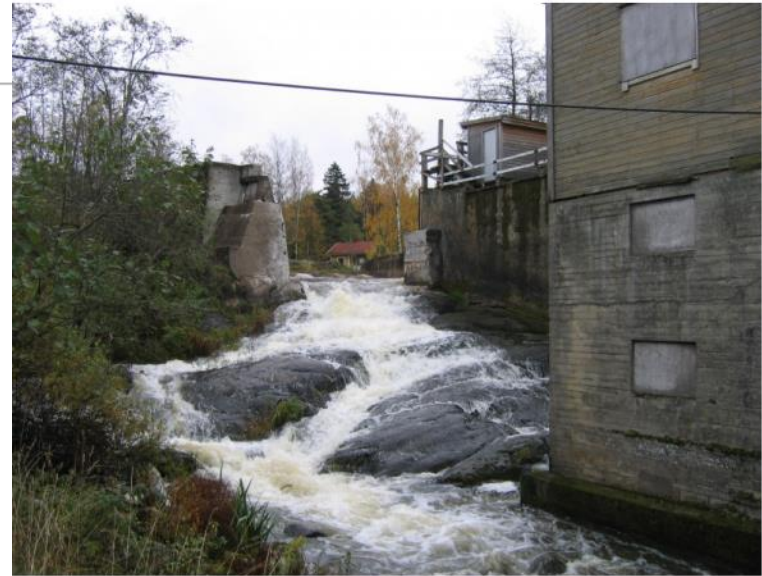
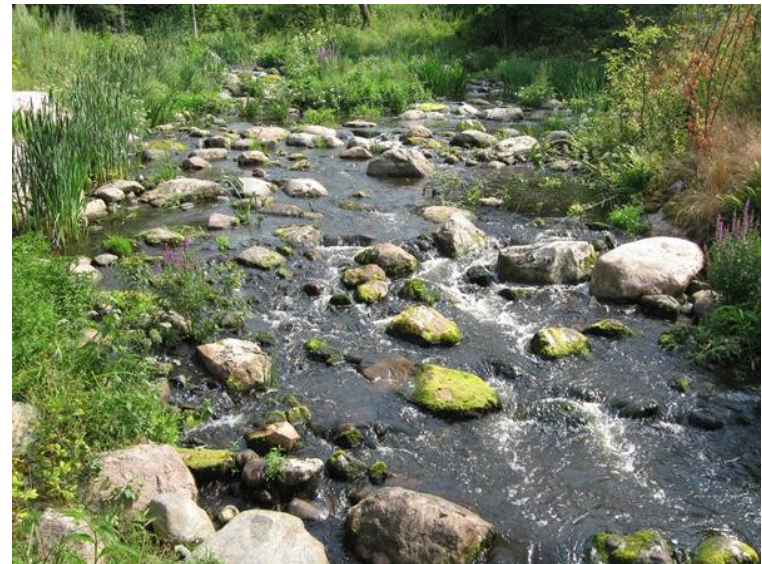
Case study: Sågarsfors

- Dam removal and bypass with habitats

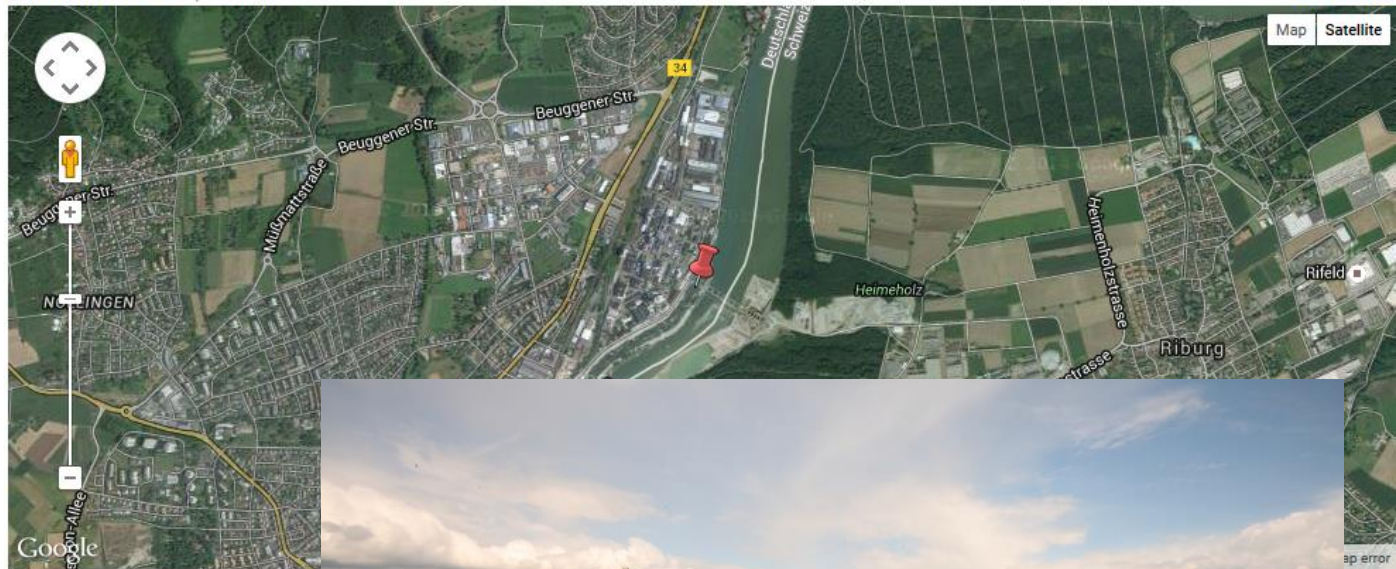
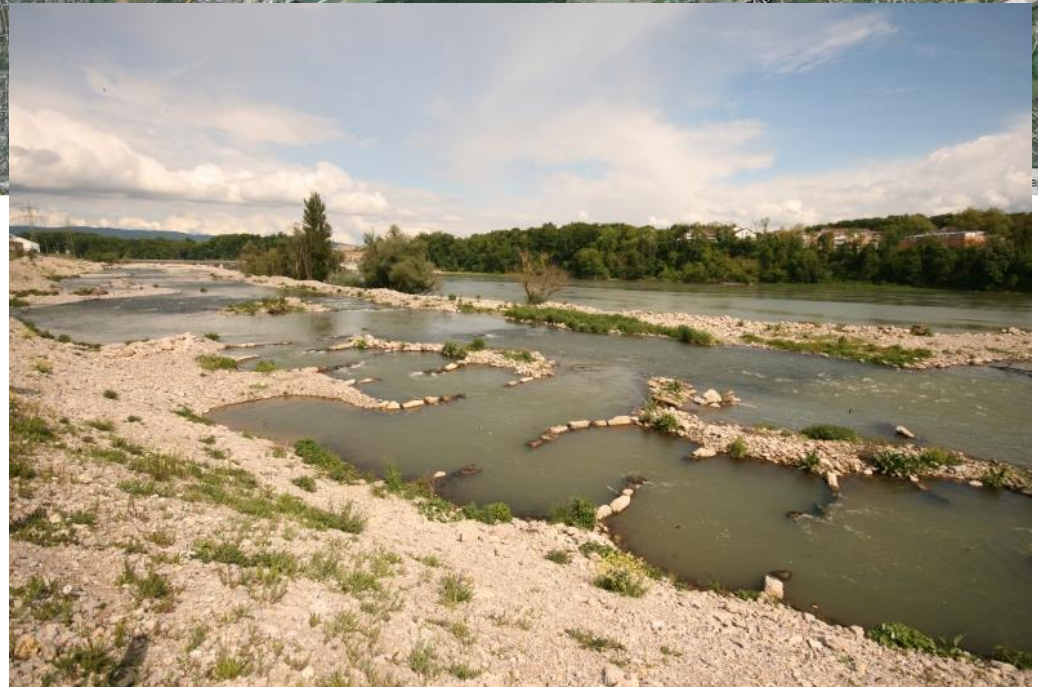
Case study: Rheinfelden bypass

- Reproduction channel
- Largest in Europe
