Improved Load Rating Procedures for Deteriorated Steel Beam Ends with Deteriorated Stiffeners

September 2021

Report No. 21-024

Principal Investigator (s)
Georgios Tzortzinis, Graduate Researcher
Dr. Sergio F. Breña
Dr. Simos Gerasimidis

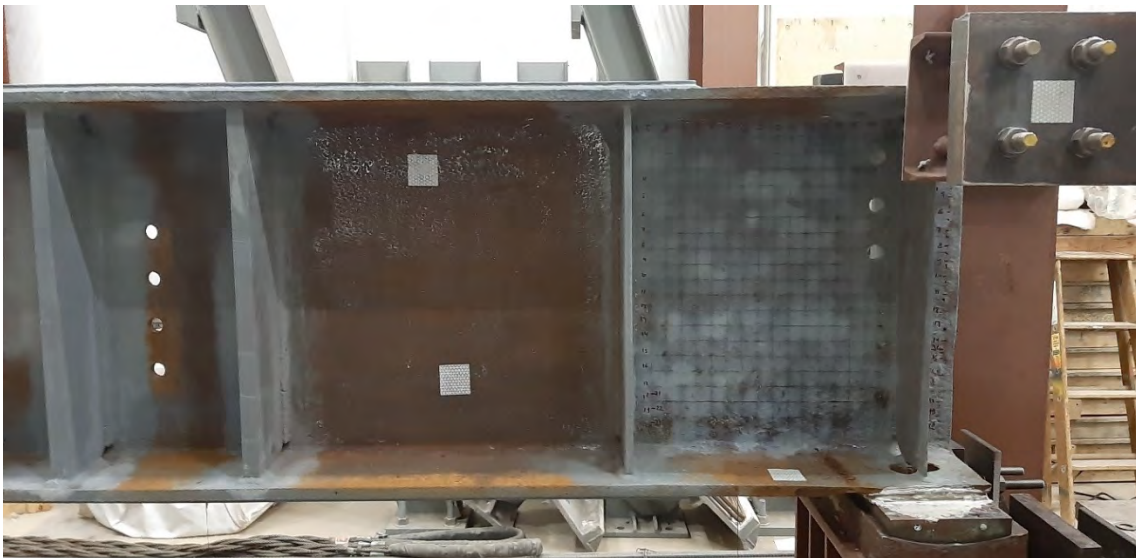
A photograph of the actual specimen is presented in Fig. 3.7. Observation of the same figure revealed perforations resulting from the removal of the riveted plates along the web. Additional perforations were found at the bottom flange, where anchor rods were passing through to restrict the girder in in-service conditions. Their existence prevented the bearing stiffeners from transferring load to the bottom flange along their whole width.

Figure 3.7: Corroded end of Specimen A

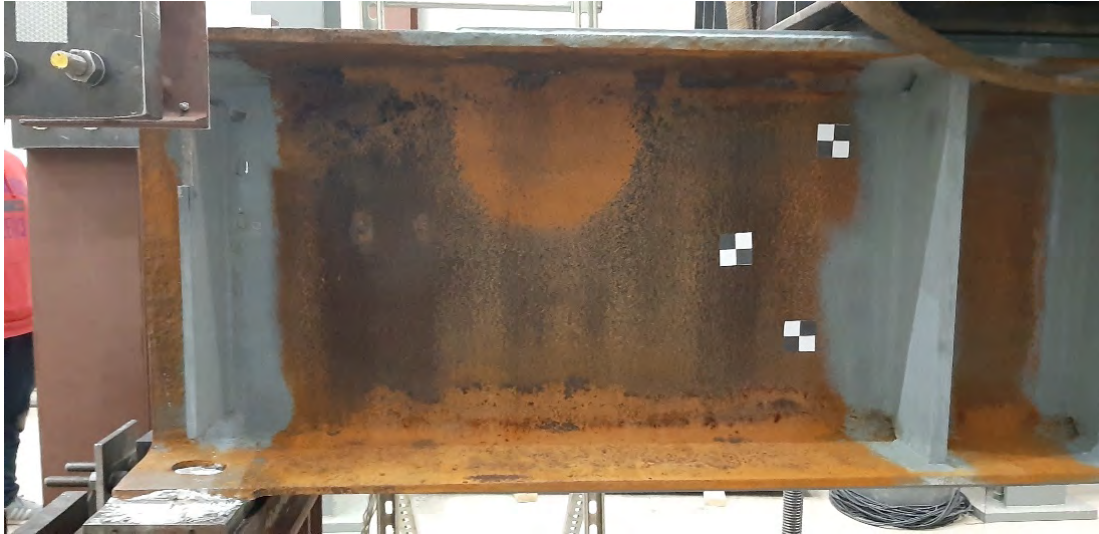
Figure 3.12: Corroded end of Specimen B

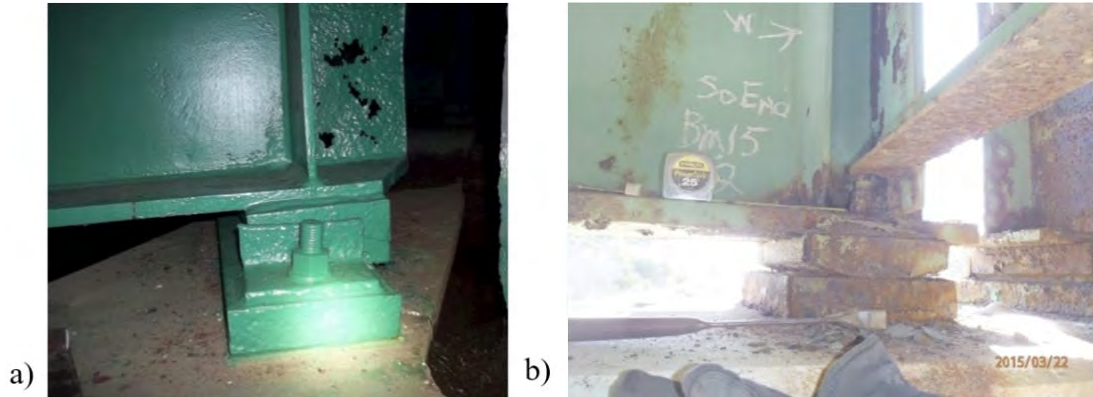
Figure 4.9: a) Expansion and b) fixed bearing types commonly found supporting corroded plate girders in Massachusetts

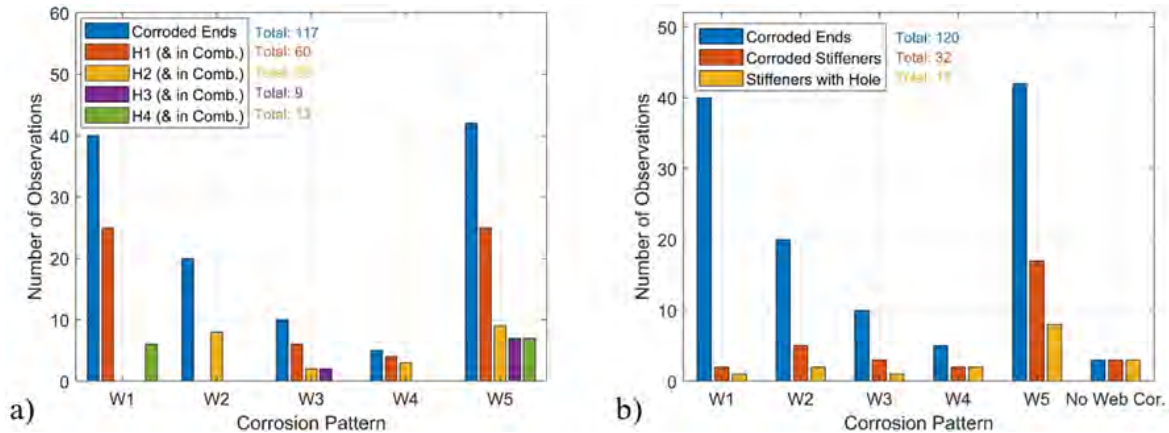
Figure 5.1: Web corrosion in correlation with a) web holes and b) stiffener condition for C1 configuration
