Session D5: Current Status of Fish Passages in South Korea

Current status of fish passages in South Korea

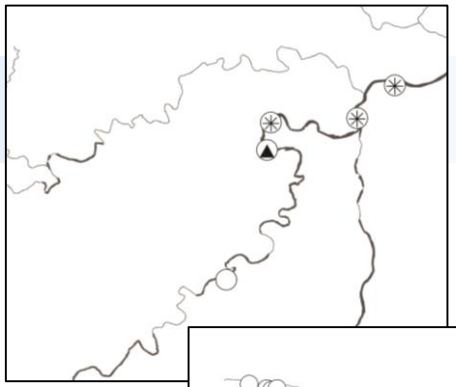
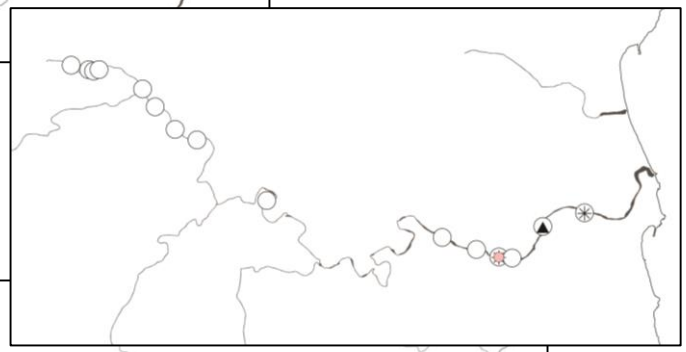
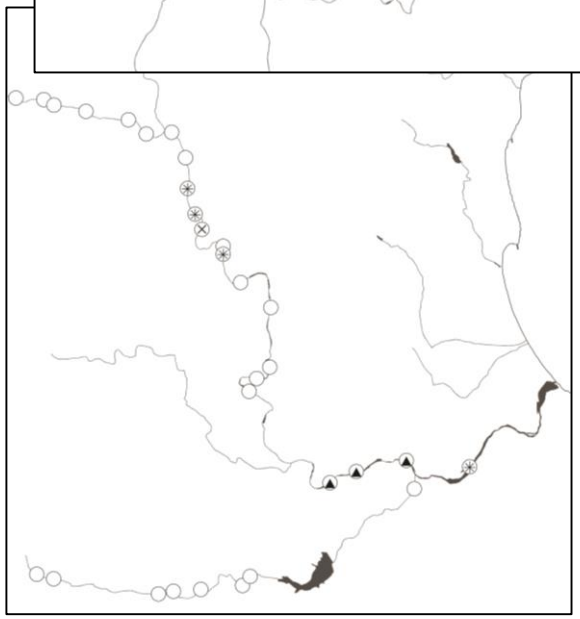
Example of connectivity

Eastern part of S. Korea

● Excellent ▲ Good

* Poor X Impassible

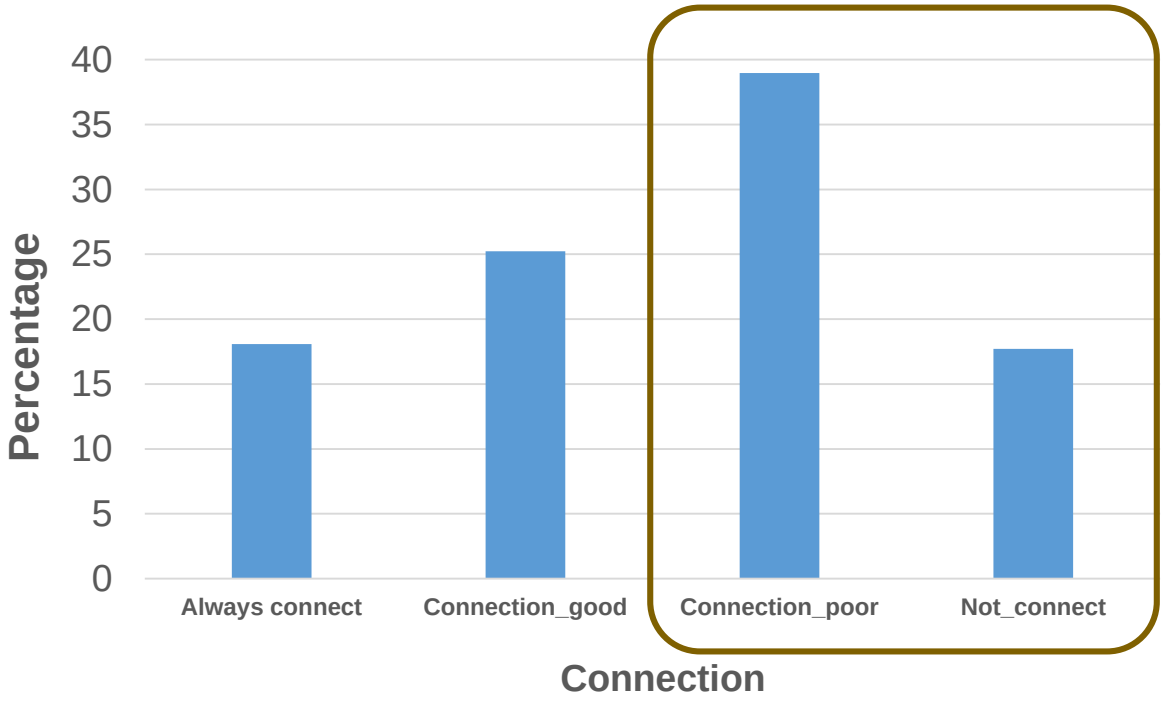
Connection of fish passage

Wrong place

- **56.7% of fish passage' connectivity is poor condition**
- **Urgent repair is required**

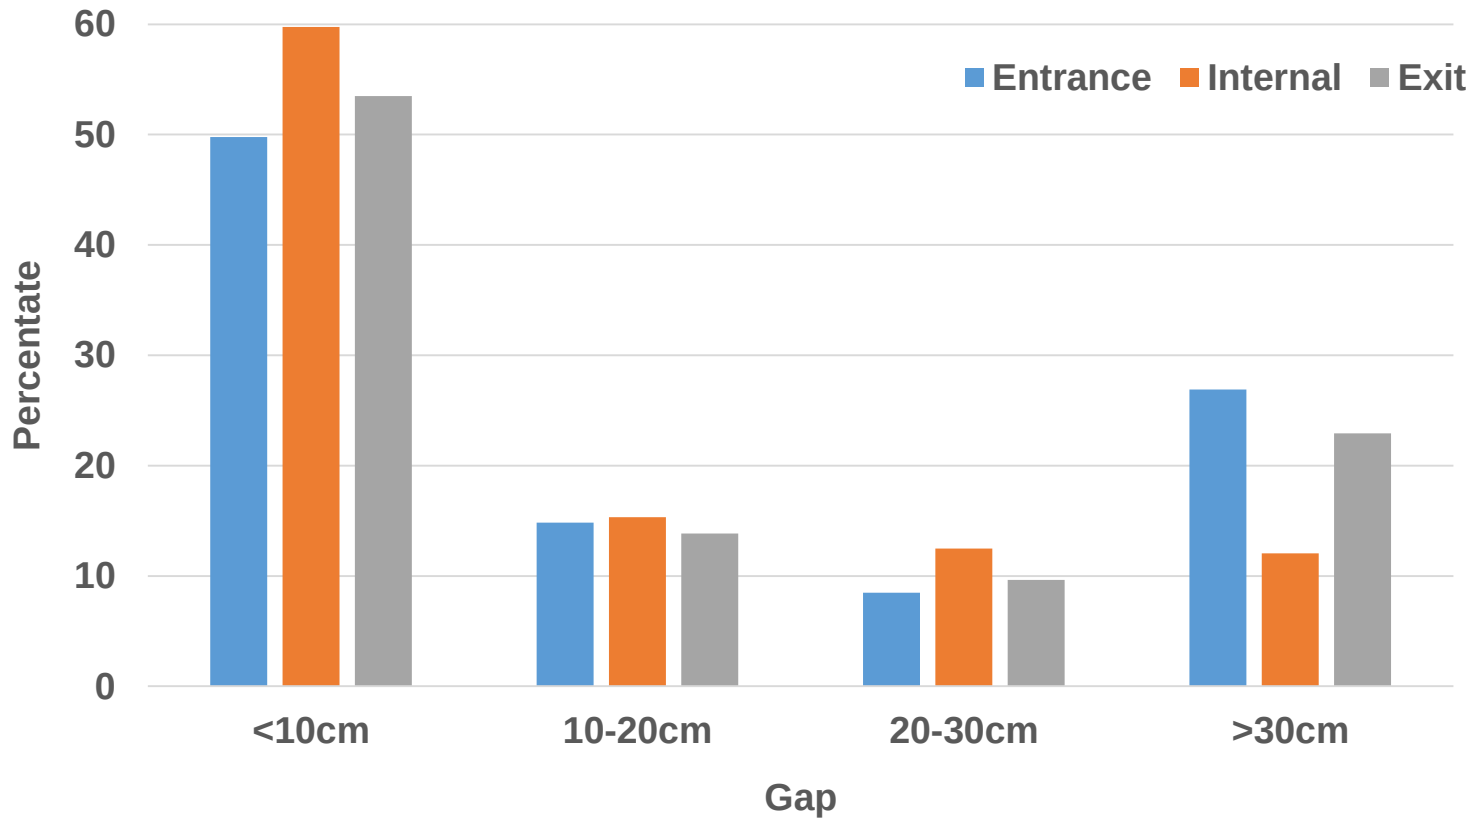
Structural status

- **Swimming ability of small Cyprinidae is relative poor**

➔ **if gap is big, fish feel hard to negotiate with fish passage**

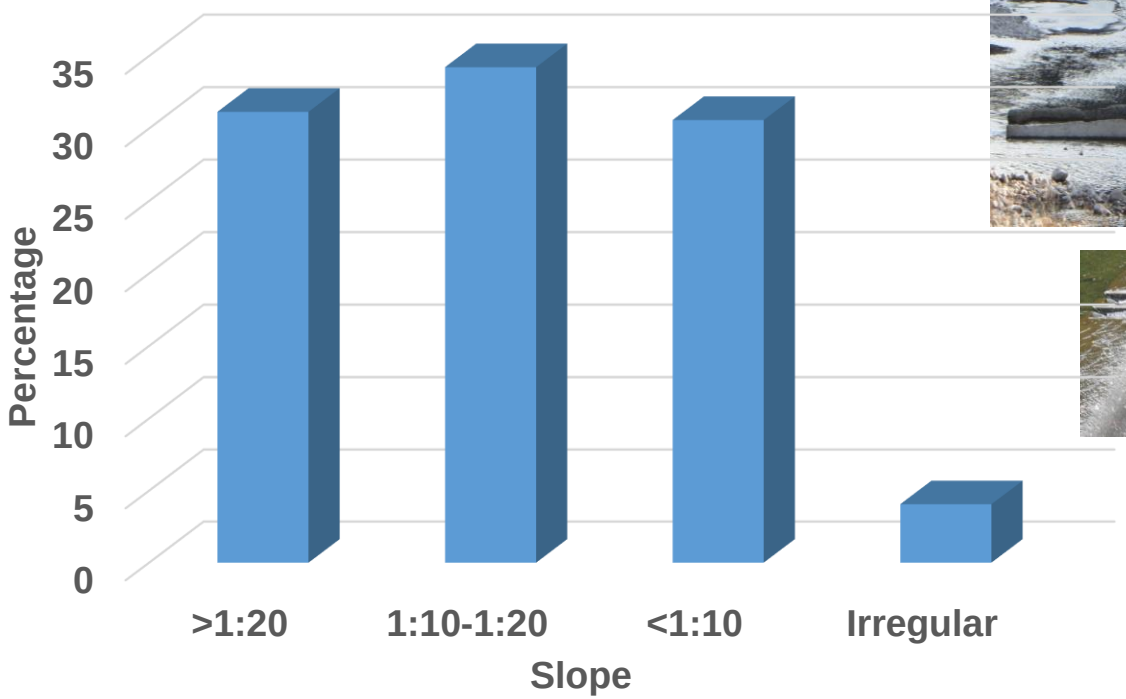
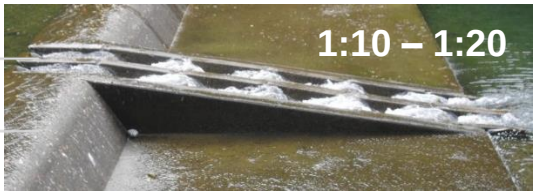
Slope

- **Recommended slope is more than 1:20**

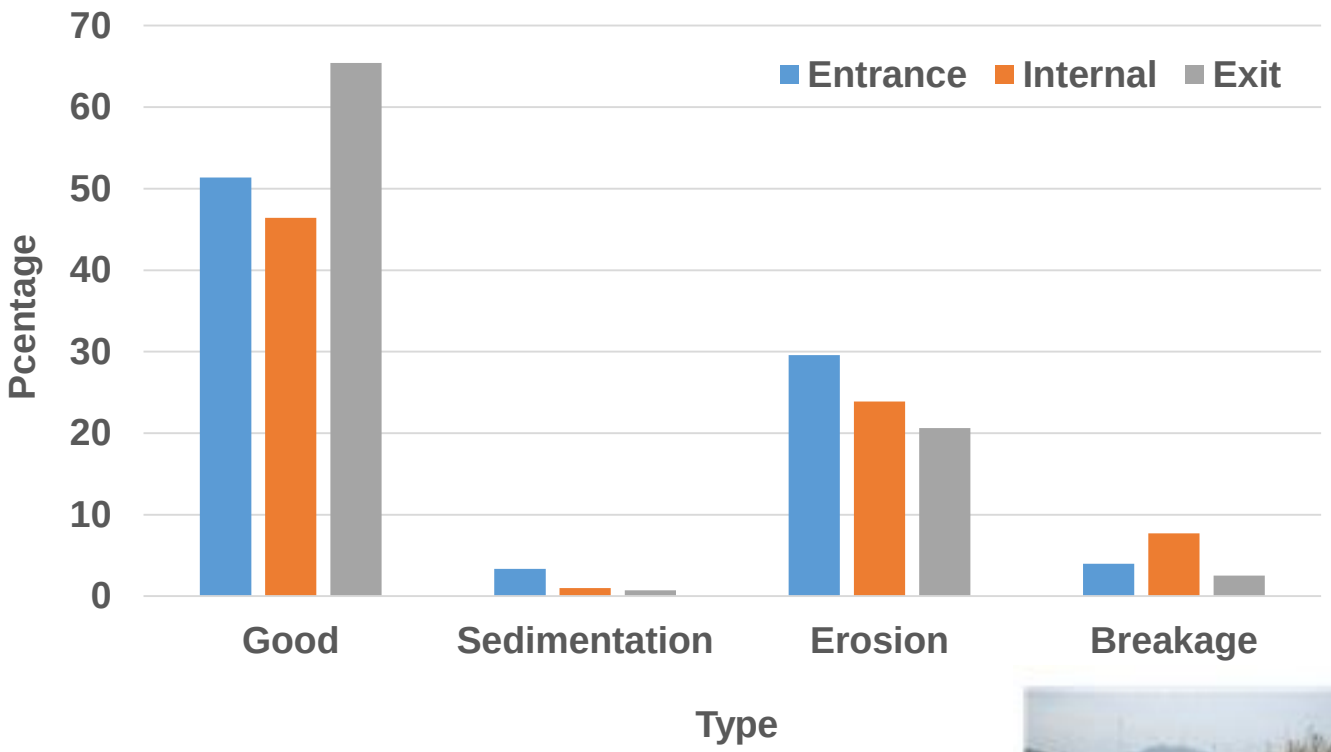
Management aspects

→ 8.1% of them are Ice-Harbor type (recently favored)
- 18.1% of installed fish passages were good condition, and urgent repair is needed for 56.7%
- Fish passages of 31.3% were the recommended slope range of Korea (1:20).
- Most of problems are related water flow, poor entrance, breakage and sedimentation
- Discontinuous installation of fish passages generates poor continuity of streams
