FISHWAY INSPECTION GUIDELINES

TR-2013-01

June 5, 2013

This technical report provides guidance for engineers, biologists, operators, regulators and dam owners involved in the inspection of fishways at dams. Volitional fish ladders, fish lifts, and other fish passage and protection facilities are devices of varying complexity frequently integrated into sophisticated reservoir management and hydropower installations. As with any device, maintenance of fish passage facilities is necessary to ensure their proper operation. Improper operation of fishways may limit or eliminate entire year classes of diadromous fish. Routine fishway inspections are a critical component of an overall fish passage operation and maintenance plan.

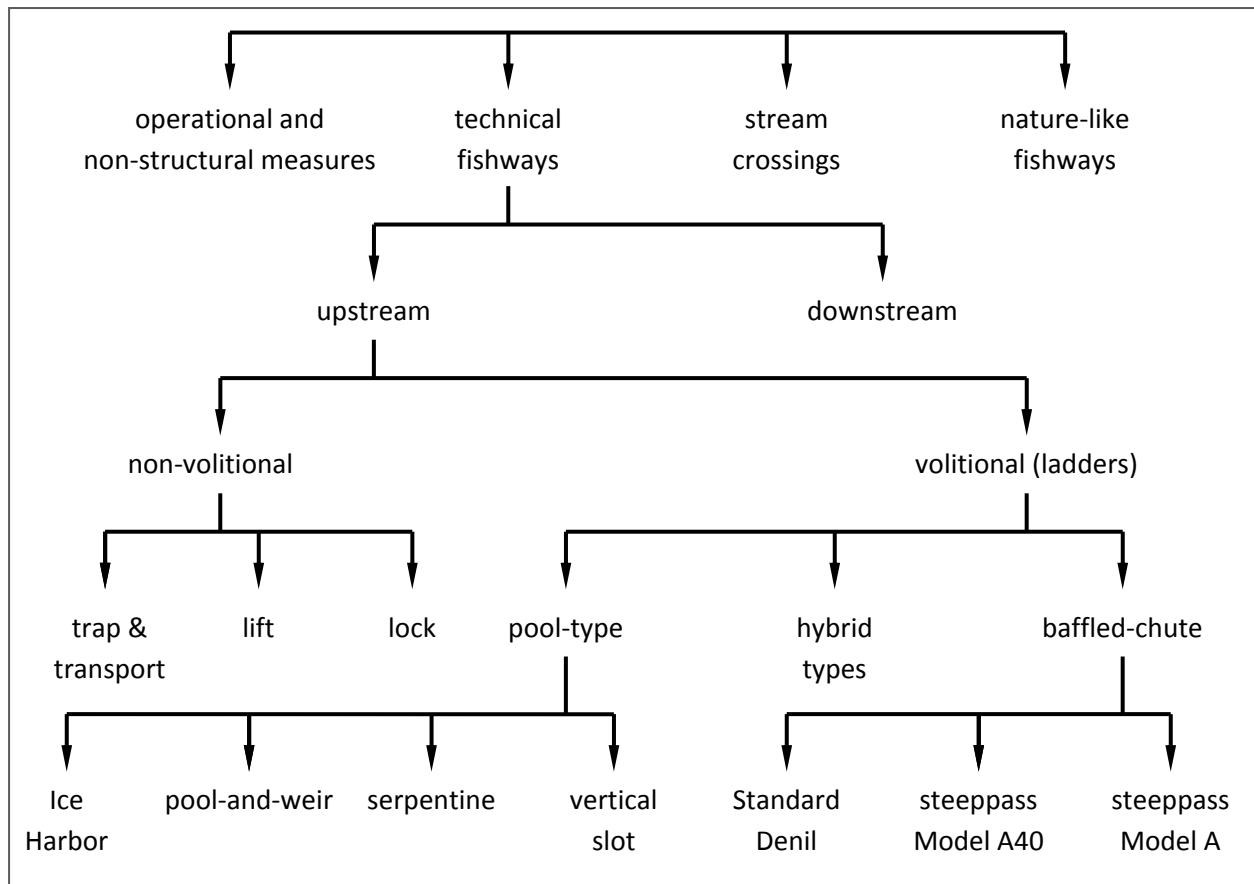
Figure 1. Common fishway types in the eastern U.S.

Fish passes can be broadly categorized as either technical fishways or nature-like fishways. Nature-like fishways include bypass channels, rock ramps and other passage structures that approximate (either functionally or aesthetically) natural river reaches. Technical fishways employ engineering designs that are typically concrete, aluminum, polymer, and wood, with standardized dimensions, using common engineering construction techniques. The physical and hydraulic structure of nature-like fishways is markedly different from technical fishways, and the inspection of nature-like fishways is beyond the scope of this report. Technical fishways (hereafter, simply fishways) can be further categorized as upstream or downstream passes. Figure 1 shows these categories and common types of fishways.

- Half Ice Harbor modified Ice Harbor; characterized by one weir opposite an L-shaped vertical baffle
- Vertical Slot flow through pools via deep, narrow, full-depth slots rather than an overflow weir
- Serpentine similar to a vertical slot with a winding, tortuous horizontal flow path

Fish Lifts/Locks: Fish lifts or elevators are non-volitional upstream fishways that attract fish into an entrance channel and mechanically crowd them above a hopper before lifting them into an impoundment (or alternatively, into an exit channel hydraulically linked to an impoundment). Fish lifts differ from volitional ladders in that they usually possess numerous mechanical, hydraulic, and electrical components. A fish lock is similar to a lift where the hopper and lift tower is replaced with a full-height, columnar structure (i.e., lock) that can be filled with water. Fish locks are rare on Atlantic coast and are therefore not addressed directly in this document.
