Proceedings of the Annual International Conference on Soils, Sediments, Water and Energy

SPILL CLEANUP OF FUEL CONTAMINATED SOILS AFTER ROADWAY ACCIDENTS USING IN SITU BIOREMEDIATION

Satya Ganti^{1§} and Bob Frye²

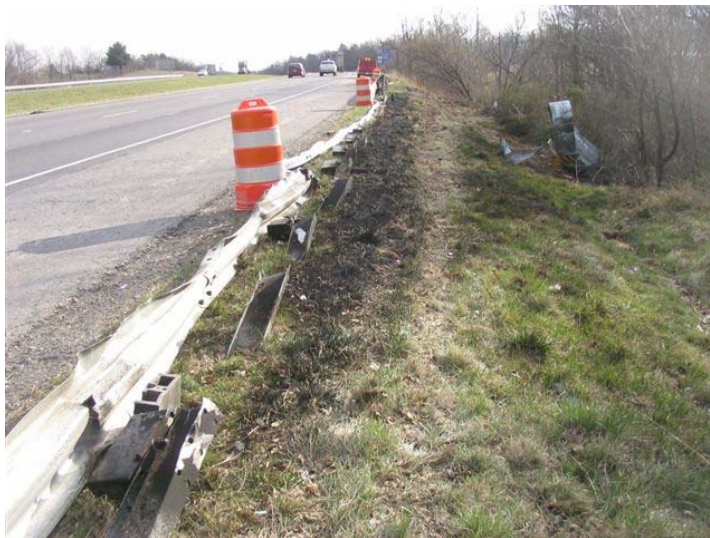
A tractor/trailer was involved in a highway accident, resulting in the release of approximately 100 gallons of diesel fuel from a ruptured saddle tank and ten gallons of motor oil from the truck engine. The wreckage ended at the bottom of the embankment, immediately adjacent the opening of the subsurface storm piping. Diesel fuel, released from the truck, flowed into soil immediate the wreckage and the open ditch. Several hundred feet of guardrail was destroyed in the accident, causing engine oil to disperse over approximately 100 feet of vegetation at the pavement edge. GEC Environmental Contracting Corp. (GEC) was contacted to provide clean up of the release. The wreckage and the site are seen in Figure 1.

Figure 1. The accident site and the wreckage of the truck.

Discussions were held with representatives of the Virginia Department of Transportation (VDOT) and implications of soil removal in this area were reviewed. The spill site was on a slope and it would be difficult to use mechanized cleanup vehicles for the cleanup. Excavation of the soil was not considered as an option for the cleanup.

It was agreed that this site is suitable for evaluation of on-site (in situ) bioremediation cleanup of highway spills. AgroRemed manufactured by Sarva Bio Remed, LLC was selected for direct application to the release point and affected soil and vegetation. AgroRemed has a track record for successful cleanup of contaminated soils after spills of diesel or heating oil both in residential and industrial facilities. AgroRemed has shown reduction in TPH values by 90% in

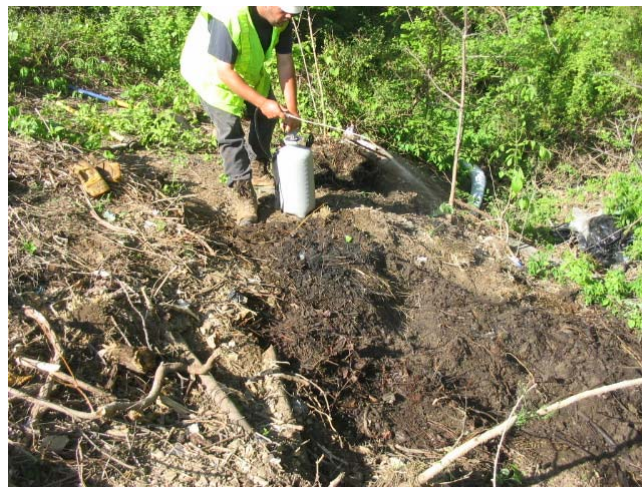
Figure 2. Application of AgroRemed to impacted soils

A soil sample was collected from the center of the diesel staining, approximately 2” below the surface. It showed a concentration of 65,000 parts per million (ppm). Impacted soil saturated with diesel was manually turned/ tilled to allow natural oxygenation before application of AgroRemed as seen in Figure 2.

A soil sample was collected after 20 days of application from this location and analyzed for TPH/DRO values and the results of hydrocarbon range C-5 to C-30 showed a value of 26,000

ppm or more than 40% reduction in the value. Application of AgroRemed was continued at regular intervals; it was noticed that the TPH/DRO was reduced from 26,000 ppm to 11,800 ppm because of drought conditions, and the soil was very dry. The conditions became favorable in September before the final application, and this time soil was sprayed with water from a tanker immediately before application of AgroRemed. In addition to the wetting, the surface of the soil was also covered with straw mulch to prevent excessive evaporation. The TPH of the soil was examined after 15 days and the levels of TPH were reduced to 650 ppm with no signs of tainting of the grass and interestingly no diesel odor. Further, the area was found to support healthy growth of grass and other vegetation indicating no residual toxicity and restoration of the soil to its condition before the spill. The DEQ agreed that there was no further action required. The total time required for the cleanup was a total of 103 days for reaching the accepted levels of contaminant.

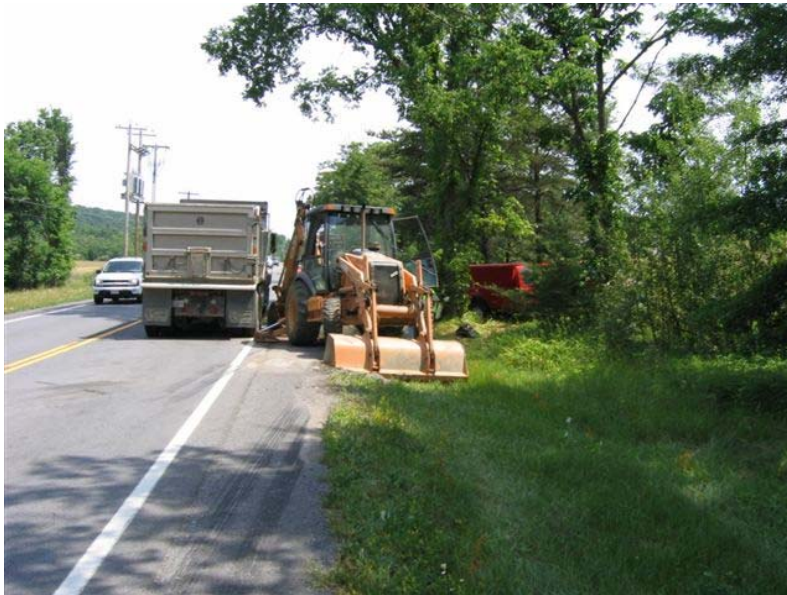
A tractor/trailer was involved in a highway accident, resulting in the release of approximately 75 gallons of diesel fuel from a ruptured saddle tank. Free petroleum product flowed into the gravel road shoulder and adjacent embankment. The site is a single lane, north/south highway of typical asphalt paved construction (Figure 3). Road shoulders are intermittent gravel, grass, and embankments. Potential receptors are humans, wildlife, and groundwater. Multiple major underground communication utilities lines were present in the accident area making it difficult to excavate.

Figure 3. Accident site showing the asphalted road affected by spill.

Diesel fuel had released on the pavement edge and gravel shoulder causing surface staining. Debris on the pavement was pushed to the gravel to allow normal traffic patterns for evening hours. Petroleum-absorbent booms were placed along the down-gradient edges of the spill area to prevent further migration during anticipated storm events. Anti-slip absorbent media was

applied to the impacted pavement and scrubbed to remove residual phase petroleum. As this material was spent, it was removed, and the process repeated until practical recovery was achieved. An additional application was then made as a slip preventative measure for traffic.
