Greenery of the Sacral Monuments – Unique Green Infrastructure in the Urban Area: Case Study Calvary in the Nitra

Mária Bihuňová¹, Denisa Halajová², Štefan Lančarič³
^{1,2}*Slovak University of Agriculture in Nitra, Department of Garden and Landscape Architecture,* ³*Nitra City Municipality*

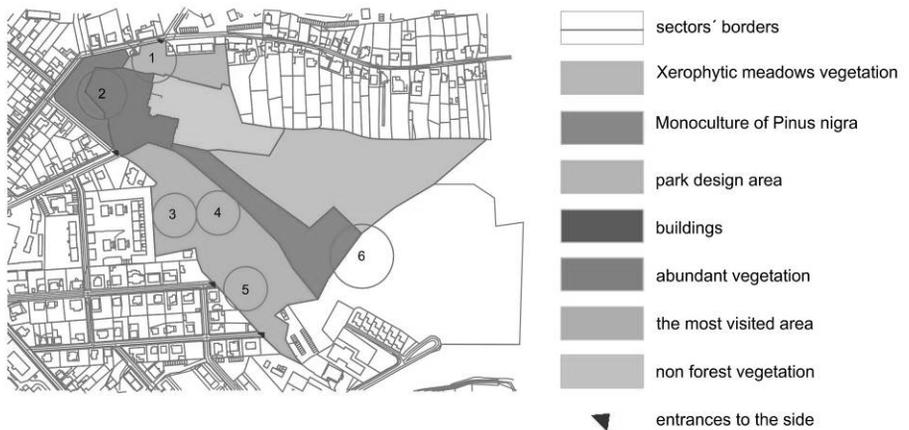
Figure 3. Category of the greenery and concept of the side

1 educational trail leads to the Cave of Holy Mary; 2 park design supported by flower beds, trees and with the protection of the views to the city; 3 Children playground designed by simply wooden elements; 4 Fire place and open meadow; 5 Sport/Fit trail; 6 Climbing rock

The landscape concept “*Living in the wood*” was chosen as the suitable proposal for revitalisation of the site. We have proposed 3 main zones: 1. *Representative entrance zone*, 2. *Zone of leisure and recreation*, 3. *Sport zone*.

The first zone will be equipped with more benches to sit, places to stop and learn some historical facts and remarkableness of the site through the educational boards, to perceive the surroundings and views, there will be added flower beds and new plantation of the greenery.

Recreational and leisure zone will be designed as a place for the families with different activities: playgrounds, fire place, benches, and new plantation of the *Rhododendron* sp.

Sport zone offers facilities for sport, recreation, fitness activities. In this part it is necessary to make thinning and new plantation of the trees from the compositional point of view.
