**The Redevelopment and Restoration of Selected Trail BMP Features to Provide Environmental, Educational, and Aesthetic Benefits**

David N. Myers

*University of Maryland College Park, Department of Plant Science and Landscape Architecture*

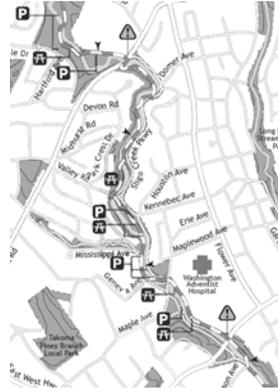
**Figure 2. Sligo Creek Trail from Piney Branch Road to Carroll Road (Montgomery County Parks, 2005)**

Documentation and on-site investigation of the entire trail was beyond the scope of this studio. The Sligo Creek Trail subsection investigated is a 2400 meter (7,929 feet) length of trail between Piney Branch Road and Carrol Road (Figure 2). An estimate of total impervious cover (not counting the co-aligned road way) is approximately 4800 sq. meters (52,272 square feet). Sligo Creek has an average gradient of 0.72-percent over 13.2 kilometers (8.2 miles) of its main stem length (MWCOG, 2009). Literature was collected for background information documentation. An inventory of the trail was made by walking the entire length of this selected trail segment multiple times. Various site conditions and opportunities were documented.

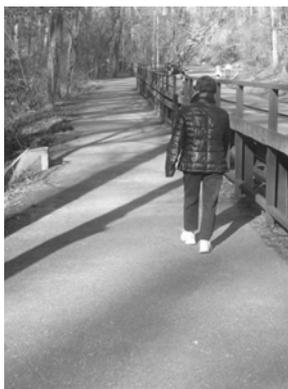
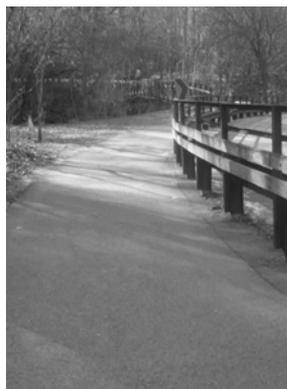
The first opportunity type is the condition where the 2.4m (8 feet) wide trail is co-aligned with the adjacent two-lane roadway. The 2.4m (8 feet) width allows for very safe two-way traffic for multi-modal use during weekdays and Saturday. On Sunday, with the closure of the Piney Branch Parkway to cars, the trail is dominated by more walkers while the roadway accommodates all types of both pedestrians and non-motorized vehicular traffic (tricycles, bicycles, inline skaters, etc.) A heavily compacted median, containing the existing safety barrier is located between the trail and roadway (Figure 3 and Figure 4). The existing barrier is a series of upright steel H-Beams, a vertical metal fence structure with an attached horizontal wood railing (the design of the railing varies from location to location). The existing design did not include water quality goals. Water from the far reach of the road sheet flows

across the road, over the safety median, across the trail, eventually sheet flowing to landscape areas between the trail and Piney Branch Creek. Numerous areas indicate excessive flows and erosion as a result of these conditions.

**Figure 3. Example 1 of Co-Aligned Trail and Roadway Condition**

**Figure 4. Example 2 of Co-Aligned Trail and Roadway Condition**

Possible solutions involve the construction of an integrated bioretention railing system in the renovated median. The benefits of this location include: 1) immediate capture of road sheet flow, the most significant quality of pervious area and financially supported in the SWAP plan; 2) that root damage is less likely in the median than in the placement of trenching and reservoir located between the trail and creek; and, 3) the prominent visibility for both vehicular and pedestrian users of a retrofitted bioretention safety rail BMP. The uprights could be replaced with water adapted materials (concrete, plastic, etc.). A storage reservoir to accommodate the required catchment area would be positioned both under the median and trail. Underdrains and overdrains would allow for flow over the capacity of the underground retention storage.

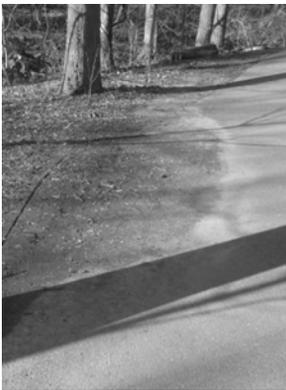
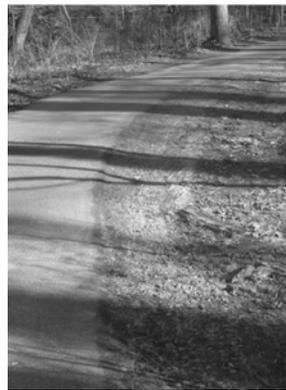
Second opportunities for BMP intervention are site conditions where a more conventional raingarden might be proposed. Figure 5 indicates a typical condition where the proposed raingarden would be located between the trail and the stream. This raingarden would not need an overdrain, thus minimally reducing cost and landscape impact. Figure 6 indicates a typical location where the proposed raingarden location would be located upgrade and on the opposite side of the trail than that of the stream. It would likely require an overdrain to help reduce sheet flow during larger rain events from flowing back across the trail toward the stream. To reduce root damage required of a raingarden installation, soil removal by water might be considered as an alternative to mechanical removal.

**Figure 5. Conventional Off-Trail Raingarden Site Condition**

**Figure 6. Conventional Off-Trail Raingarden Site Condition**

In both cases, these raingardens offer the opportunity to introduce vegetation that might be adaptable to vernal ponds or semi-wet shaded environments. This would be an added benefit in increasing the overall biological diversity and providing additional opportunities to reintroduce native plant education. Raingardens have minimal costs. These BMP opportunities would be a much smaller catchment area than the previously noted BMP. However these features are in line with the catchment areas that have been built and are being proposed. Cumulatively, these catchment areas will make a contribution in providing for more water infiltration and thus water quality improvements.
