# Proceedings of the Fábos Conference on Landscape and Greenway Planning

## Structural Soil in Dense City Areas - Functions and Chances for Urban Greenway Development

## Structural soil in dense city areas - functions and chances for urban greenways development

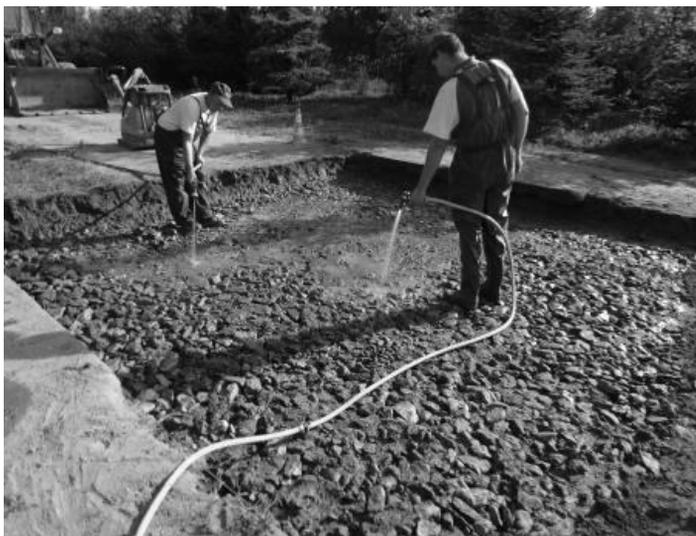
**Figure 1.** Filling the vegetation layer with substrate using the water

The process of filling the substrate into the vegetation layer with use of water is most effective when the thin layer of substrate is applied onto a surface with a thickness of 1 cm and this operation is repeated until full filling the space between the grains of aggregate (fig. 1).

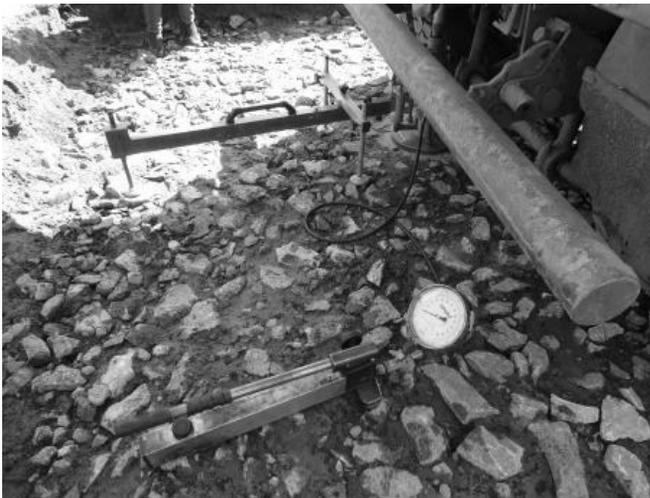
**Figure 2. Bearing capacity examination of coarse aggregate layer**

As mentioned before to test have been used the following aggregates:  
(1) fraction of 63-120 mm (aeration layer of 30 cm)  
(2) fraction 31,5-63 mm (vegetative layer - 20 cm). Both layers were compacted using a vibrating plate followed by the VSS load bearing capacity test (fig. 2).

The result of VSS test on 30 cm layer of 63-120 mm fraction coarse aggregate have shown that the bottom layer of the structural soil withstands the load-bearing capacity of 80 MPa.

The upper layer of the structural soil, constructed by 20 cm of 31,5-63 mm aggregate fraction resulted in 130 MPa load capacity on this layer.

According to a study load capacity reached at the upper layer of the profile was  $E_2 = 132$  MPa, which testifies to the fulfillment of the requirements for the substructure under roads with heavy traffic  $E_2 > 120$  MPa. In addition, the obtained deformation ratio ( $E_2 / E_1 = 2.18$ ) provides the proper compaction of the layer. The top of the structural soil should be considered as base to the wear layer. On the subgrade will be sited the road surface suited to the character of the use.

The lower layer is also characterized by high load carrying capacity with a modulus  $E_2 = 80$  MPa. The measured deformation ratio  $E_2 / E_1 = 3.32$  indicates that the layers are properly compacted. In the case of coarse clastic aggregates, and such has been applied to the lower layer, it can be assumed density criterion  $E_2 / E_1 < 4.0$  according to PN-S-02205.
