## Review of Mechanical and Hydraulic Dredging at Two Sediment Remediation Sites

#### **REVIEW OF MECHANICAL AND HYDRAULIC DREDGING AT TWO SEDIMENT REMEDIATION SITES**

James Wescott<sup>§</sup>, John Dirgo, Jack Brunner, Scott Ireland, Scott Cieniawski  
*Tetra Tech EM Inc., 1 South Wacker Drive, Suite 3700, Chicago, IL 60606*

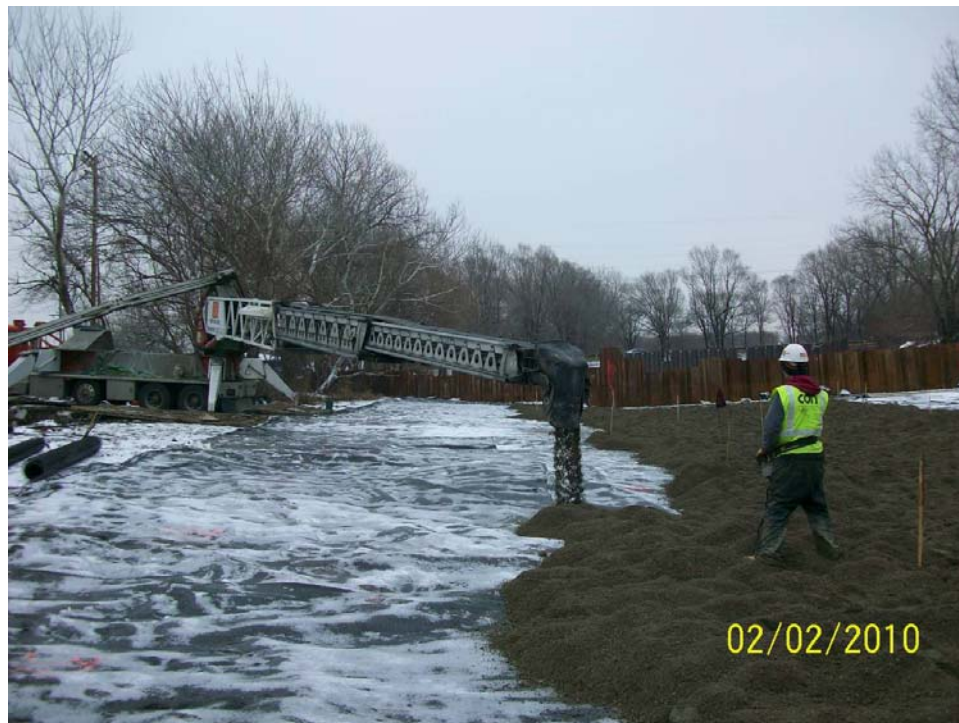
telescoping belt conveyor was then used to distribute the granular cover in thinner layers over the geosynthetic material (Figure 1).

*Figure 1.* Granular cap placement by belt conveyor

The design for the engineered cap consisted of an activated carbon mat covered by two feet of granular material. More than one bidder suggested a geo grid between the sediment and activated carbon mat. The addition of the geogrid provided some additional stability during cap placement. After unrolling the geo grid and activated carbon mat, the contractor initially attempted to spread the granular cap over the mat in a single 2 foot lift. Uncontrolled movement of the underlying sediment created small mud waves that disrupted the mat placement and final excavation elevation. Placement of the granular cover was modified by using a telescoping belt conveyor to distribute the granular cover in thinner layers over the geosynthetic material.

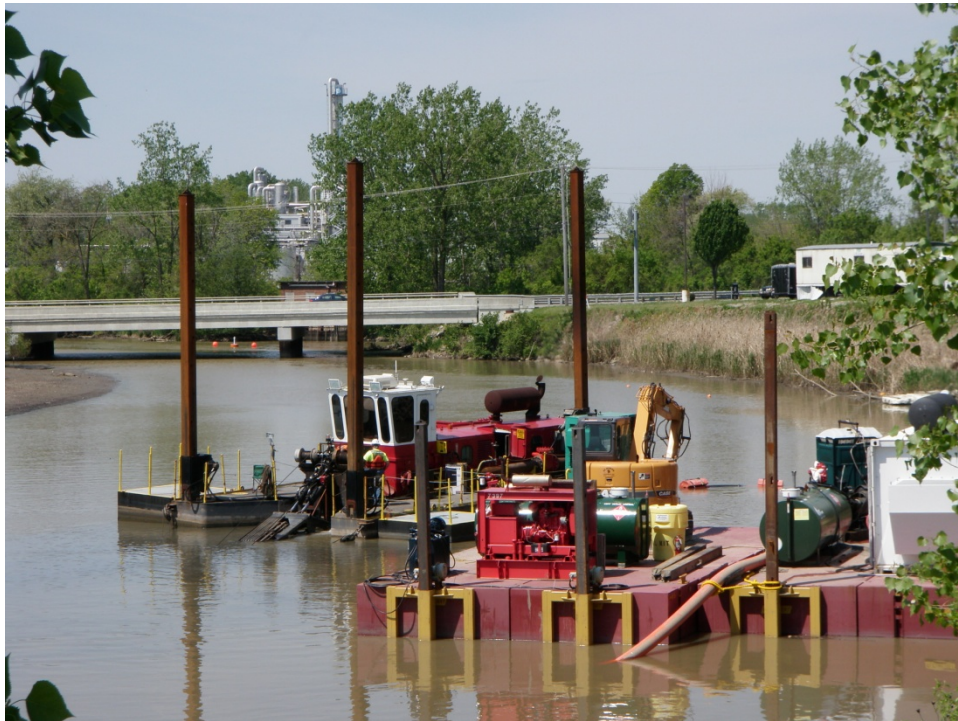
The landside facilities were substantially complete in April 2010. Upon completion of the pre-dredge survey, dredging operations began May 3, 2010. The contractor mobilized two 8-inch dredges and one 10-inch dredge. One 8-inch dredge and the 10-inch dredge would normally operate 24 hours per day, six days per week, with the second 8-inch dredge on standby in case one of the operating dredges needed to be taken off line (Figure 2).

*Figure 2.* Ten-inch hydraulic dredge working area in Reach 2
