Case study: Submarine Crashes into Uncharted Seamount

Version 0.2 • June 17, 2008

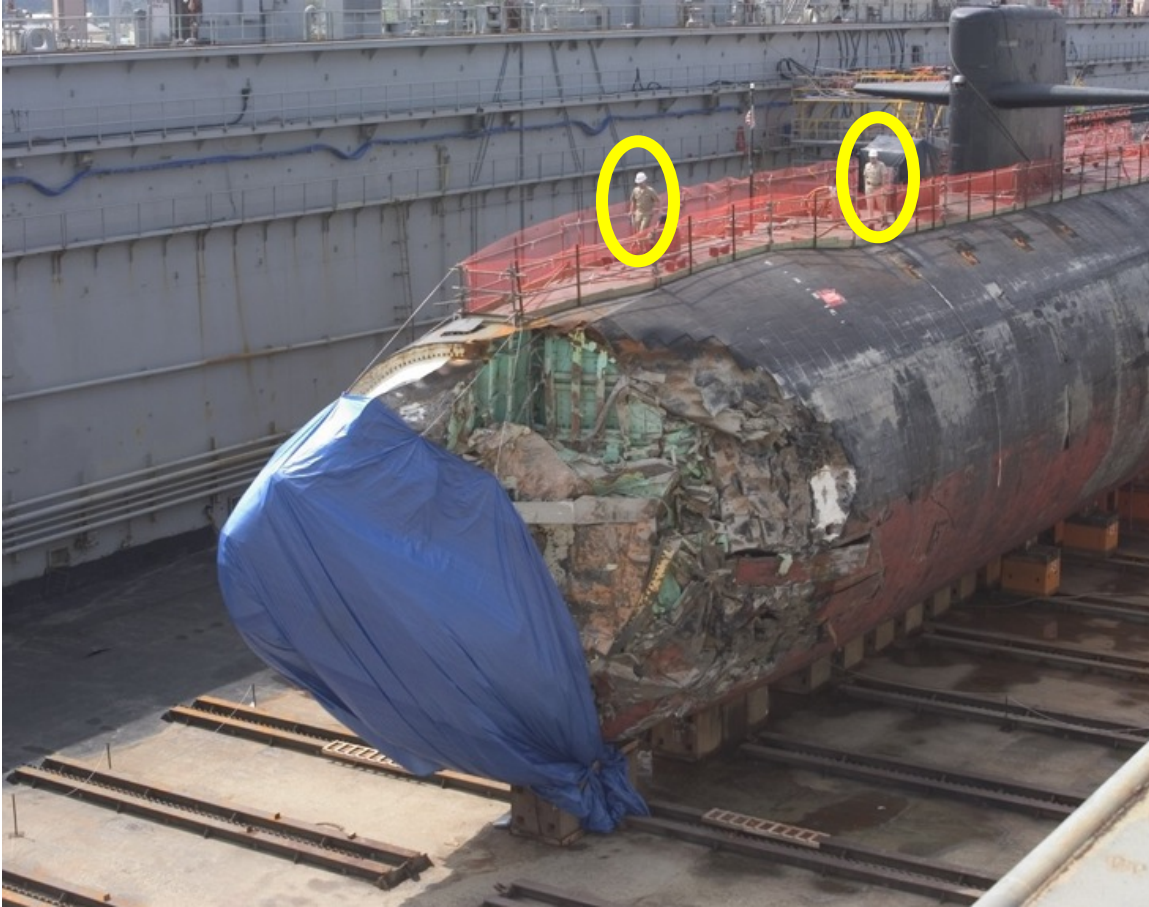
Fig. 1. Photograph of the *USS San Francisco* in dry dock after the accident (courtesy of David Sandwell, Scripps Institution of Oceanography). Note the men walking within the orange, gated area on top of the submarine for scale.

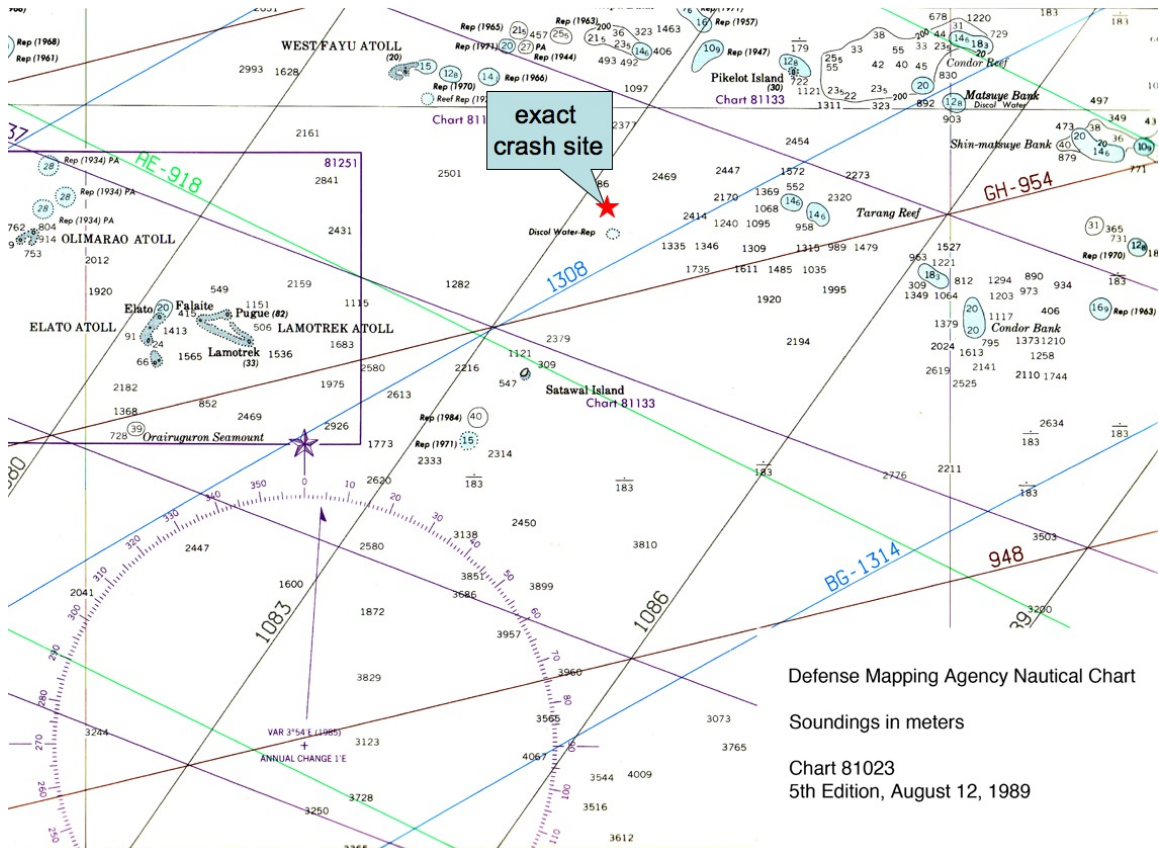
Fig. 2. Defense Mapping Agency (DMA) nautical chart of 1989 with the location marked of the submarine’s collision with the seamount (Sandwell and Wessel, 2006). Note the paucity of soundings in the DMA’s database for this part of the western Pacific.

The commander of the *USS San Francisco* accepted full blame for the incident, acknowledging several critical mistakes, including traveling too fast given the lack of existing data on their navigational chart, not taking enough forward soundings to ensure that their path was really clear, and failing to cross-check the route with other charts. Subsequent interviews with the commander, with fifteen other officers and enlisted men, as well as a review of Navy reports, raises questions about the training and support of U.S. submariners in general, but also the relatively primitive state of nautical charts upon which the crews rely. To wit, Navy officials reported that the main navigational chart in use by the crew, was prepared in 1989 by the Defense Mapping Agency (DMA) and had never been revised. The chart did not show any potential obstacles within three nautical miles of the crash (Figure 2). Soon after the incident, Department of Defense (DoD) officials reported finding a Landsat satellite image from 1999 showing a seamount rising to within 100 feet of the sea surface in the area of the crash (as indicated by subtle variations in water color). Why hadn't the DMA updated their 1989 charts to show this feature? Navy officials said that the incident occurred in an area that was no longer of high priority for updating bathymetry (ocean floor topography) due to the cessation of the Cold War. Although the Navy began basing submarines out of Guam in 2002, it has focused improvement of its nautical charts in the shallow coastal waters of the Middle East as part of the

“war on terror.” The DMA had also consistently lacked the resources to properly compile, convert and interpret satellite data for the systematic updating of charts, nor had it been able to fully ensure the accuracy, precision, resolution, and validity of current charts. This agency has since been absorbed into the DoD’s National Geospatial-Intelligence Agency (NGA), for the provision of maps, nautical charts and other geographic intelligence to the nation’s combat forces.
