## Spill Cleanup Of Fuel Contaminated Soils After Roadway Accidents Using In Situ Bioremediation

# SPILL CLEANUP OF FUEL CONTAMINATED SOILS AFTER ROADWAY ACCIDENTS USING IN SITU BIOREMEDIATION

Satya Ganti<sup>1§</sup> and Bob Frye<sup>2</sup>

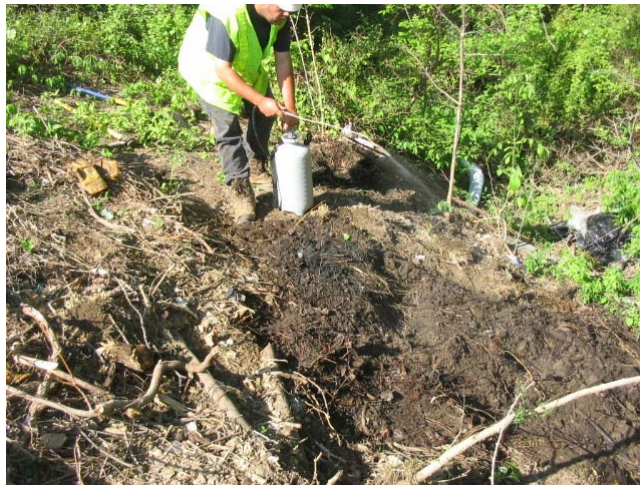
*Figure 2.* Application of AgroRemed to impacted soils

A soil sample was collected from the center of the diesel staining, approximately 2” below the surface. It showed a concentration of 65,000 parts per million (ppm). Impacted soil saturated with diesel was manually turned/ tilled to allow natural oxygenation before application of AgroRemed as seen in Figure 2.

A soil sample was collected after 20 days of application from this location and analyzed for TPH/DRO values and the results of hydrocarbon range C-5 to C-30 showed a value of 26,000

ppm or more than 40% reduction in the value. Application of AgroRemed was continued at regular intervals; it was noticed that the TPH/DRO was reduced from 26,000 ppm to 11,800 ppm because of drought conditions, and the soil was very dry. The conditions became favorable in September before the final application, and this time soil was sprayed with water from a tanker immediately before application of AgroRemed. In addition to the wetting, the surface of the soil was also covered with straw mulch to prevent excessive evaporation. The TPH of the soil was examined after 15 days and the levels of TPH were reduced to 650 ppm with no signs of tainting of the grass and interestingly no diesel odor. Further, the area was found to support healthy growth of grass and other vegetation indicating no residual toxicity and restoration of the soil to its condition before the spill. The DEQ agreed that there was no further action required. The total time required for the cleanup was a total of 103 days for reaching the accepted levels of contaminant.

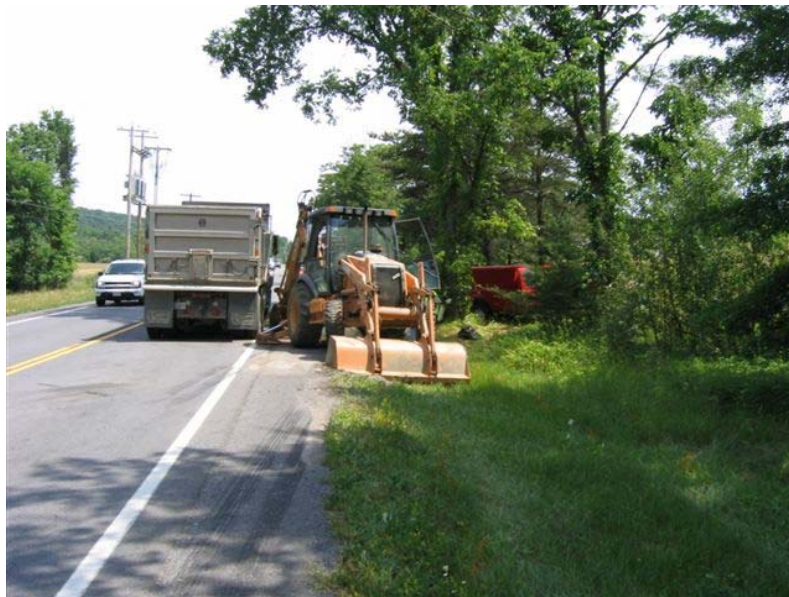
Figure 3. Accident site showing the asphalted road affected by spill.

Diesel fuel had released on the pavement edge and gravel shoulder causing surface staining. Debris on the pavement was pushed to the gravel to allow normal traffic patterns for evening hours. Petroleum-absorbent booms were placed along the down-gradient edges of the spill area to prevent further migration during anticipated storm events. Anti-slip absorbent media was
