Spill Cleanup Of Fuel Contaminated Soils After Roadway Accidents Using In Situ Bioremediation

SPILL CLEANUP OF FUEL CONTAMINATED SOILS AFTER ROADWAY ACCIDENTS USING IN SITU BIOREMEDIATION

Satya Ganti^{1§} and Bob Frye²

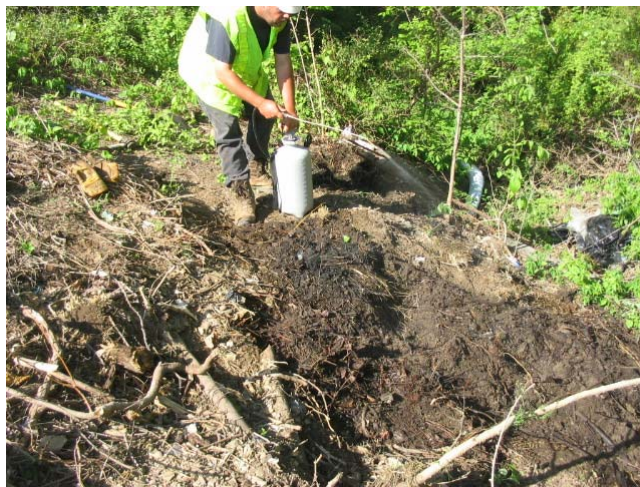
Figure 2. Application of AgroRemed to impacted soils

A soil sample was collected from the center of the diesel staining, approximately 2” below the surface. It showed a concentration of 65,000 parts per million (ppm). Impacted soil saturated with diesel was manually turned/ tilled to allow natural oxygenation before application of AgroRemed as seen in Figure 2.

A soil sample was collected after 20 days of application from this location and analyzed for TPH/DRO values and the results of hydrocarbon range C-5 to C-30 showed a value of 26,000

ppm or more than 40% reduction in the value. Application of AgroRemed was continued at regular intervals; it was noticed that the TPH/DRO was reduced from 26,000 ppm to 11,800 ppm because of drought conditions, and the soil was very dry. The conditions became favorable in September before the final application, and this time soil was sprayed with water from a tanker immediately before application of AgroRemed. In addition to the wetting, the surface of the soil was also covered with straw mulch to prevent excessive evaporation. The TPH of the soil was examined after 15 days and the levels of TPH were reduced to 650 ppm with no signs of tainting of the grass and interestingly no diesel odor. Further, the area was found to support healthy growth of grass and other vegetation indicating no residual toxicity and restoration of the soil to its condition before the spill. The DEQ agreed that there was no further action required. The total time required for the cleanup was a total of 103 days for reaching the accepted levels of contaminant.
