Effect of Intermittent Water Supply on Water Quality in a Model Pipeline

Master of Science in Civil Engineering

Department of Civil and Environmental Engineering
University of Massachusetts
Amherst, MA 01003

May 2021

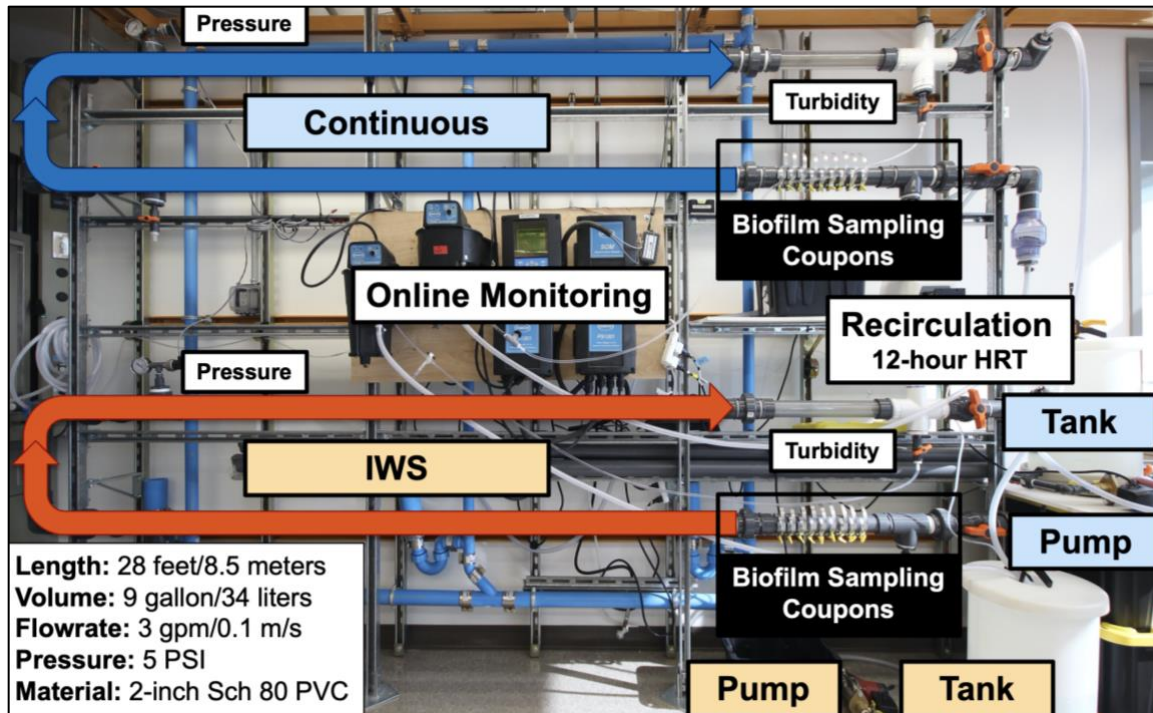
Figure 1. Both experimental pipeloops were supplied with water from the Amherst, MA town water distribution system.

For this study, we constructed two model drinking water distribution systems (DWDS) consisting of two identical piped recirculation systems. One was operated intermittently as an IWS (experiment) and the other operated continuously as a CWS (control) (Figure 1). The pipes were made of 2-inch diameter Schedule 80 PVC, as PVC piping is commonly used throughout regions experiencing IWS. Each pipeloop was 28-ft in total length (8.5 meters). The model was attached to a slotted metal framing strut channel hung vertically in the lab. The set-up was located in a temperature-controlled location with a setpoint temperature of 72 degrees C. Each pipeloop included a 0.06 HP circulation pump, 38 L cylindrical polypropylene reservoir tank with cover, and 2 sample taps. Water flow was maintained at 3gpm (0.1 m/s) and at a setpoint pressure of 5 PSI in the CWS at all times, and in the IWS during supply hours. A 12-hr hydraulic residence time (HRT) was created by using a dual channel chemical feed pump to pump fresh tap water into each tank at a rate that would replace the system volume (34 liters) twice per day. Inflowing fresh tap water from the chemical feed pump displaced water in the tank causing excess water volume to flow out of the system via an overflow valve in the reservoir tanks.

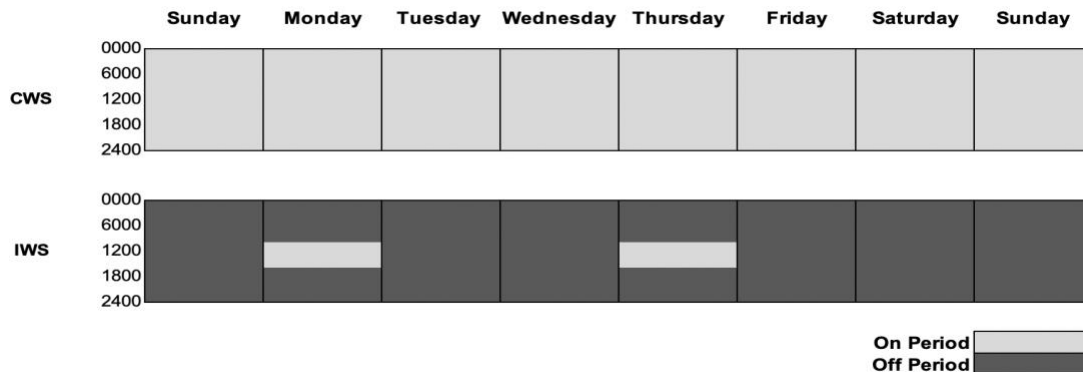
Figure 2. Visual diagram of the operational schedule used for the continuous and intermittent operation of the pipeloops.

The schedule for the intermittent water supply was an ‘on’ period of 6-hrs (~10am – 4pm) a day for two days a week, which were almost always Monday and Thursday, with a few exceptions (Figure 2). The system was operated by hand by turning the pump on and off. Water was drained from the intermittent system during ‘off’ periods in the supply schedule. The water was allowed to completely drain during IWS off periods to represent the draining of water in full scale distribution systems through leakage points that occur when the water supply is turned off. Water was drained through two sample ports at the bottom of each pipeloop. The continuous water supply was always ‘on’ at a steady flow rate, apart from several off periods needed for maintenance of the system.

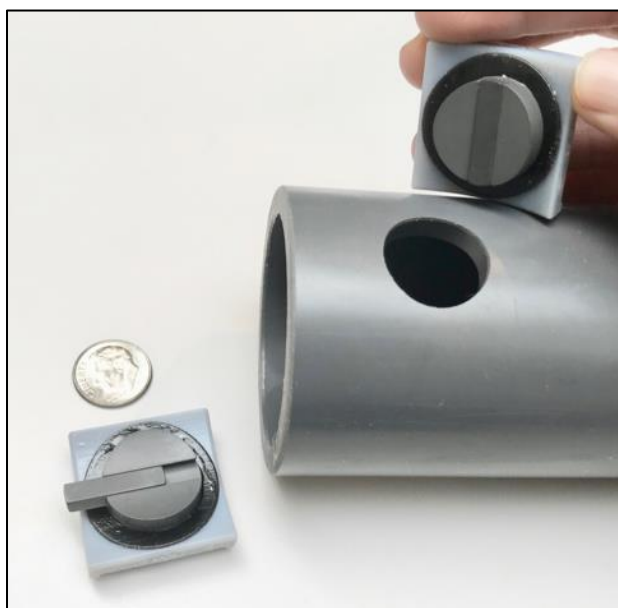
Figure 3. Biofilm sampler on left with an insert partially removed, with dime positioned above for scale. Biofilm samplers fit into holes drilled into pipe walls as demonstrated on the right. This design is based on the biofilm sampling coupon from the Pennine Water Group at the University of Sheffield (Deines et al. 2010).

Holes were drilled in a section of each pipeloop and biofilm samplers were inserted. The biofilm sampling coupons matched the design of Pennine Water Group (PWG) biofilm sampling coupons (Deines et al. 2010) (Figure 3). The biofilm samplers were cut from the same pipes used in the construction of the pipeloop so that they would match the internal curvature of the pipe. The biofilm samplers included a flat insert to be used for microscopic imaging and an outer surface for the later removal of biofilm to be used for future extraction of DNA for genetic analysis. Each pipeloop had a pipe section with 15 biofilm samplers: 9 samplers arranged at the bottom of the piped sections, 3 in the middle, and 3 at top. Biofilm samplers were arranged at the top, middle, and bottom of a pipe to provide information on potential variability of the biofilm at various positions around the pipe circumference. Biofilm samplers were wiped with 70% ethanol before being inserted into the pipeloop.

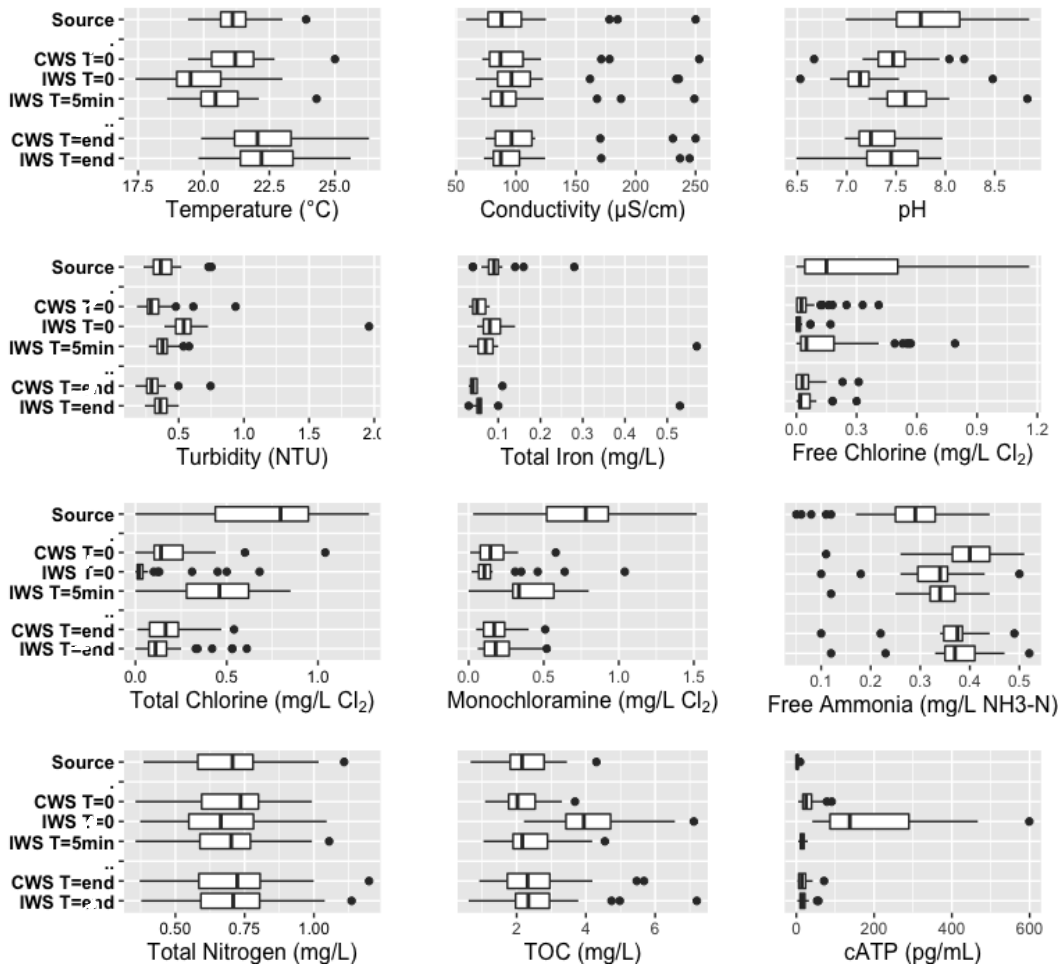
Figure 4. Box and whisker plots show the median, lower and upper quartiles, range, and outliers of water quality parameters of samples collected from Source; CWS at time 0 and end; and IWS at time 0, 5 minutes, and end. Sampling ranged from June 18 – November 19, 2019.

Results of water quality analysis from source water, the IWS pipelooop, and the CWS pipelooop are presented in Table 2 and Figure 3. Differences between the sample groups were found to be statistically significant across all parameters except conductivity ($p = 0.6100$) and total nitrogen ($p = 0.6473$). There was very little change in the median between the different groups for conductivity concentrations.

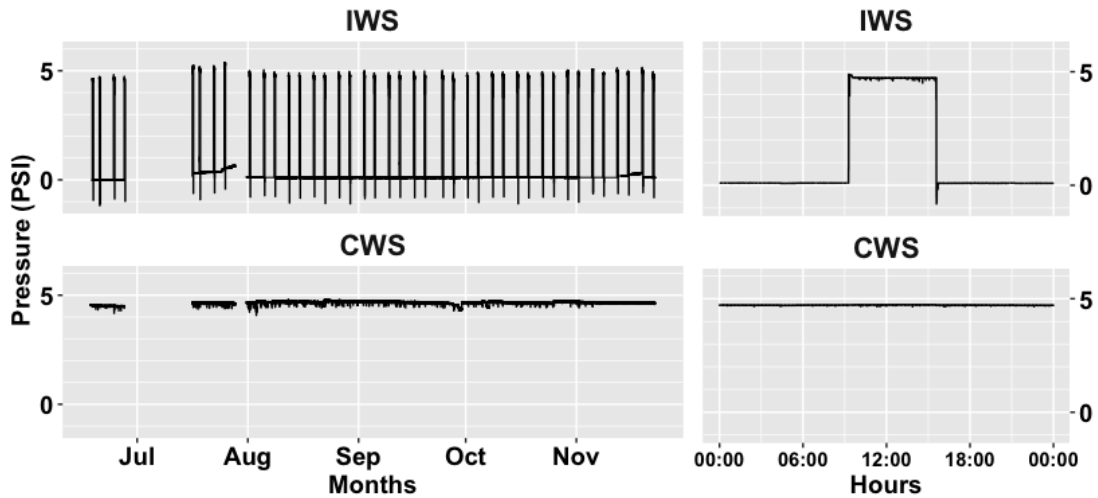
Figure 5. Pressure measured every 10 seconds over the 6-month experimental period (June 18 – November 19, 2019) in the CWS and IWS pipelooop (left). Pressure reading over a single day (September 5, 2019) in the CWS and IWS pipelooop (right). Gaps in data represent data lost due to equipment failures.

Pressure and turbidity were logged in each experimental pipelooop every 10 seconds. Mean IWS supply duration during the experimental period was 6hrs and 21 minutes. Pressure in the CWS remained at around 5 PSI. During an IWS “on” period, pressure rose almost immediately to approximately 5 PSI (Figure 5), similar to the CWS operating pressure, and remained until the

end. When the pump was switched off and water from the pipeloop was allowed to drain, pressure reached negative values of around -1 PSI. Negative pressures observed in the pipeloop may have important implications: in a full-scale distribution system, negative pressures can draw contaminated water or other substances surrounding the distribution system into the distribution system via backflow or intrusion. This intruded material may introduce pathogens and other contaminants.

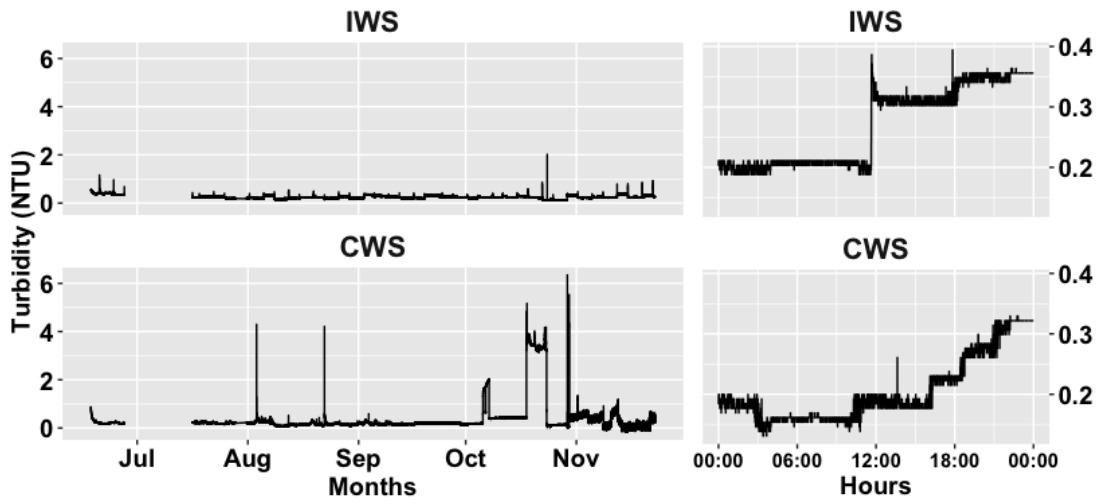
Figure 6. Turbidity measured every 10 seconds over the 6-month experimental period (June 18 – November 19, 2019) in the CWS and IWS pipelooop (left). Turbidity readings in a single day (September 5, 2019) in the CWS and IWS pipelooop (right). Gaps in data represent lost data.

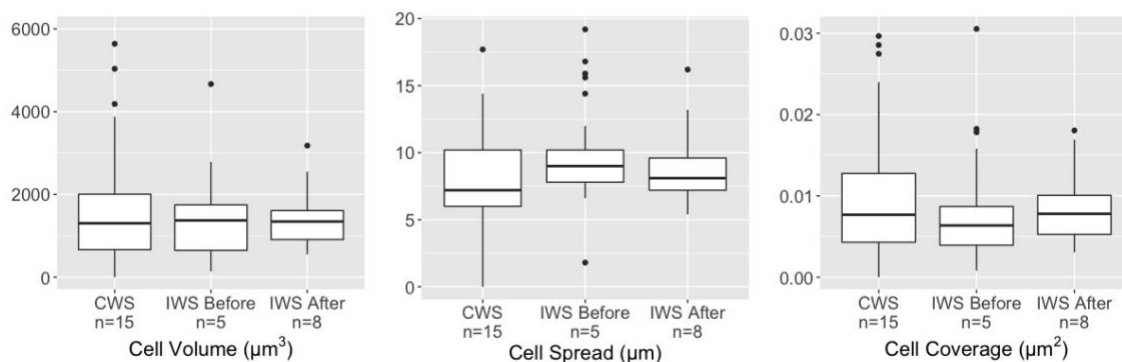
Figure 7. Comparison of biofilms sampled from the CWS supply and before and after an IWS supply cycle. Box and whisker plots show the median, lower and upper quartiles, range, and outliers of biofilm cell volume, biofilm cell spread, and biofilm density.

Results of biofilm analysis are presented in Table 3 and Figure 7. Biofilm samples were taken from the CWS pipeloo (n = 15) and from the IWS pipeloo before (n = 5) and after the IWS supply cycle (n = 8). Biofilm samples were also designated by position in the pipeloo pipe wall; bottom (n = 16), middle (n = 6), and top (n = 6). Samples were stained with DAPI to identify the cells that made up the biofilm and five fields of view, as replicates, were taken from each sample. Examples of images taken of the biofilms are presented in Figure 8.

Cell spread appeared to be the greatest in the IWS Before group among all the biofilms sampled from the various positions, with a median of 9.0 μm (Figure 7). This compared with a median of 8.1 μm in the CWS group and a median of 7.2 μm in the IWS After group. Both the IWS Before and IWS After groups had a larger cell spread than the CWS group. Among the IWS groups, the IWS Before had a thicker spread. This suggests that part of the biofilm in the IWS system may have been sheared off during IWS startup and operation and resulted in a loss of ‘thickness’ in the biofilm.

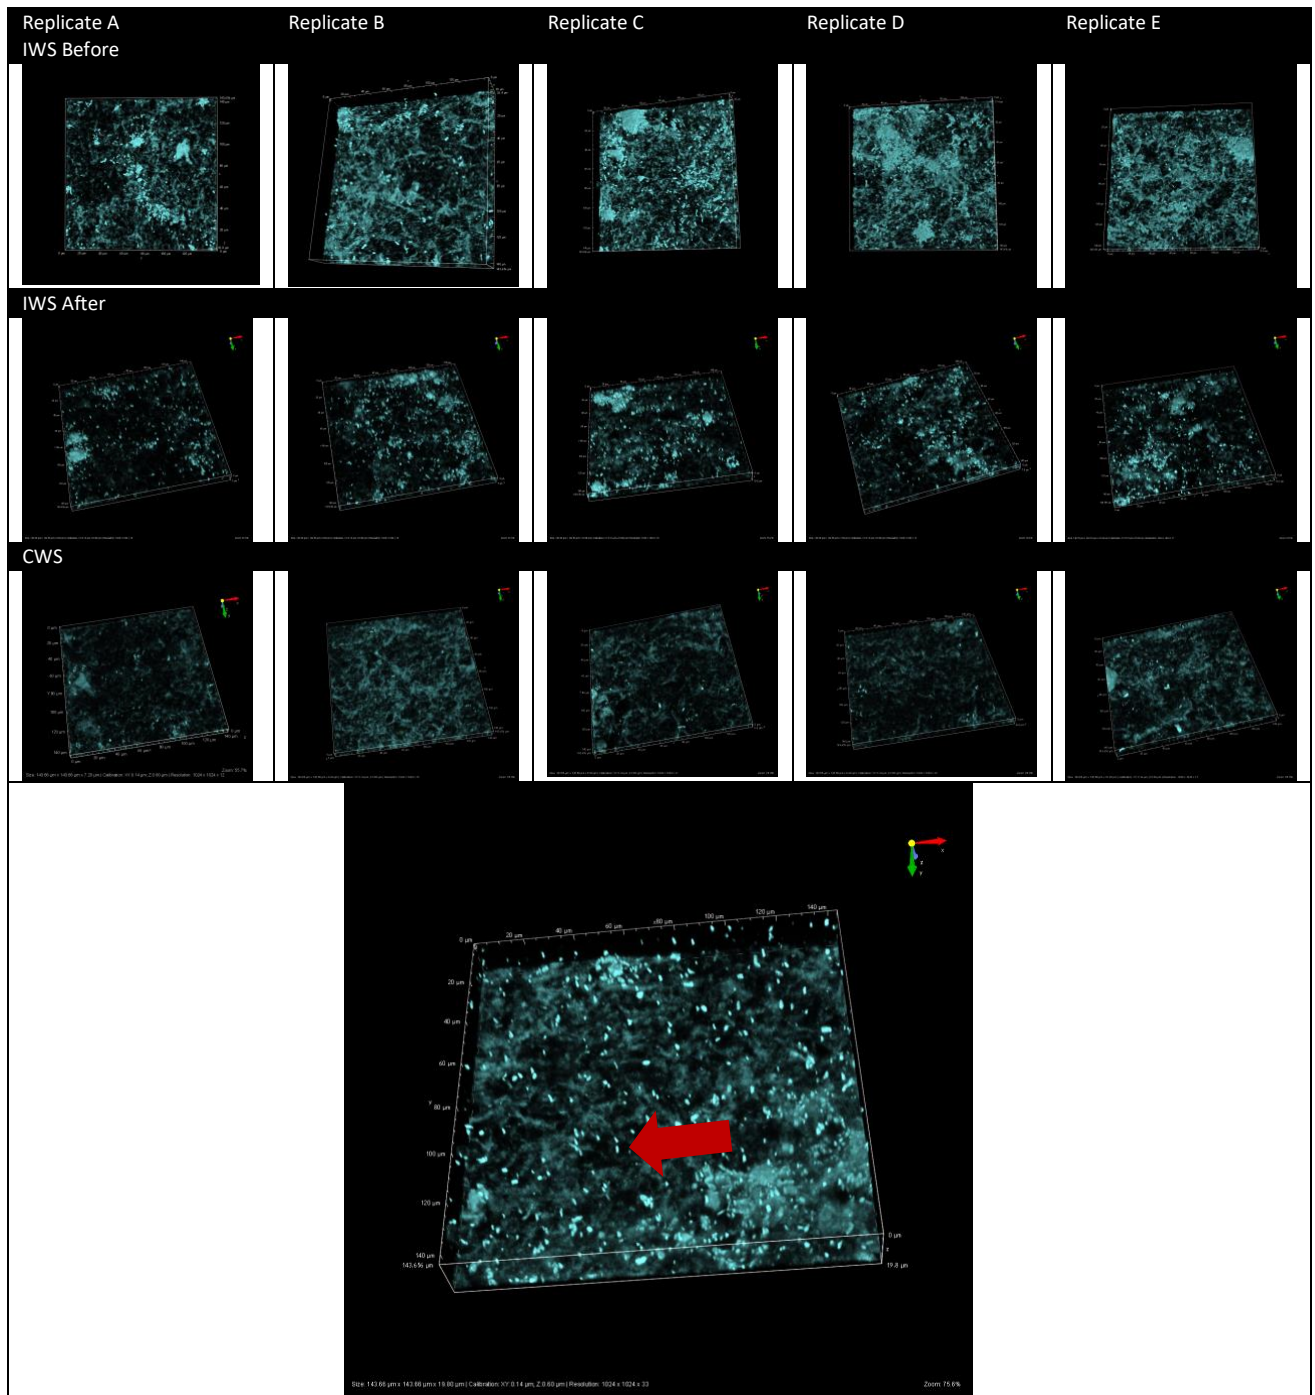
Figure 8: Selection of biofilm Z-stack images taken on a confocal scanning microscope that represent biofilms taken from the IWS before and after a supply cycle and from the CWS. At bottom is a zoomed in image for better illustration. Bright round objects are cells, an example of which is pointed out by the red arrow. Shading/noise on the bottom plane is autofluorescence from the plastic substrate of the biofilm insert. Cell spread was calculated by measuring the distance in the z-direction from the center of the bottom most and topmost cell in each image. This image was taken from a biofilm sampling coupon insert from an IWS system before the start of a supply cycle.

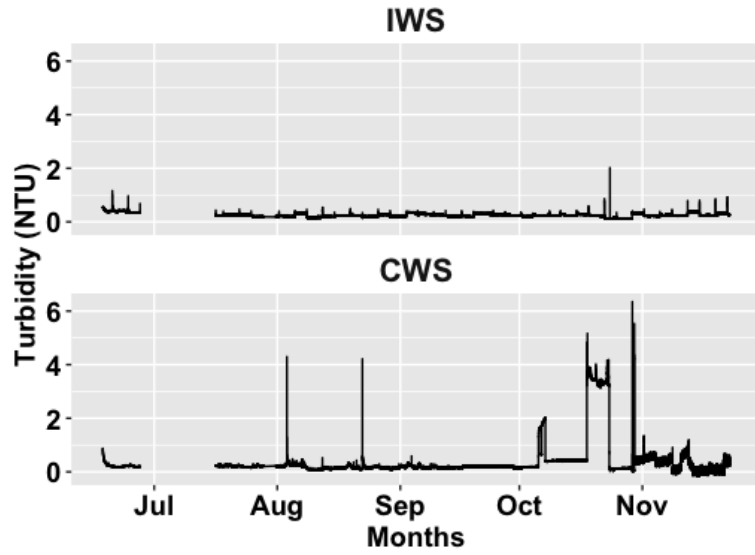
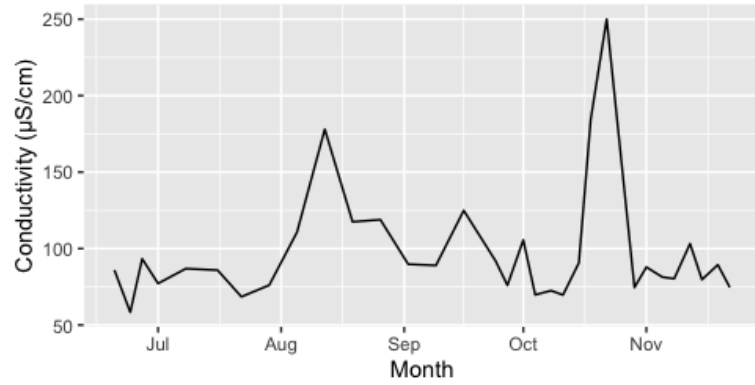
Figure S1. Comparison of online turbidity in the IWS and CWS pipeloops from June 18 – Nov 22, 2019 (a) compared to conductivity in the measured tap water coming into both of the pipeloo systems (b). Changes in turbidity may be due to water supply changes in the Town of Amherst, MA tap water as indicated by changes in conductivity over the same period.

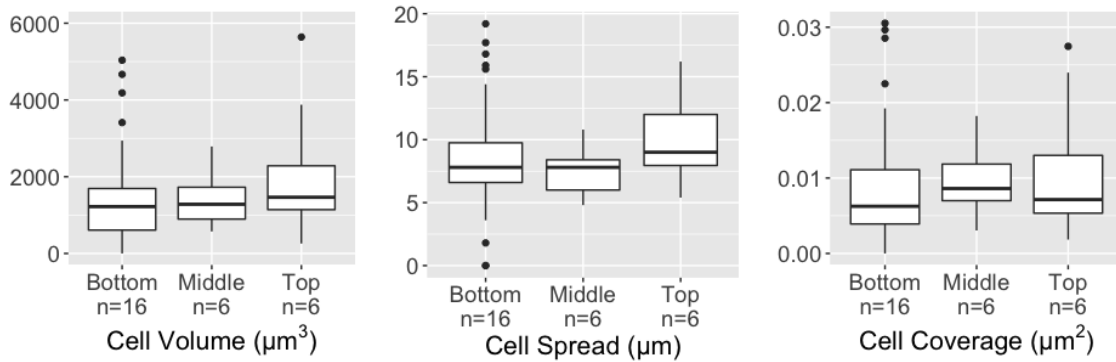
Figure S2. Comparison of biofilms sampled from biofilm samplers from the top, middle, and bottom position of the pipe wall. Box and whisker plots show the median, lower and upper quartiles, range, and outliers of biofilm cell volume, biofilm cell spread, and biofilm density.

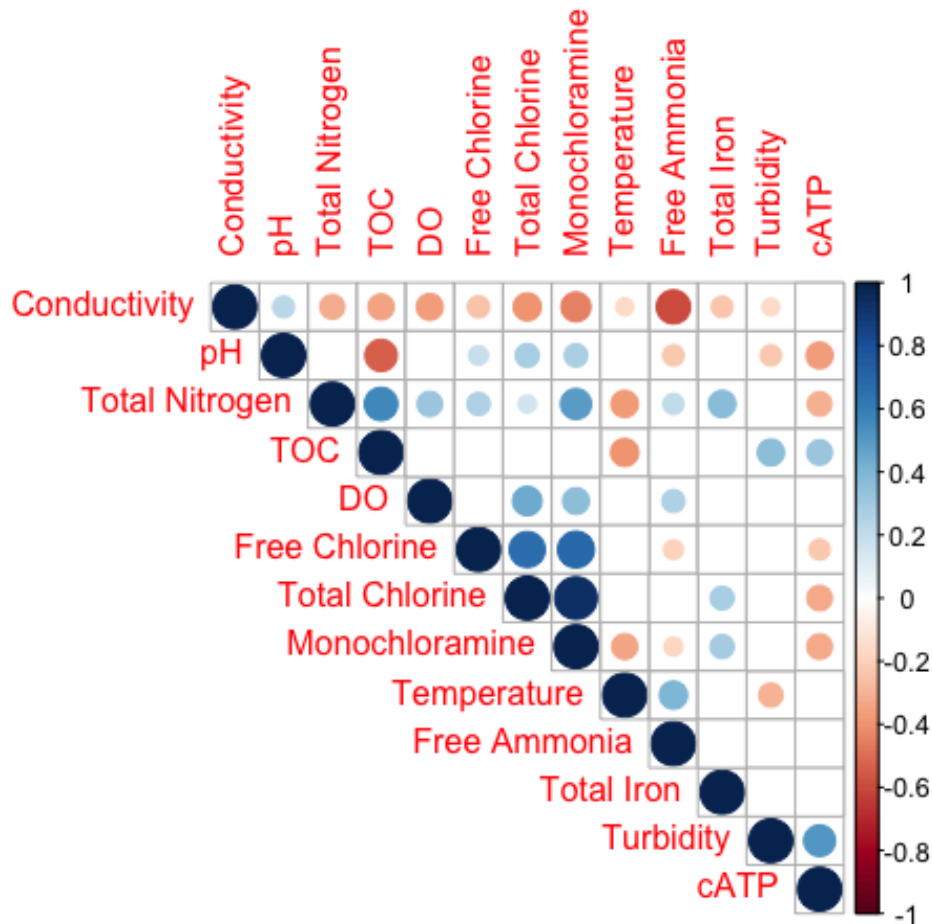
Figure S3. Correlation matrix of the water quality parameters measured from the bulk water samples. Positive correlations are displayed in blue and negative correlations in red. Color intensity and size of circle correspond proportional to the correlation coefficients. Insignificant correlations are blank ($p > 0.05$).

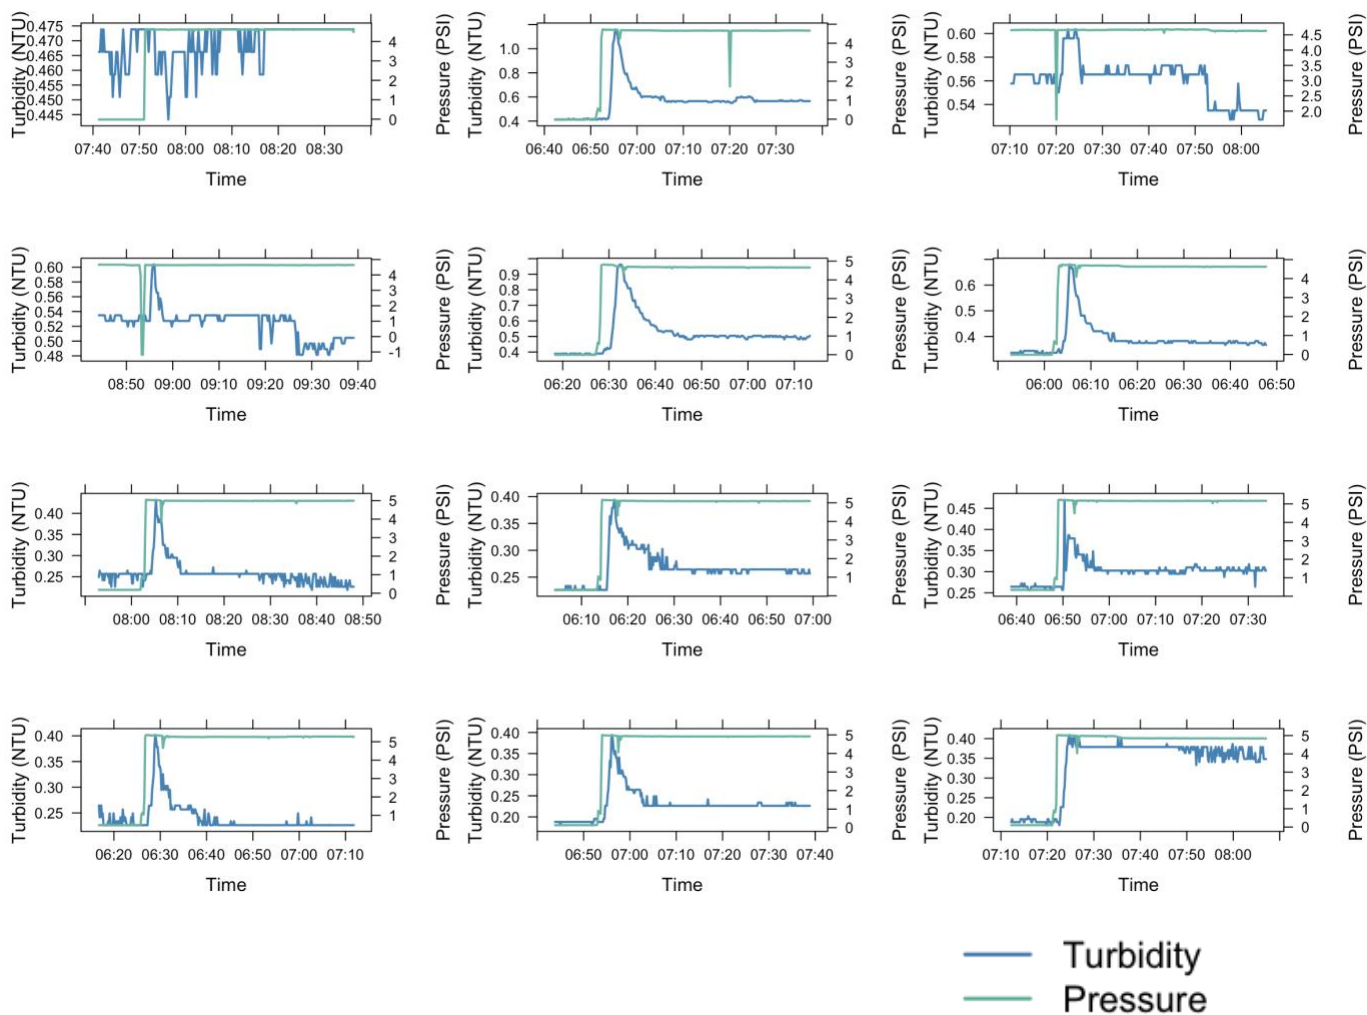
Figure S4. Matrix of plots of the first 12 instances of IWS supply cycle. Plotted are online pressure versus online turbidity for the first 5 minutes before an IWS on cycle and 1 hour after the IWS supply cycle. It is noted that turbidity spikes in about the first 5 minutes during IWS start up and then rapidly decreases and stabilize over the next 10 minutes after that.
